SERIOUS INCIDENT

Aircraft Type and Registration:	Boeing 757-2T7, G-MONK	
No & Type of Engines:	2 Rolls-Royce RB211-535E4-37 turbofan engines	
Year of Manufacture:	1988	
Date & Time (UTC):	13 December 2008 at 1045 hrs	
Location:	On approach to London Gatwick Airport, West Sussex	
Type of Flight:	Commercial Air Transport (Passenger)	
Persons on Board:	Crew - 8	Passengers - 78
Injuries:	Crew - None	Passengers - None
Nature of Damage:	None	
Commander's Licence:	Airline Transport Pilot's Licence	
Commander's Age:	51 years	
Commander's Flying Experience:	10,350 hours (of which 6,750 were on type) Last 90 days - 81 hours Last 28 days - 23 hours	
Information Source:	AAIB Field Investigation

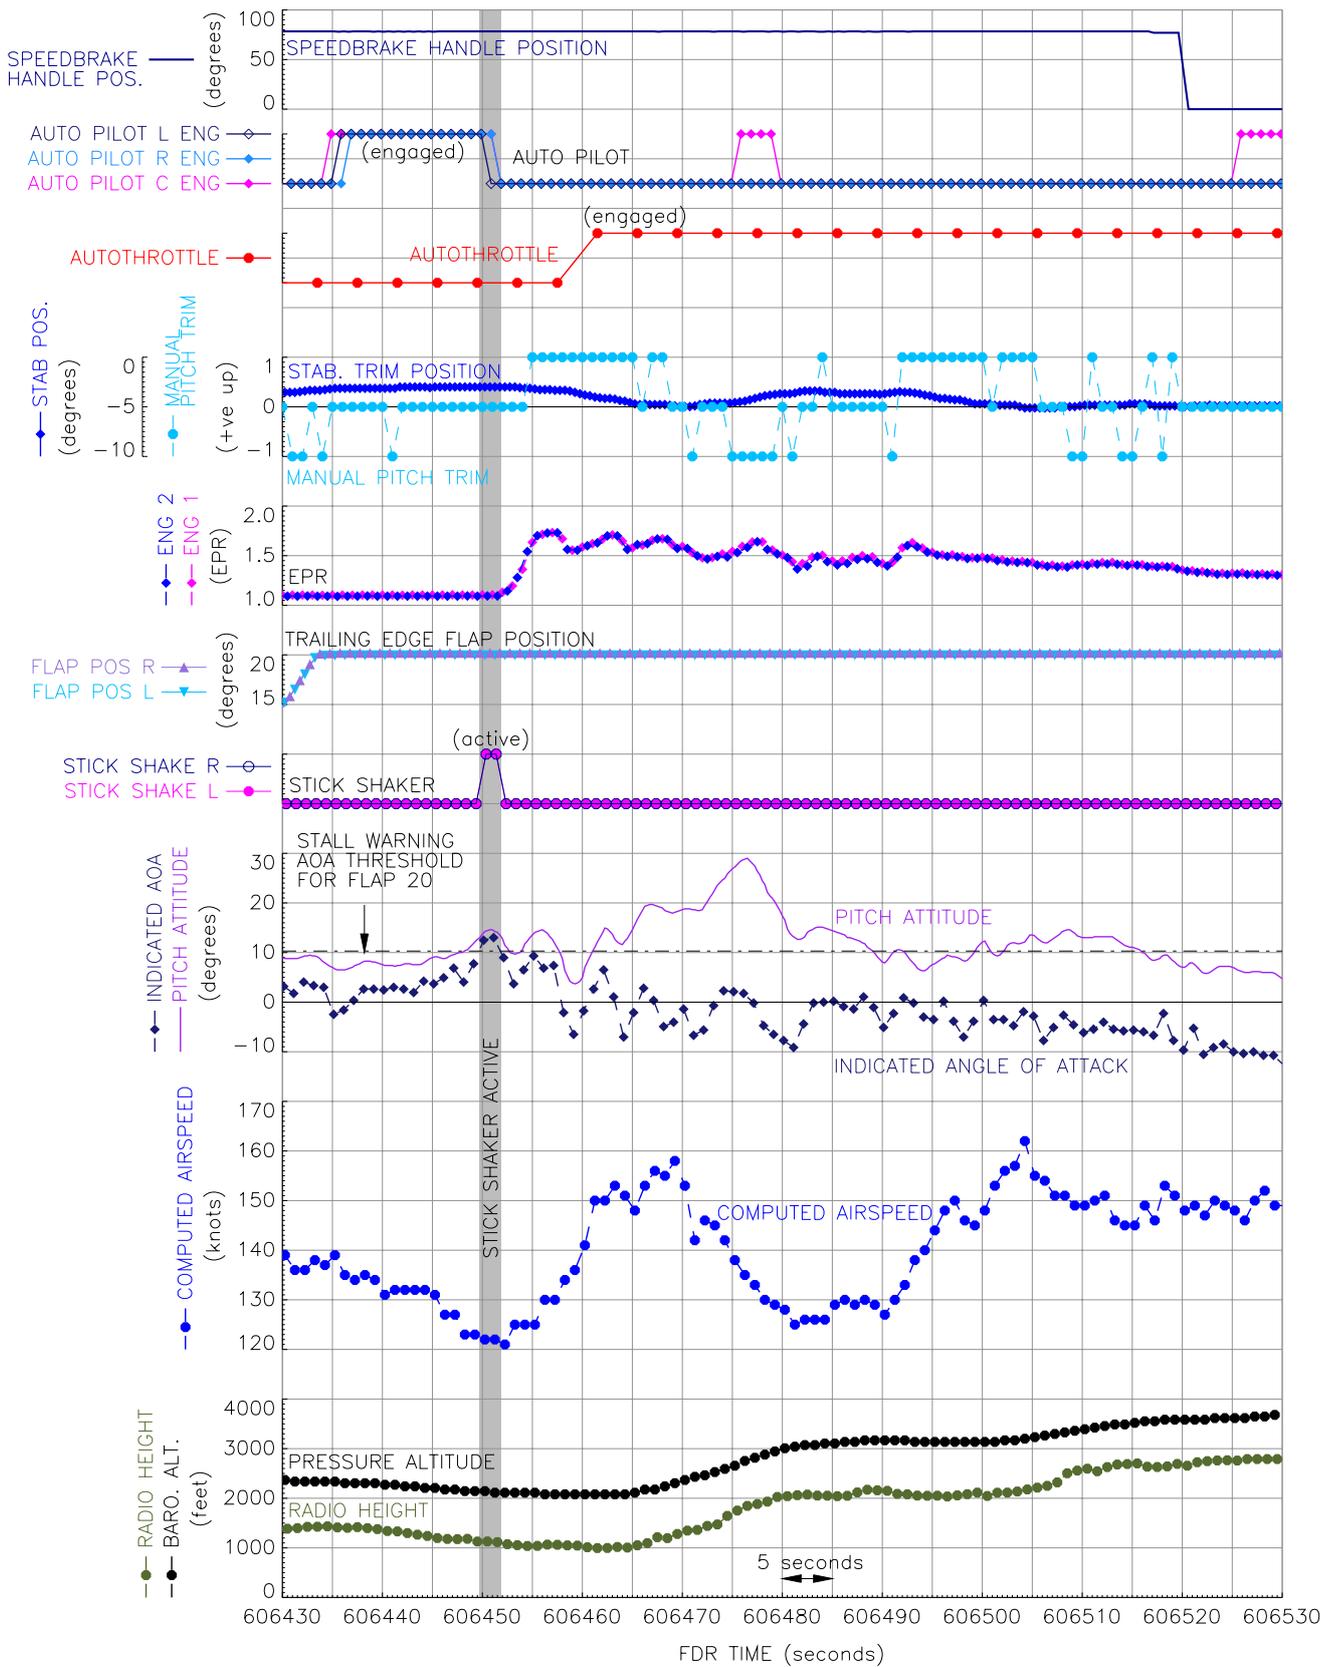
Figure 1
Salient FDR Parameters for the serious incident to G-MONK

Data downloaded from the FDR is shown in Figure 1. The data starts about 30 seconds after both the autopilot and auto throttle have been disengaged on the approach to LGW. The aircraft is at 2,400 ft pressure altitude, descending at 140 kt computed airspeed and slowing with the flaps extending to Flap 20 and the speedbrakes out. The engines are at a nominal Engine Pressure Ratio (EPR) of 1.10 and nose-down pitch trim was being manually applied.

As the flaps reached Flap 20, the autopilot was re-engaged. The aircraft continued to descend and slow; however, no further nose-down pitch trim was applied apart from one small burst (ie less than one second in duration). The pitch attitude then started to increase, from a nominal 7° nose-up, reaching 10° about 13 seconds later as the airspeed slowed to 123 kt. The angle of attack (alpha) was also increasing, and as the pitch reached 10°, the rate of increase for both alpha and pitch rose sharply. As alpha passed through 10.3° (the stall warning threshold for Flap 20), at a height of about 1,000 ft, the stick shaker activated and the autopilot disengaged. The stick shaker stayed active until the aircraft's pitch attitude was reduced and thrust applied: it was active for no more than two seconds. The speedbrakes remained extended.

About six seconds later, with the speedbrakes still out and as the aircraft accelerated to about 150 kt, the TOGA button was pressed. The aircraft continued to accelerate to 158 kt before slowing as it pitched up and climbed away. During the climb the maximum recorded nose-up pitch attitude was 28° (although the alpha was only about 2°) and the minimum recorded airspeed was 125 kt. The rest of the climb was uneventful, and, as the aircraft passed through 3,600 ft pressure altitude, the speedbrakes were retracted; 70 seconds after the stick shaker first activated.
