## Fournier RF4D, G-AWLZ

<b>AAIB Bulletin No: 7/2004</b>	<b>Ref: EW/G2004/04/11</b>	<b>Category: 1.3</b>
<b>Aircraft Type and Registration:</b>	Fournier RF4D, G-AWLZ	
<b>No &amp; Type of Engines:</b>	1 Volkswagen 1600 piston engine	
<b>Year of Manufacture:</b>	1968	
<b>Date &amp; Time (UTC):</b>	13 April 2004 at 1800 hrs	
<b>Location:</b>	Nympsfield, Gloucestershire	
<b>Type of Flight:</b>	Private	
<b>Persons on Board:</b>	Crew - 1	Passengers - None
<b>Injuries:</b>	Crew - None	Passengers - N/A
<b>Nature of Damage:</b>	Substantial to propeller, possible shock loading to engine and minor damage to fuselage	
<b>Commander's Licence:</b>	Private Pilot's Licence	
<b>Commander's Age:</b>	55 years	
<b>Commander's Flying Experience:</b>	1,708 hours (of which 153 were on type)	
	Last 90 days - 5 hours	
	Last 28 days - 5 hours	
<b>Information Source:</b>	Aircraft Accident Report Form submitted by the pilot and further AAIB enquiries

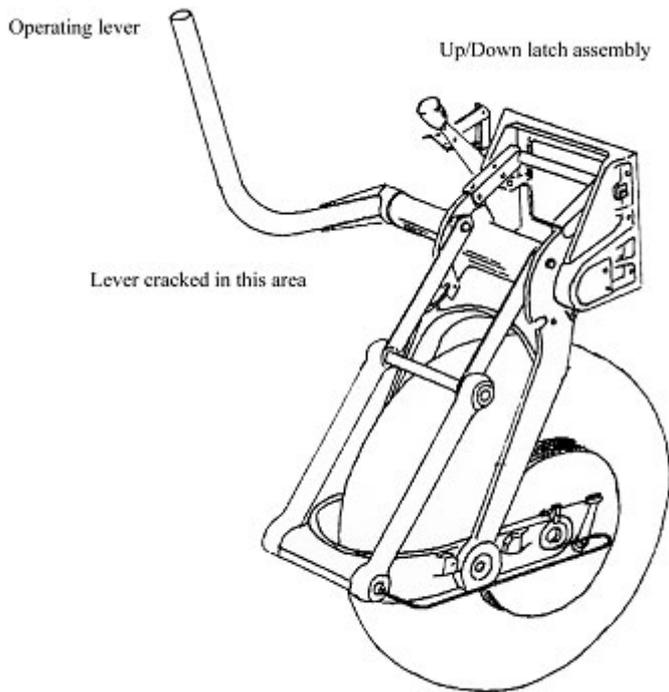
LANDING WHEEL GENERAL ARRANGEMENT

The maintenance organisation advised that a crack had been found at the base of the lever, and that it had separated from the rest of the assembly when the aircraft was recovered. Examination of the crack by the maintenance organisation showed that although the final fracture was new, there was evidence that some of the crack was old damage. It was surmised that the crack had been growing, so

that when the pilot moved the lever to the extended position, the lever moved without fully extending the gear or engaging the downlock latch.

The landing gear lever can be difficult to reach, and some pilots have been known to have had difficulty moving it fully forward and have used a foot to move the lever. It is well documented that very high forces can be exerted by foot pressure. In addition, the landing gear downstop is a strip of wood across the rear of the wheel bay, and on this aircraft it had become oil soaked and crushed allowing the gear to go beyond the point where the downlock latch would engage properly.

The area of the fracture is not easy to inspect, and this may account for these defects going undetected until the failure occurred.
