ACCIDENT

Aircraft Type and Registration:	Pegasus Quantum 15-912, G-BYNO	
No & Type of Engines:	1 Rotax 912 piston engine	
Year of Manufacture:	1999	
Date & Time (UTC):	5 April 2006 at 1225 hrs	
Location:	Clench Common Airfield, near Marlborough, Wiltshire	
Type of Flight:	Training	
Persons on Board:	Crew - 1	Passengers - 1
Injuries:	Crew - 1 (Serious)	Passengers - 1 (Serious)
Nature of Damage:	Aircraft destroyed; damage to other aircraft and barn roof	
Commander's Licence:	Private Pilot's Licence	
Commander's Age:	49 years	
Commander's Flying Experience:	14,000 hours approximately (of which about 600 were on type) Last 90 days - 22 hours Last 28 days - 8 hours	
Information Source:	AAIB Field Investigation, with the participation of the British Microlight Aircraft Association

Synopsis

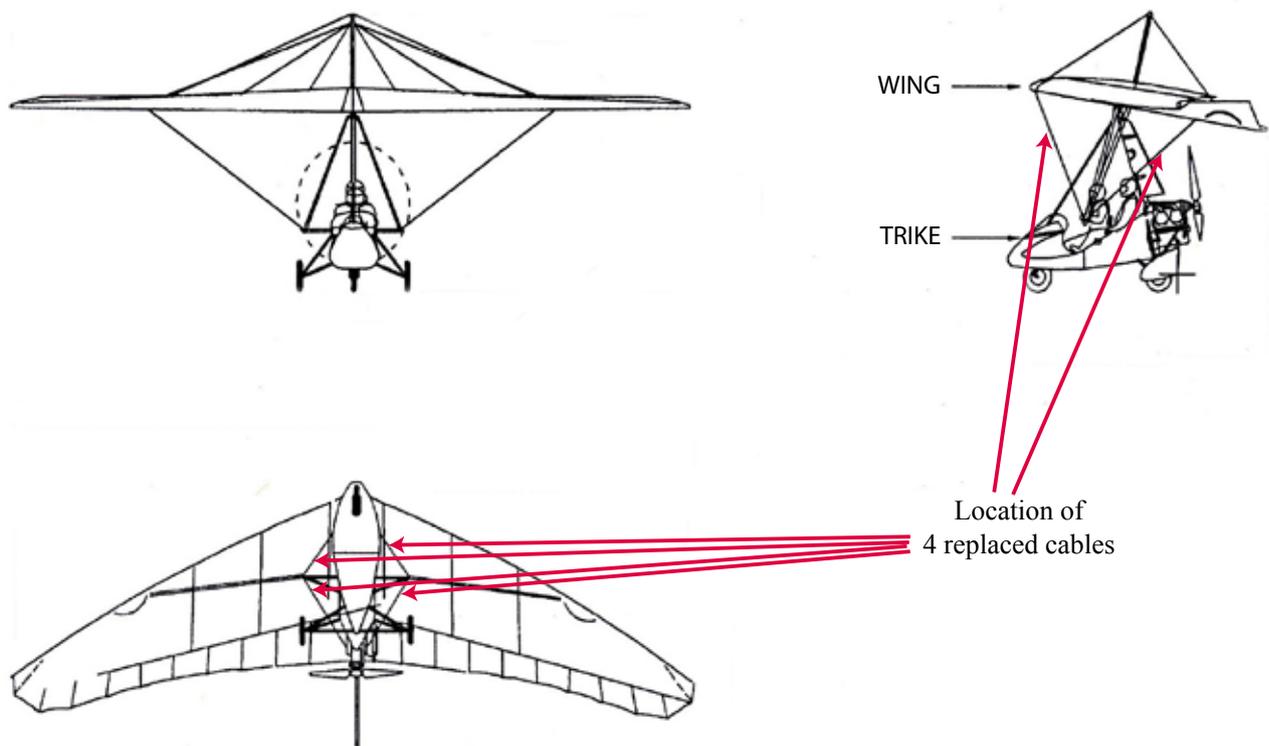
Figure 1a

Four rigging cables brace the control frame relative to the wing. Two cables run from the bottom of the left control frame, one forward and one rearwards, and similarly, two cables run from the bottom of the right control frame, one forward and one rearwards (see Figures 1a and 1b). These cable assemblies consist of

Aircraft layout and location of replaced cables

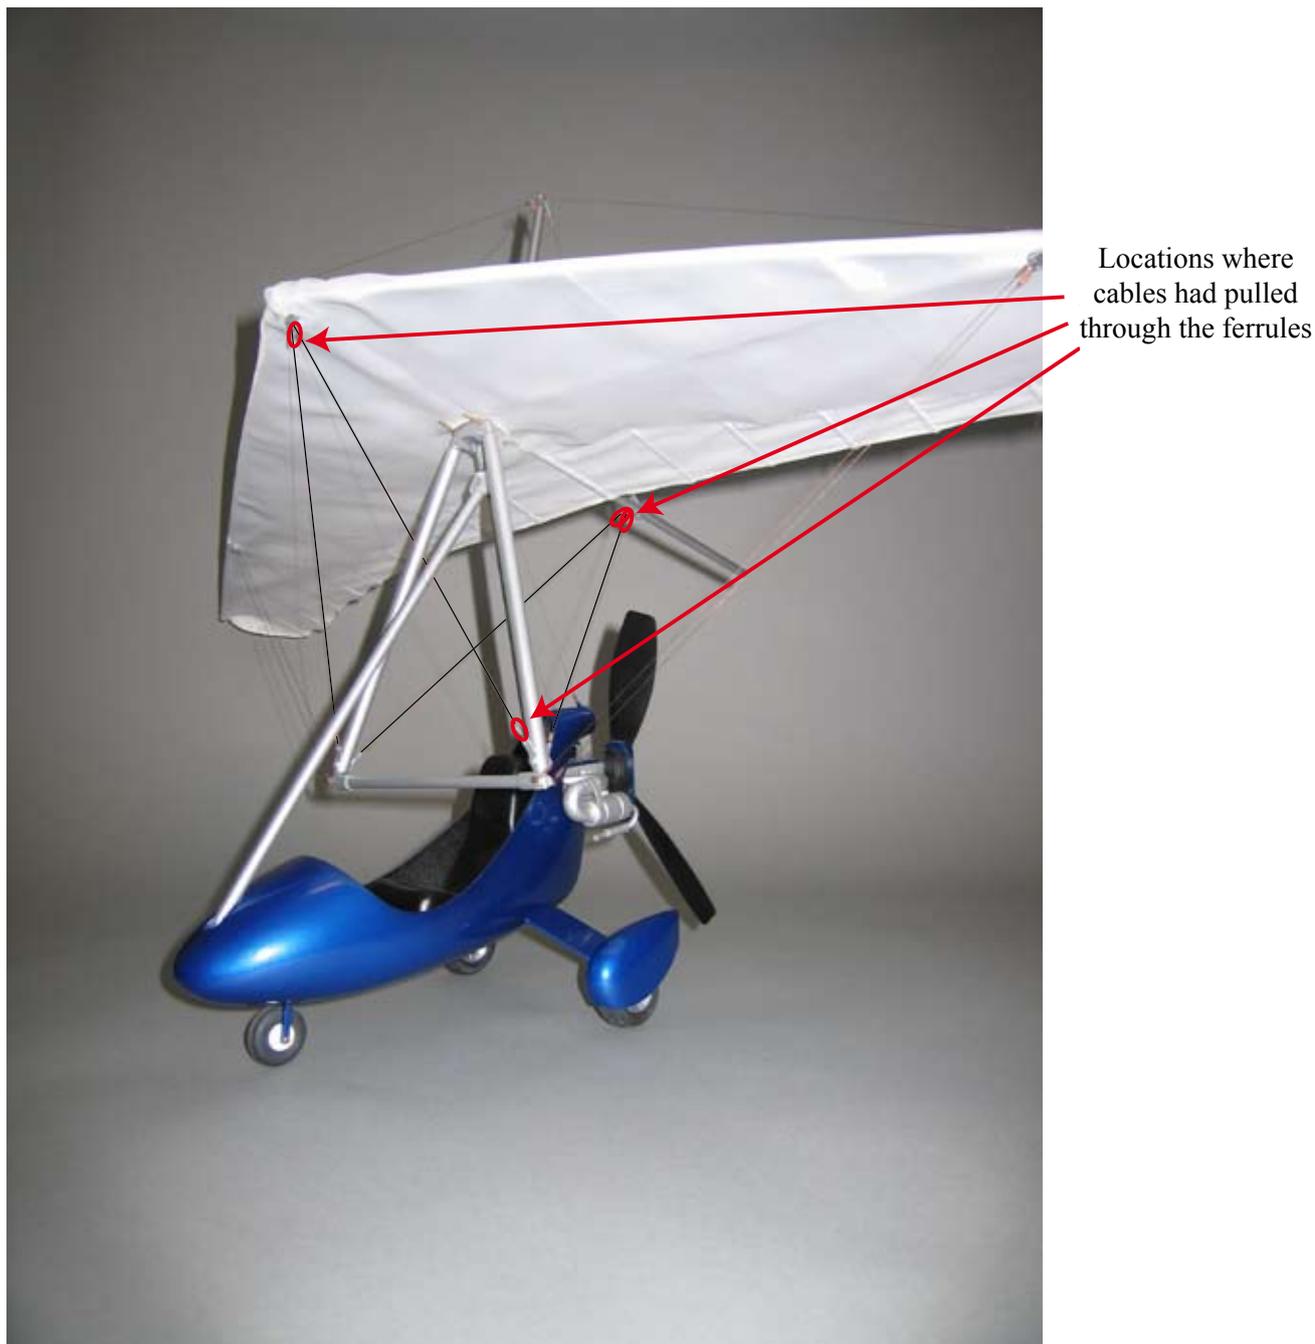
Figure 1b

Location of the failures in the cable assemblies
(Note: generic microlight model shown)

During the initial examination, failure of the ferrules to grip the wire rope at one end of each of the four rigging cable assemblies was evident. See Figure 2 for an example of failed ferrules (note the wire rope has pulled through the ferrules) and Figures 1a and 1b for a diagram showing the location of the four cables. No ferrules or plastic shrouds were found on the rear ends of the two

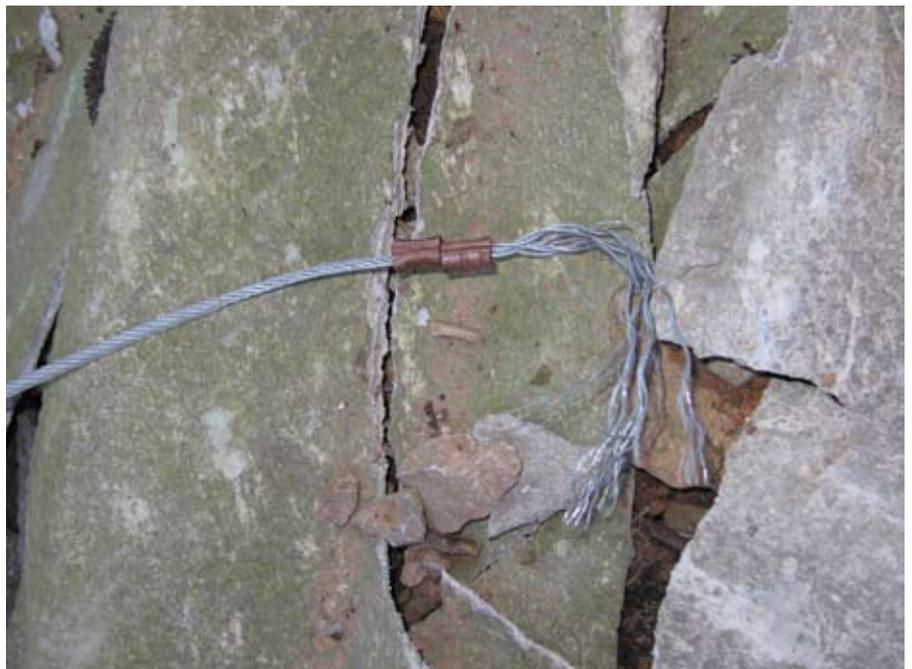
Figure 2

rear cables and these cable ends had damage consistent with having been struck by the propeller.

The G-BYNO cables pulled through the ferrules, indicative of insufficient purchase by the ferrules, without the wire rope failing. The two results for G-BYNO cables show significant variation and, importantly, it should be noted that the other ends of the cables tested must have failed on the aircraft at lower loads than those achieved during the tests. The destructive tests on the G-BYNO cables resulted in the appearance of the cable ends being similar to that found on the failed cables ends at the wreckage site - see Figure 2.

It is recommended that the BMAA update their Guide to Airworthiness to state clearly that only parts approved either by the manufacturer or in a BMAA approved modification, should be used for the replacement of all safety critical items.

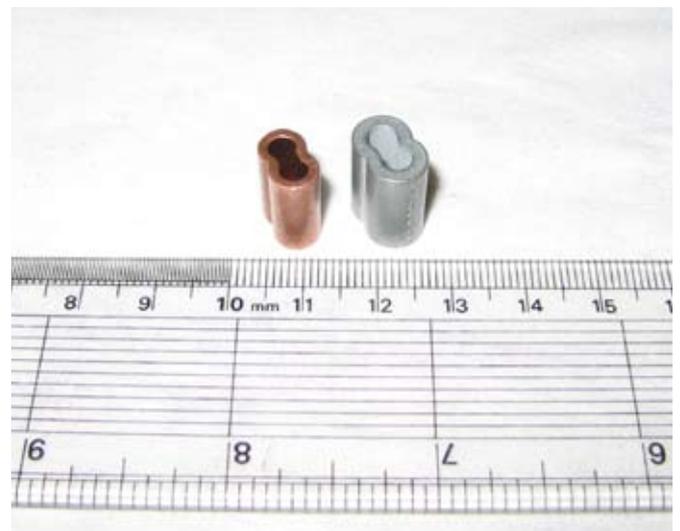
A comparison was made between the cable assemblies fitted to G-BYNO and a new set supplied from the manufacturers. The only discernable difference was the type of ferrule used; see Figure 3 for a comparison of uncrimped ferrules, and Figures 4a and 4b for a comparison of the end of cable assemblies. The following comparisons were made:

Two unused ferrules, one of the type used on G-BYNO and one of the type used in factory-supplied cables, were obtained. The widths, before crimping, were 11.0 mm and 13.2 mm respectively. Thus the effect of crimping the ferrules in G-BYNO was to reduce the width of the ferrule, ie produce a neck, in two places, typically from 11.0 mm to 8.5 mm; a compression of 2.5 mm. For the

manufacturer's supplied cables the reduction was from 13.2 to 9.2 mm; a compression of 4.0 mm.

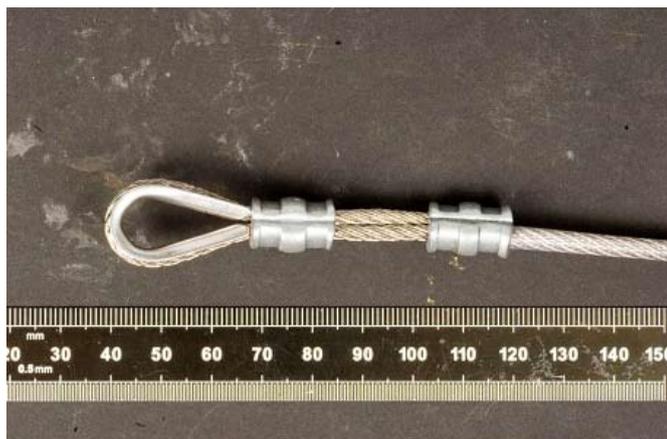
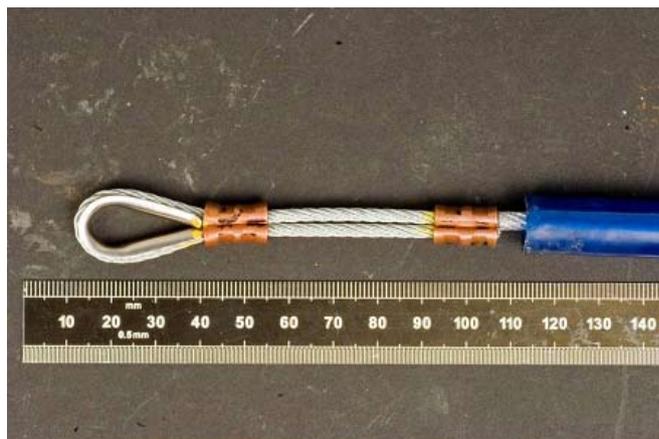
**Figure 4a***Photo: QinetiQ*

End of cable assembly (factory-supplied)

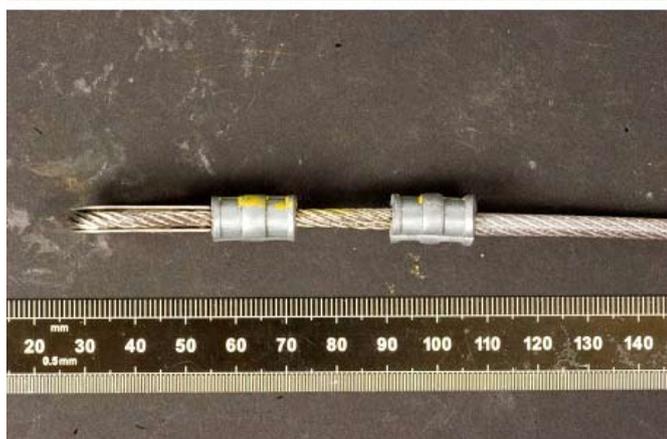
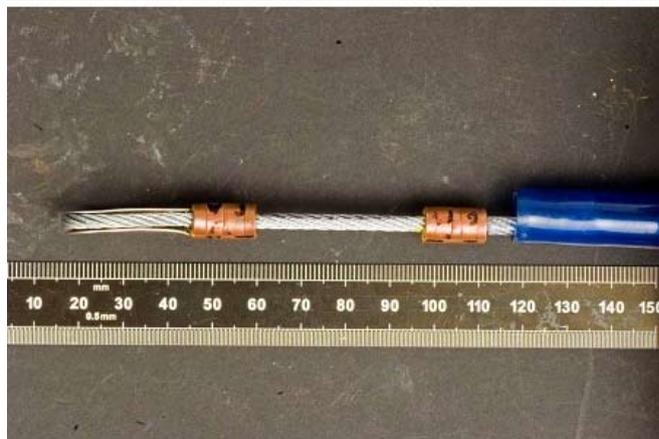
Figure 4b*Photo: QinetiQ*

End of cable assembly (G-BYNO)

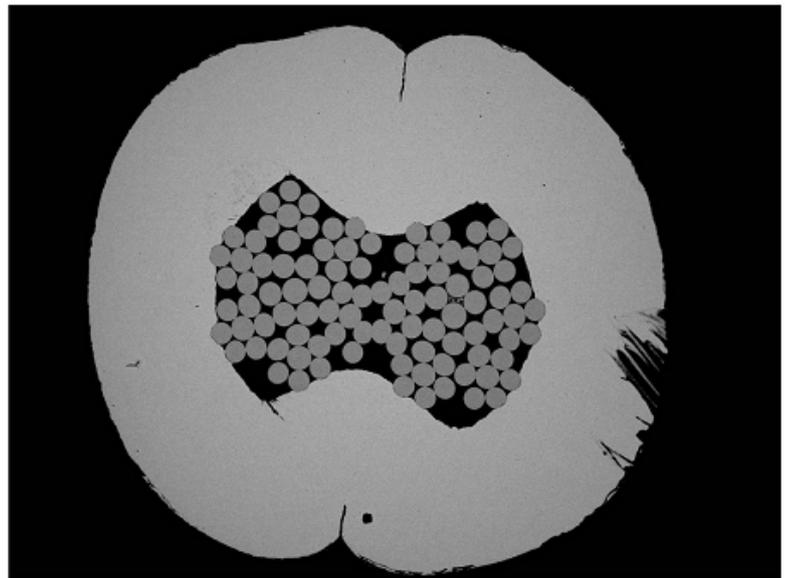
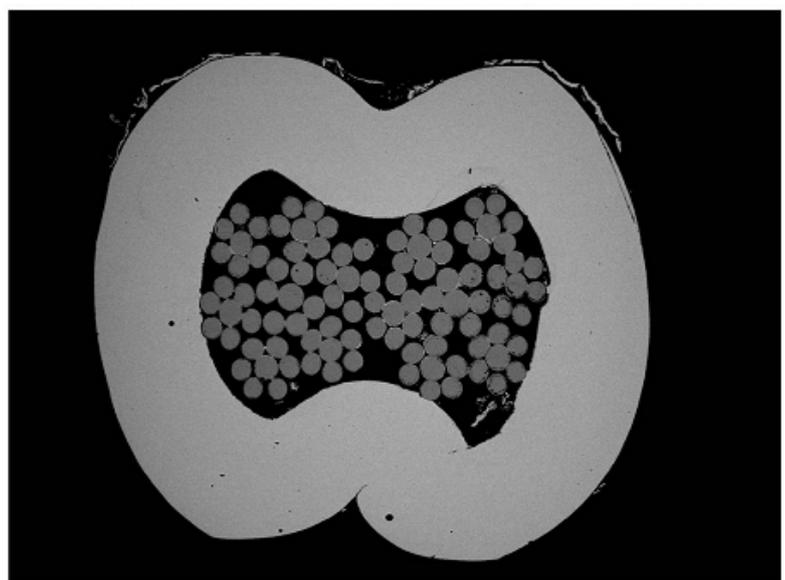
Figures 5a (top) and 5b (bottom)

The end of one cable assembly from G-BYNO that did not fail, and a comparable factory-supplied item were sectioned and polished. The sections were made through the ferrules and wire rope in the region of the neck produced by crimping. Figure 5a and Figure 5b show the sections from the factory-supplied cables and G-BYNO respectively. Comparing the two sections it is evident that for the factory-supplied items there is:

- a) more contact between strands of the wire rope and the ferrule;
- b) more contact between the strands and other strands of wire rope;
- c) less void space.

Sections through crimped ferrules

These tests also confirmed that the tested cables from G-BYNO failed as a result of the wire rope pulling through the ferrules. This resulted in the cable ends having a similar appearance to those found at the wreckage site. The lower wall thickness of the ferrules used for the G-BYNO rigging cables appears to have resulted in reduced grip on the wire rope and this conclusion is supported by the comparative photographs of the sections through the cable assemblies. The copper used in the ferrules for G-BYNO was harder
