**INCIDENT**

<b>Aircraft Type and Registration:</b>	Piper PA-28-181 Cherokee Archer II, G-BNGT	
<b>No &amp; Type of Engines:</b>	1 Lycoming O-360-A4M piston engine	
<b>Year of Manufacture:</b>	1985	
<b>Date &amp; Time (UTC):</b>	17 December 2005 at 1130 hrs	
<b>Location:</b>	Edinburgh Airport	
<b>Type of Flight:</b>	Private	
<b>Persons on Board:</b>	Crew - 2	Passengers - 1
<b>Injuries:</b>	Crew - None	Passengers - None
<b>Nature of Damage:</b>	Damage to nose landing gear assembly and propeller tips	
<b>Commander's Licence:</b>	Commercial Pilot's Licence	
<b>Commander's Age:</b>	53 years	
<b>Commander's Flying Experience:</b>	5,729 hours (of which 1615 were on type) Last 90 days - 39 hours Last 28 days - 12 hours	
<b>Information Source:</b>	Aircraft Accident Report Form submitted by the pilot and metallurgical examination of components returned to the AAIB

**Synopsis**

Prior to takeoff the aircraft suffered a nose landing gear collapse. Stress corrosion was identified in the failed component.

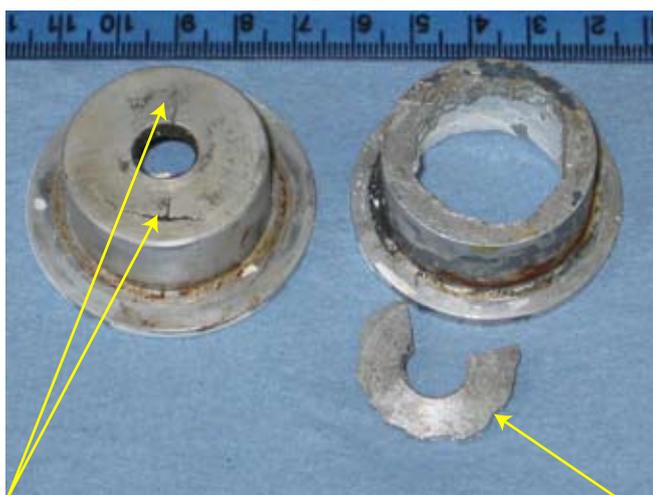
**Figure 2**

The failed axle plug was returned to the AAIB for metallurgical examination. The end of the plug had been plastically deformed prior to being separated from the remains of the plug, the final failure being mainly in shear (see Figure 2). Paint was present on parts of the fracture faces indicating that the separation had been progressive and that the cracks were present when the component was last painted. Examination of the failure surfaces indicated that multiple progressive, intergranular corrosion paths were present, which is

typical of a slow stress corrosion mechanism in extruded aluminium alloys. Stress corrosion occurs under the simultaneous action of a tensile stress and a corrosive environment. The general direction of progression was normal to the radial tension stresses induced by the plastic deformation. It is considered that the deformation resulted from over tightening of the nut on the wheel through bolt.

Radial and circumferential cracking on similar axle plug

Failed plug with plastic deformation of the end piece and 'castellated' nature of fracture

Failed axle plug (right) and plug (left) showing similar cracking

Several other axle plugs were also returned to the AAIB by the maintenance organisation. All showed some distortion similar to the accident axle plug, and one showed similar radial and circumferential cracking (see Figure 2) although it had not failed. The maintenance organisation policy is now to change the axle plugs whenever distortion is observed during any disassembly of the axle.
