SERIOUS INCIDENT

Aircraft Type and Registration:	Boeing 747-412, B-KAG	
No & Type of Engines:	4 Pratt & Whitney PW4056 turbofan engines	
Year of Manufacture:	1992	
Date & Time (UTC):	1 March 2008 at 0128 hrs	
Location:	Manchester Airport	
Type of Flight:	Commercial Air Transport (Cargo)	
Persons on Board:	Crew - 2	Passengers - None
Injuries:	Crew - None	Passengers - N/A
Nature of Damage:	Damage to Nos. 1, 2 and 4 engine nacelles, one main landing gear tyre ruptured	
Commander's Licence:	Airline Transport Pilot's Licence	
Commander's Age:	48 years	
Commander's Flying Experience:	10,800 hours (of which 699 were on type) Last 90 days - 188 hours Last 28 days - 55 hours	
Information Source:	AAIB Field Investigation

Synopsis

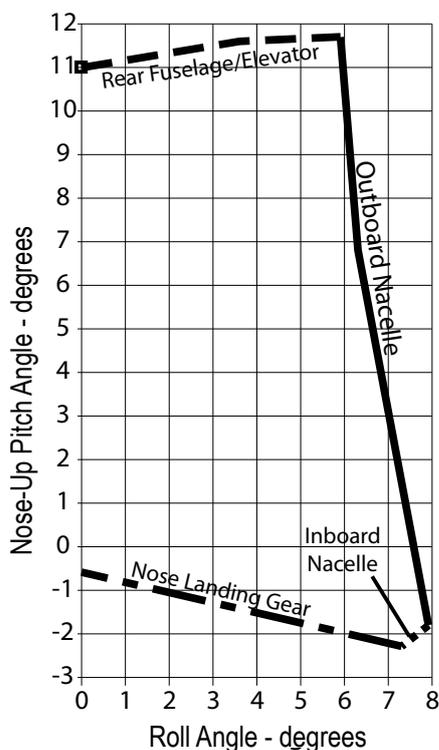
With the landing gear wheels in ground contact, the clearance of the engine nacelles from the ground is primarily dependent on the combination of aircraft pitch and bank angles. The nominal combinations at which the nacelles contact the ground are shown in Figure 2 (MLG shock struts compressed). Nacelle ground clearance

is also affected by wing bending due to aerodynamic and inertial loading. With B-KAG standing on all five landing gears, the average nacelle ground clearance was measured at 1.81 m (5.93 feet) for the outboard nacelles and 0.99 m (3.25 feet) for the inboards.

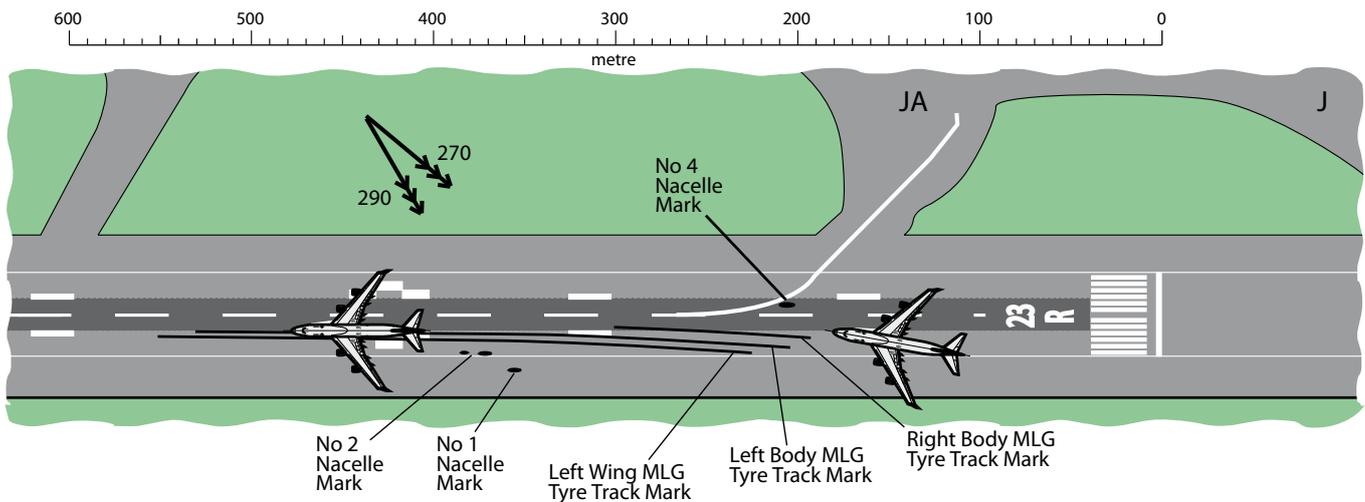
Figure 4
Runway marks

Examination of Runway 23R revealed a number of scrape marks, indicative of nacelle contact, and several tyre track marks that, by virtue of their relative locations and by comparison with the aircraft damage, could be matched to B-KAG's landing (Figure 4).

The initial mark, from the right body MLG tyres, started around 193 m from the threshold. This was almost immediately followed by a short scrape mark, 6.1 m right of the runway centreline, caused by momentary contact of the No 4 nacelle, and by the start of tracks from the left body MLG tyres. The markings indicated that the aircraft Centre of Gravity (CG) was around 15 m left of the runway centreline at initial touchdown, with the aircraft tracking approximately 4° right of the runway heading. Tracks from the left wing MLG started at 226 m.

The MLG tyre tracks continued, curving to the left. A short scrape mark from the No 1 nacelle started at 359 m and two short scrape marks from the No 2 nacelle started at 375 m. The tyre tracks showed that by around 500 m B-KAG was tracking parallel to the runway, approximately 8 m left of the centreline.

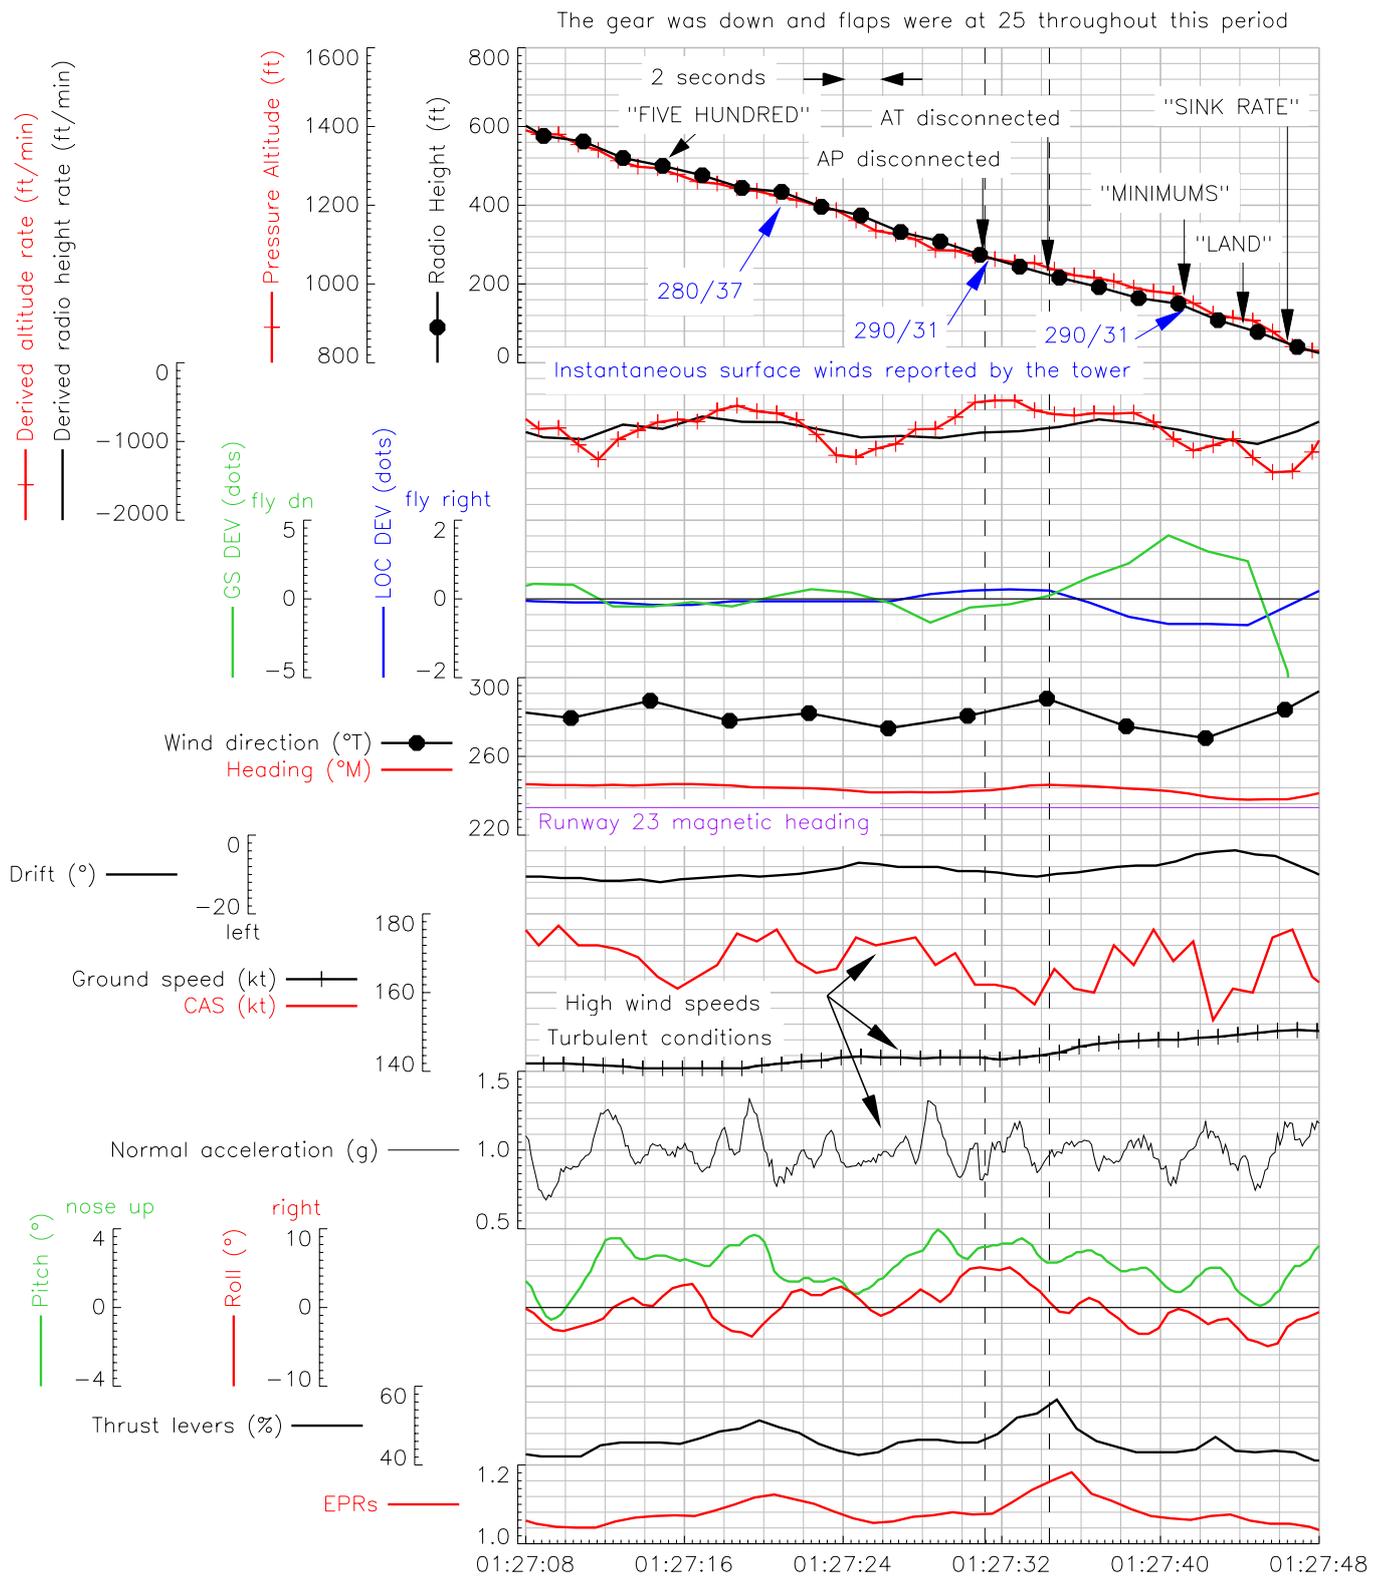
Figure 5
Salient FDR parameters - final approach

The next call was 280°/21 kt gusting 36 kt. This was followed 13 seconds later by the automatic 500 ft callout and then periodic ‘instantaneous’ surface winds as shown in Figure 5.

Figures 5 and 6 show the recorded information during the final approach and landing. Of note are the gusty conditions evident in the data. The only wind parameter recorded was the wind direction and this was only recorded once every 4 seconds, which is inadequate for analysis of the prevailing wind conditions.

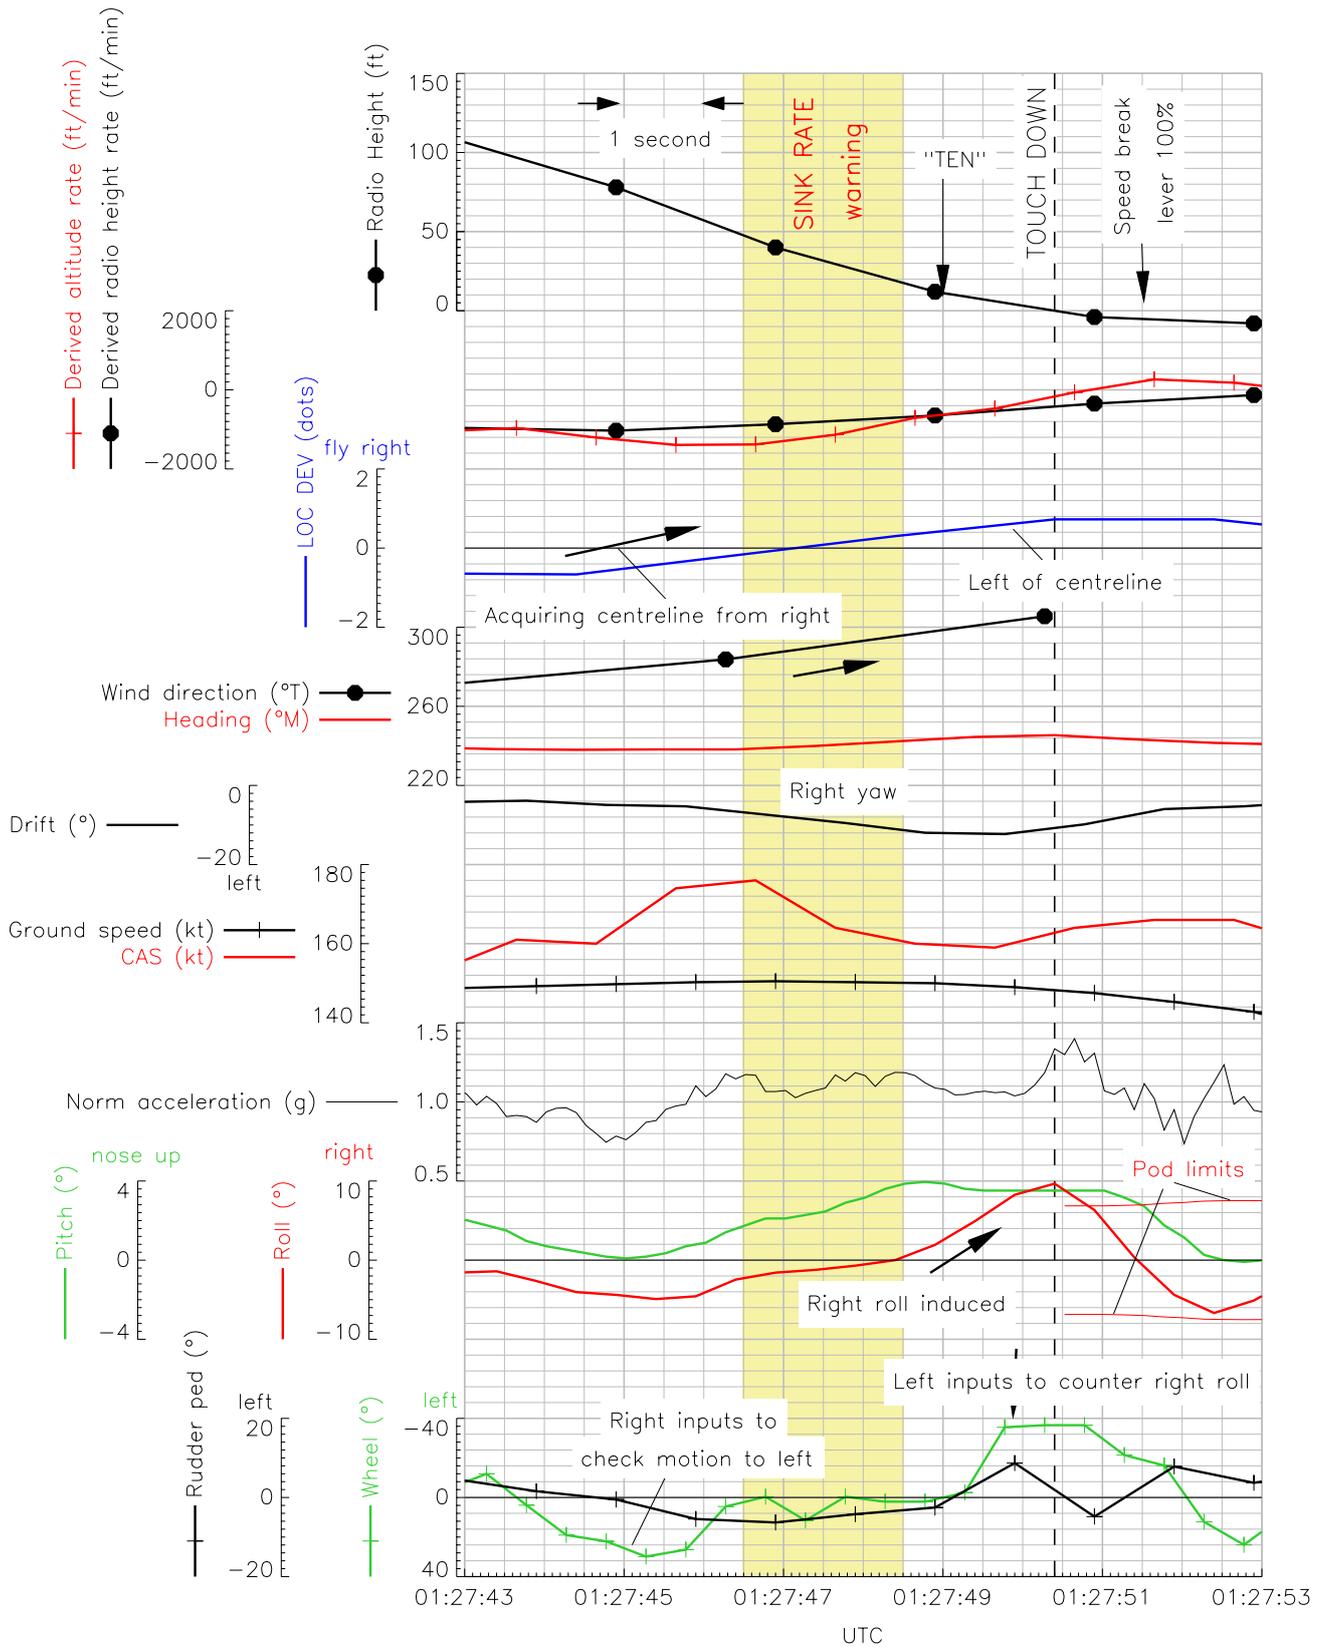
Figure 6
Salient FDR parameters - landing
Flight data analysis by aircraft manufacturer

The autopilot and autothrottle systems were disconnected at approximately 270 ft agl and 220 ft agl, respectively. During this period “MINIMUMS” was called and the captain responded with “LAND”. At this point the aircraft was slightly to the right of the centreline and rolling left to recover the centreline. Right pedal and roll inputs were made, checking the left bank and motion at the same time that the wind speed started to ramp up and change direction so it was mostly from the right of the aircraft. The aircraft started yawing right and rolling right. Left control wheel and rudder inputs were made, slowing the rate of roll to the right but not stopping it before touchdown.

At touchdown, the aircraft was to the left of the centreline and had a recorded right roll of 9.7°. This exceeded the nominal ‘pod scrape’ roll limit for the recorded pitch angle. At the point of touchdown only a small Normal acceleration was measured. However, it is worthy of note that the sensor position is inappropriate for measuring forces at the wing.

The aircraft rolled left and the maximum recorded left roll was 6.7°. This did not exceed the nominal 7.5° pod scrape roll limit for the recorded pitch angle but the peak value of roll may not have been recorded and the pod scrape limit would not account for dynamic flexing of the wing. The rollout then stabilised.
