**ACCIDENT**

<b>Aircraft Type and Registration:</b>	Cameron Z-350 balloon, G-VBFG	
<b>No &amp; Type of Engines:</b>	None	
<b>Year of Manufacture:</b>	2007	
<b>Date &amp; Time (UTC):</b>	5 March 2011 at 1604 hrs	
<b>Location:</b>	Ulpha, near Broughton-in-Furness, Cumbria	
<b>Type of Flight:</b>	Commercial Air Transport (Passenger)	
<b>Persons on Board:</b>	Crew - 1	Passengers - 16
<b>Injuries:</b>	Crew - None	Passengers - 2 (1 Serious) (1 Minor)
<b>Nature of Damage:</b>	51 panels damaged	
<b>Commander's Licence:</b>	Commercial Pilot's Licence	
<b>Commander's Age:</b>	50 years	
<b>Commander's Flying Experience:</b>	887 hours (of which 139 were on type) Last 90 days - 11 hours Last 28 days - 4 hours	
<b>Information Source:</b>	Aircraft Accident Report Form submitted by the pilot and further enquiries by the AAIB

**Synopsis**

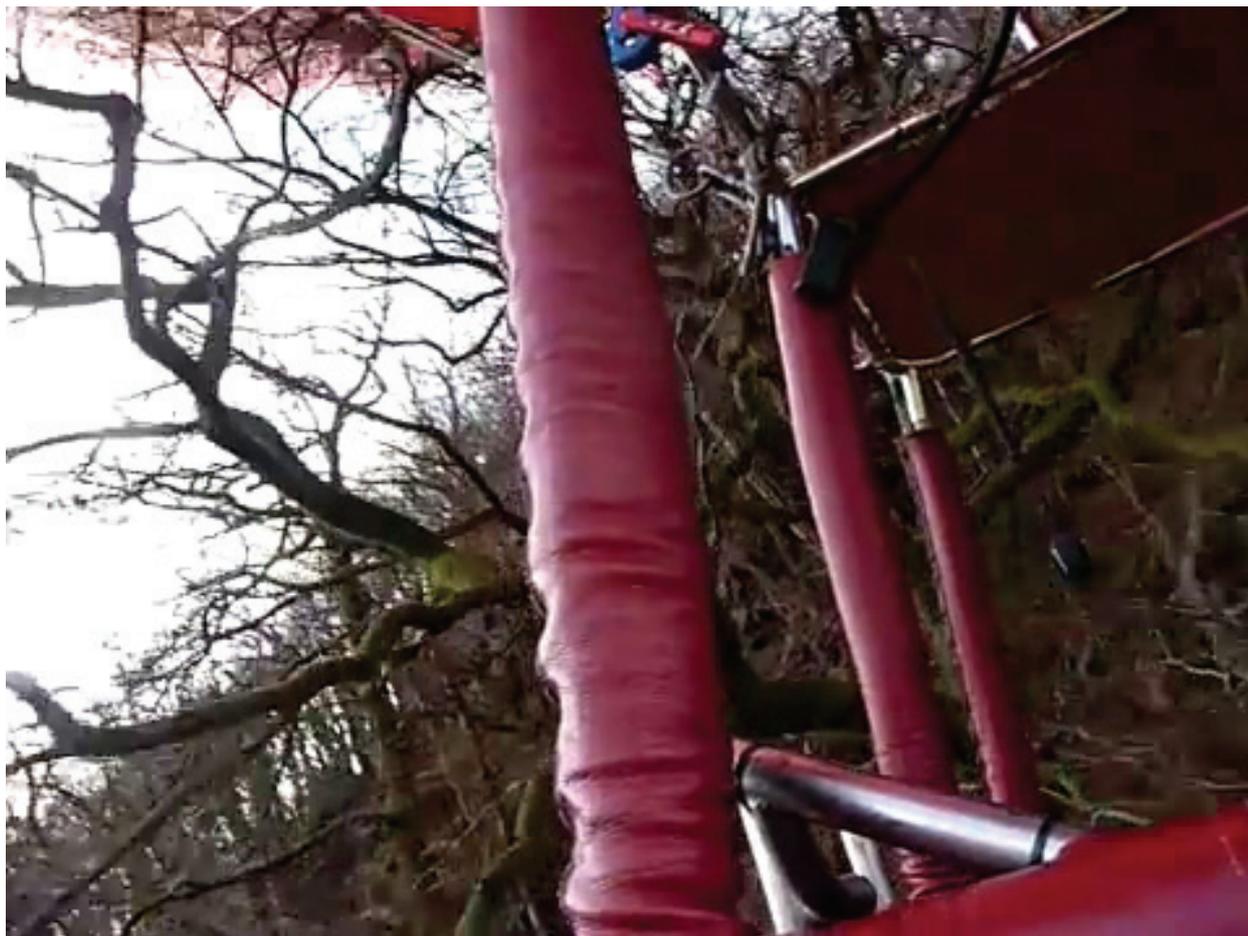
**Figure 1**

A 41-second video of the first landing impact on the upslope was taken by one of the passengers. It starts with the shorter side of the basket leading, just before it impacted the trees with no burners on. Figure 1 shows a still taken from the video at the moment of impact. The balloon initially impacted trees about 20 ft into the canopy, breaking large branches. Seven seconds into the video the pilot is visible in a position where he is likely to be pulling the red and white venting line in order to close the RDS. Fifteen seconds into the video the pilot can be seen pulling on the red and white venting line for 2 seconds, followed by a burn with two burners for 1 second. He then pulls on the red and white venting line for 4 seconds. There is then a 5 second burn using four burners followed by an 8 second period of inactivity from the pilot as the balloon appears to be deeper into the tree canopy. The final 2 seconds of the video shows the pilot using all four burners for 2 seconds as it clears the trees. The video does not show the pilot using the burners 'hands free'.

Picture from the video at the moment of impact

The video begins, at about the moment of impact, with the burners OFF. It is then 18 seconds before the pilot uses two of the burners, as he was closing the RDS/parachute vent. Had the pilot latched all four burners on in the 'hands free mode' as soon as he decided to abort the landing and then closed the RDS, maximum heating would have been achieved, improving climb performance and potentially reducing the chance of impact with the trees. Using four burners may also have prevented the second impact.

The video shows the pilot making 12 'pulls' on the red and white venting line, without releasing it, as he attempts to close the RDS parachute valve. This indicates that the RDS parachute valve was OPEN at the time of impact with the trees. The flight manual states that red RDS rip line is not to be used at heights greater than 6 ft agl and may be pulled immediately before touchdown. Had the pilot kept the RDS closed, until a landing was assured, heating of the air in the envelope would have been more efficient, heat would not have escaped through the open RDS and the climb after the aborted landing may have been expedited making an impact with the trees less likely.
