**ACCIDENT**

<b>Aircraft Type and Registration:</b>	Gemini Flash IIA, G-MTIA	
<b>No &amp; Type of Engines:</b>	1 Rotax 503 piston engine	
<b>Year of Manufacture:</b>	1987	
<b>Date &amp; Time (UTC):</b>	16 June 2009 at 1155 hrs	
<b>Location:</b>	Caernarfon Airport, Gwynedd	
<b>Type of Flight:</b>	Private	
<b>Persons on Board:</b>	Crew - 1	Passengers - 1
<b>Injuries:</b>	Crew - 1 (Minor)	Passengers - 1 (Minor)
<b>Nature of Damage:</b>	Substantial	
<b>Commander's Licence:</b>	National Private Pilot's Licence	
<b>Commander's Age:</b>	70 years	
<b>Commander's Flying Experience:</b>	109 hours (of which 41 were on type) Last 90 days - 13 hours Last 28 days - 8 hours	
<b>Information Source:</b>	Aircraft Accident Report Form submitted by the pilot

**Synopsis**

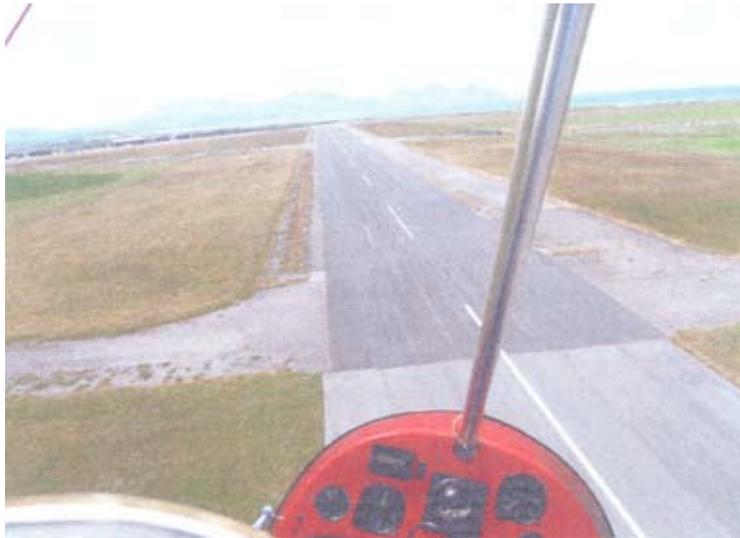
**Figure 1**

View on short final approach from on board the aircraft before the accident
