APPENDIX A

Bell Helicopter Company

Sequence of disintegration of the main transmission gearbox

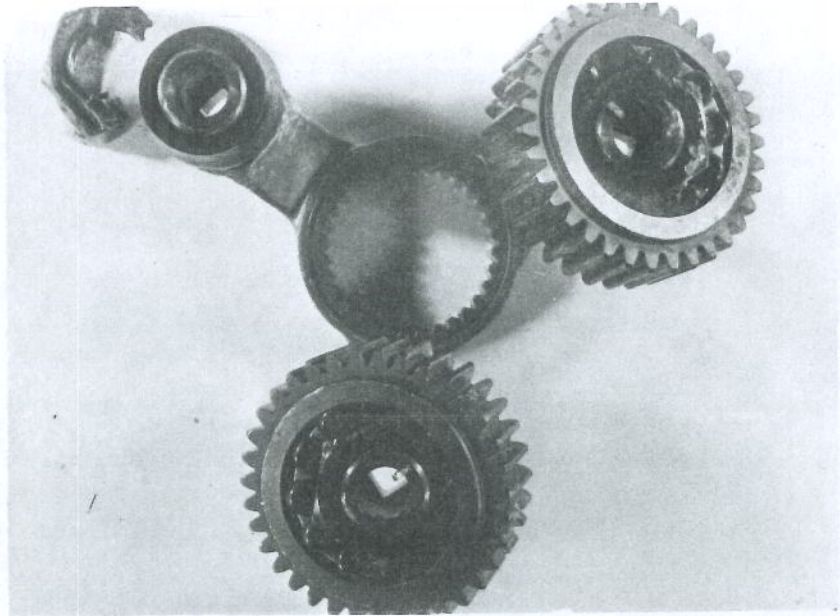
Planetary Assembly

- 1 More than 30 hours prior to the accident a sub-surface fatigue crack may have originated and developed into spalling in one of the planet pinion gears, P/N 206-040-035-5, bearing races. The area of spalling increased in size and severity with time. The alloy steel fragments dispersed throughout gear box.

- 2 Another pinion P/N 206-040-035-5 possibly started to spall, adding to the steel particles inside the transmission case. The spalling of this pinion P/N 206-040-035-5 may have been initiated by the metallic trash thrown off from the first pinion going through this pinion's bearing.

- 3 Continued roughening and spalling caused wear and eventual fracturing of the pinion P/N 206-040-035-5 bearing cage. As the silver plated aluminium cage fragmented and the particles flooded the oil system (lodging in significant quantities in the oil filter), the rollers started to rub against each other causing additional alloy steel debris, heat and oil contamination.

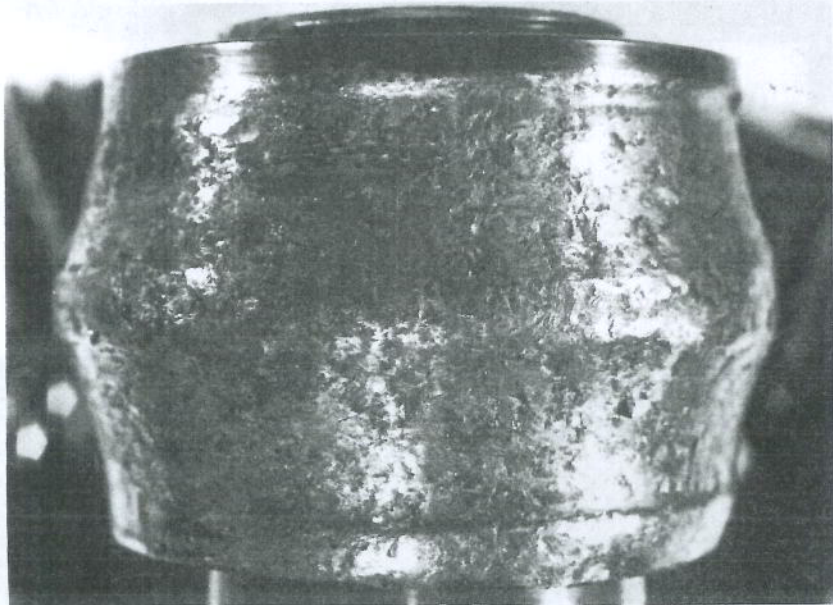
Inner Race No.3

- 4 Some rollers may have turned sideways and produced intermittent locking between the inner and outer bearing races. Other than changes in oil temperature and pressure, this may have been the first operational indication of malfunction. The possible occasional locking caused the inner bearing race to spin on its mounting pin, P/N 206-040-043. Later, the inner race P/N 206-040-035-5, and the pin P/N 206-040-043, galled and seized. The nut, P/N 206-040-044 backed off the pin, P/N 206-040-043. There was no evidence of a cotter pin having been installed.

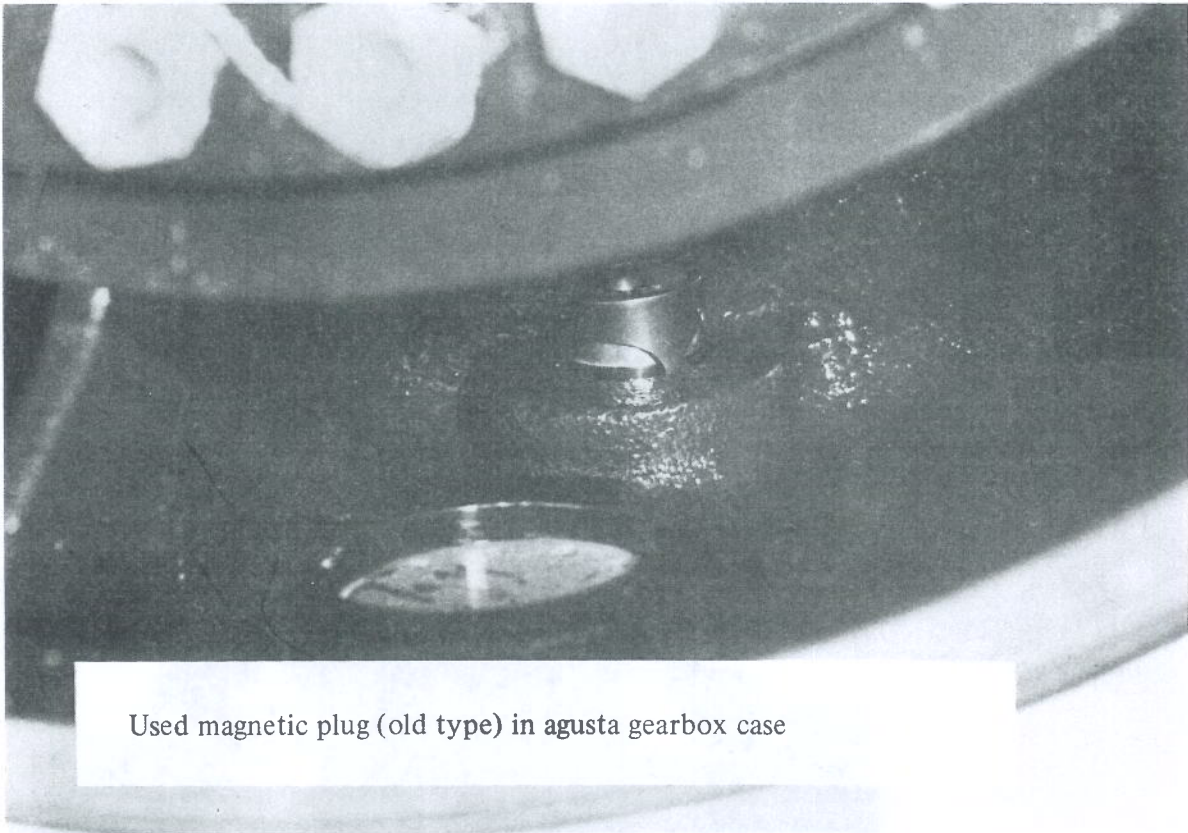
Used magnetic plug (old type) in agusta gearbox case

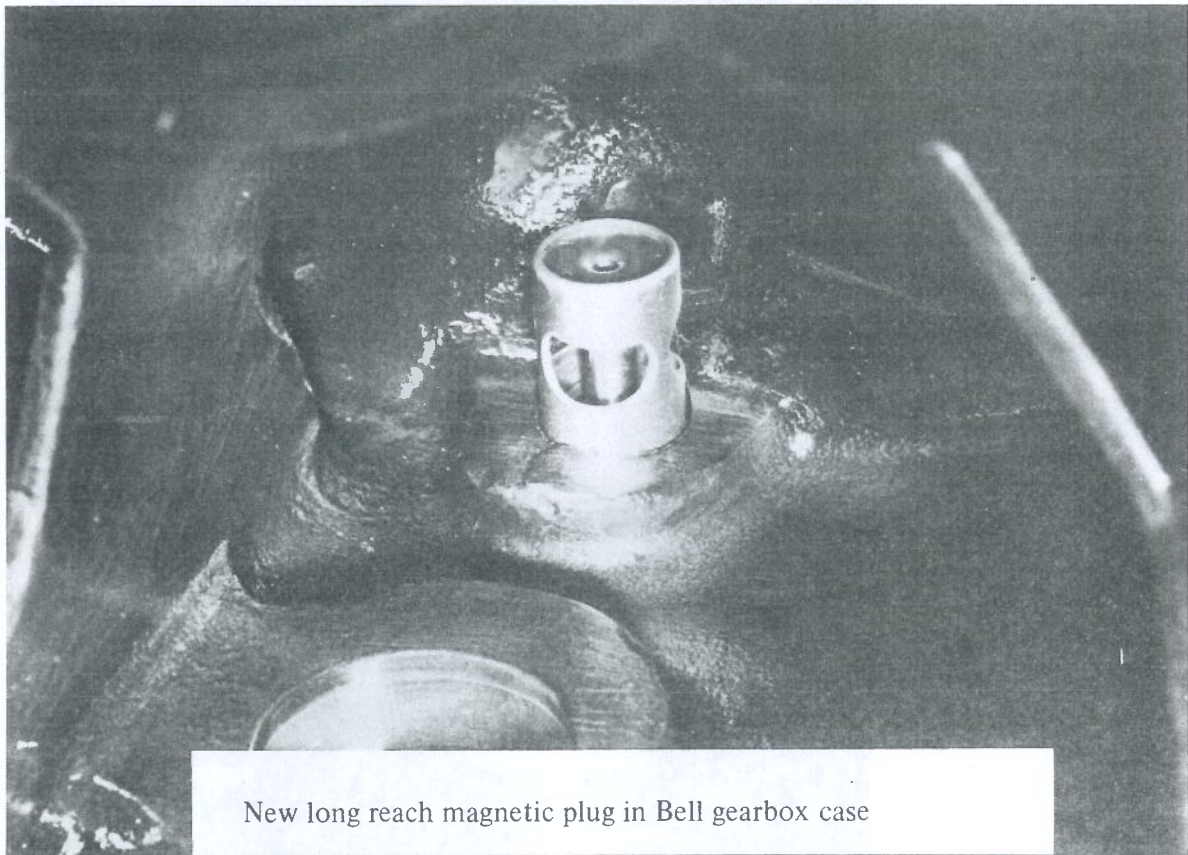
New long reach magnetic plug in Bell gearbox case
