ACCIDENT

Aircraft Type and Registration:	Piper PA-28-161 Cherokee Warrior II, G-BYKR	
No & type of Engines:	1 Lycoming O-320-D3G piston engine	
Year of Manufacture:	1988	
Date & Time (UTC):	30 August 2006 at 0810 hrs	
Location:	Oxford Airport, Kidlington	
Type of Flight:	Training	
Persons on Board:	Crew - 2	Passengers - 1
Injuries:	Crew - None	Passengers - None
Nature of Damage:	Aircraft damaged beyond economic repair	
Commander's Licence:	Commercial Pilot's Licence	
Commander's Age:	28 years	
Commander's Flying Experience:	1,019 hours (of which 800 were on type) Last 90 days - 44 hours Last 28 days - 25 hours	
Information Source:	AAIB Field Investigation

Synopsis

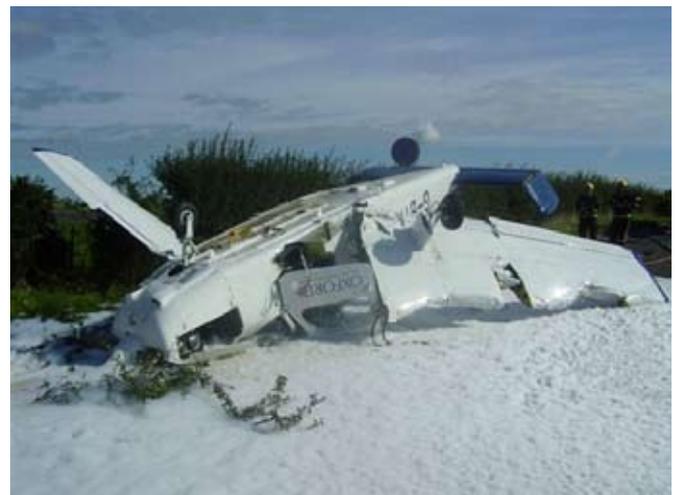
Figure 1

Photograph of aircraft wreckage

The wing spars had been severed at the wing root by the impact, disrupting the fuel pipes, and the fuselage, empennage and nose landing gear had also sustained severe damage.

Chord-wise scrape marks on the propeller blades and circumferential scoring of the spinner indicated that the propeller was turning when the aircraft struck the boundary fence, but the lack of any distortion of the propeller blades suggested that the engine had been running at low power.
