ACCIDENT

Aircraft Type and Registration:	Schweizer 269C, G-OGOB	
No & Type of Engines:	1 Lycoming HIO-360-D1A piston engine	
Year of Manufacture:	1987	
Date & Time (UTC):	4 September 2005 at 1200 hrs	
Location:	Putts Corner, Honiton, Devon	
Type of Flight:	Private	
Persons on Board:	Crew - 1	Passengers - 1
Injuries:	Crew - None	Passengers - 1
Nature of Damage:	Significant damage to the cockpit, main rotors and tail boom	
Commander's Licence:	Private Pilot's Licence	
Commander's Age:	39 years	
Commander's Flying Experience:	273 hours (of which 120 were on type) Last 90 days - 10 hours Last 28 days - 4 hours	
Information Source:	AAIB Field investigation

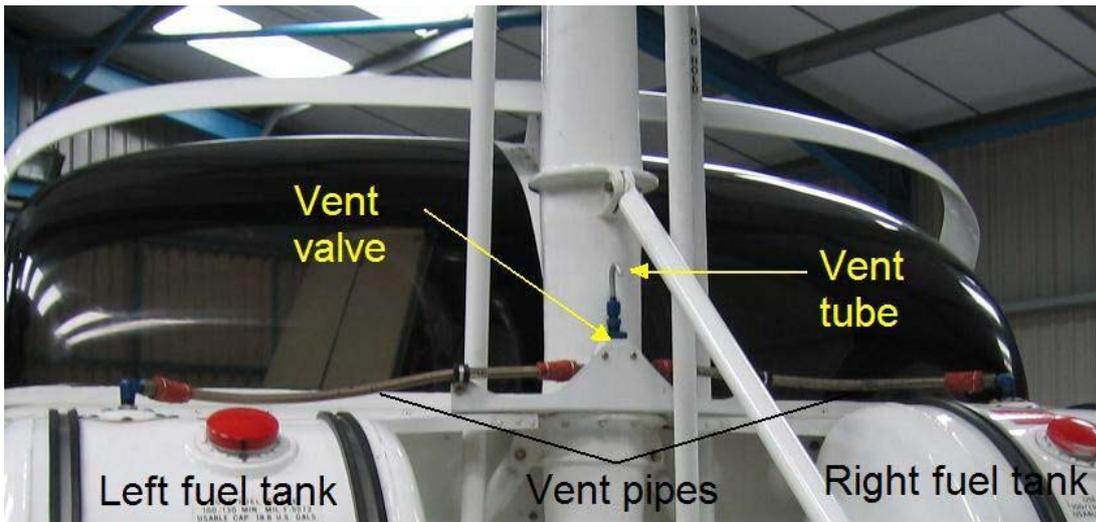
Figure 1

Location of fuel tanks vent

On the Schweizer 269, the fuel tank vent connections are positioned on the upper left surface of each tank, Figure 1. In the event of a roll over, and depending on the fuel state of the helicopter, the possibility exists that fuel may flow from the higher tank to the lower tank.

The orientation of the connections means that the risk of a fuel tank becoming 'overfilled' is greater if the helicopter should roll onto its left side rather than its right. As fuel was reportedly seen leaking from the vent system after the accident, the fuel tank vent system was removed from the aircraft and taken to the AAIB for detailed examination and testing.

The test also indicated that in the event of the helicopter rolling over to an angle of less than 91° there is the possibility, particularly with large quantities onboard, of fuel escaping from the vent tube if the lower fuel tank becomes full. Due to the arrangement of the fuel vent system this is more likely if the helicopter rolls onto its left side. The volume of fuel released in such a situation is dependant on how 'air tight' each fuel tank is, but the tests showed that, in this condition, a minimum of approximately 0.5 litres could be released. However, if hydrostatic equilibrium cannot be achieved in the higher of the two fuel tank, ie, air is able to enter the tank as

fuel drains away, fuel could escape through the vent tube at a rate of 0.5 litres per minute,. The position of the fuel tanks and vent system on the airframe, in relation to the engine and exhaust manifold mean that any such fuel leakage from this area would provide a significant fire hazard, thus negating the reason for fitting the vent system modification in the first place.

It is recommended that the Federal Aviation Administration require the Schweizer Aircraft Corporation to review modification SA269K-101-1, relating to the fuel tank vent system on the Schweizer 269 helicopter, to further reduce the possibility of fuel escaping from the fuel tank vent system in the event of the helicopter rolling over.

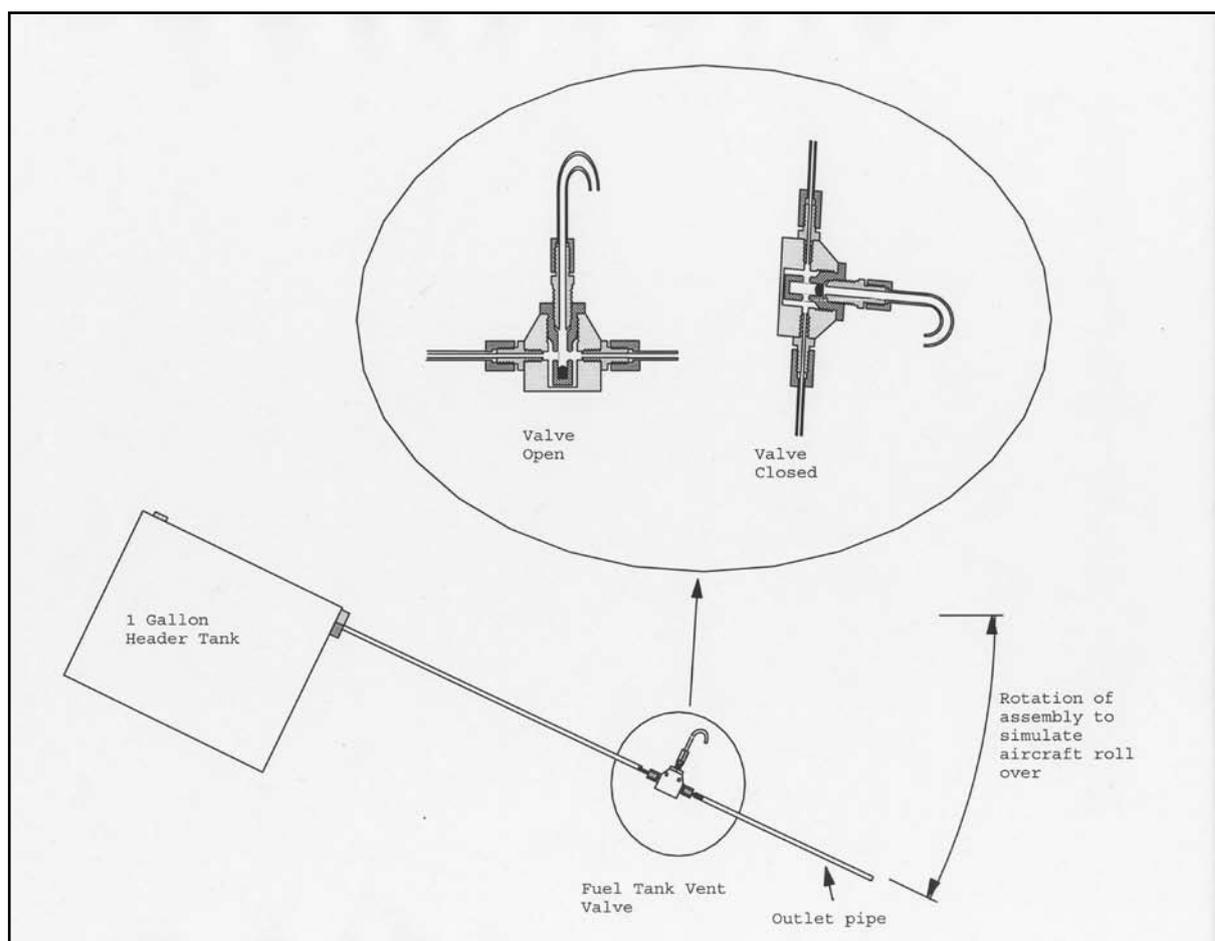
Figure 2

The first series of tests allowed free fluid flow from a one gallon unsealed header tank through the vent system, whilst rotating the system to simulate the roll over, see Figure 2. This resulted in a few drops of fluid being released from the vent tube before the vent valve closed at approximately a 91° roll angle.

A second series of tests were conducted by closing the outlet pipe before the system was rolled to simulate the 'overfilling' of the lower fuel tank. In this condition, at roll angles greater than 45°, fluid flowed from the vent tube at a rate of 0.5 litres per minute until the system was rotated to 95°, when the flow ceased by the action of the valve closing. This series of tests was repeated after sealing the header tank, to simulate an airtight system. The maximum flow rate from the vent tube was reduced to 0.3 litres per minute, with the valve closing at 91° on the majority of occasions. During three of these tests, the valve failed to close completely, and could be clearly heard 'shuttling' in the valve body, with pressure pulses felt within the system. In this condition, a very rapid dripping flow of five drips per second was released from

the vent tube for approximately 45 seconds, or until the roll angle had been increased to 99°.

Although the testing carried out on the fuel vent system indicated that, at roll angles greater than 91°, the fuel tank vent valve regularly prevented the external release of fuel, they also showed that it was possible, in certain conditions, for the fuel vent valve to 'shuttle' which allowed the release of fuel at roll angles greater than 91°. The fuel system was tested using a small header tank of different rigidity to the helicopter fuel tanks and, as such, the duration of any valve 'shuttling', and the rate of fuel release on the helicopter, may differ from the test results.
