ACCIDENT

Aircraft Type and Registration:	McDonnell Douglas Helicopters Hughes 369E, G-KSWI	
No & Type of Engines:	1 Rolls Royce Allison C250-C20B turboshaft engine	
Year of Manufacture:	1986	
Date & Time (UTC):	19 June 2011 at 1317 hrs	
Location:	Glastonbury, Somerset	
Type of Flight:	Private	
Persons on Board:	Crew - 1	Passengers - None
Injuries:	Crew - 1 (Serious)	Passengers - N/A
Nature of Damage:	The aircraft was destroyed	
Commander's Licence:	Private Pilot's Licence	
Commander's Age:	57 years	
Commander's Flying Experience:	730 hours (of which 720 were on type) Last 90 days - 20 hours Last 28 days - 10 hours	
Information Source:	AAIB Field Investigation

Synopsis

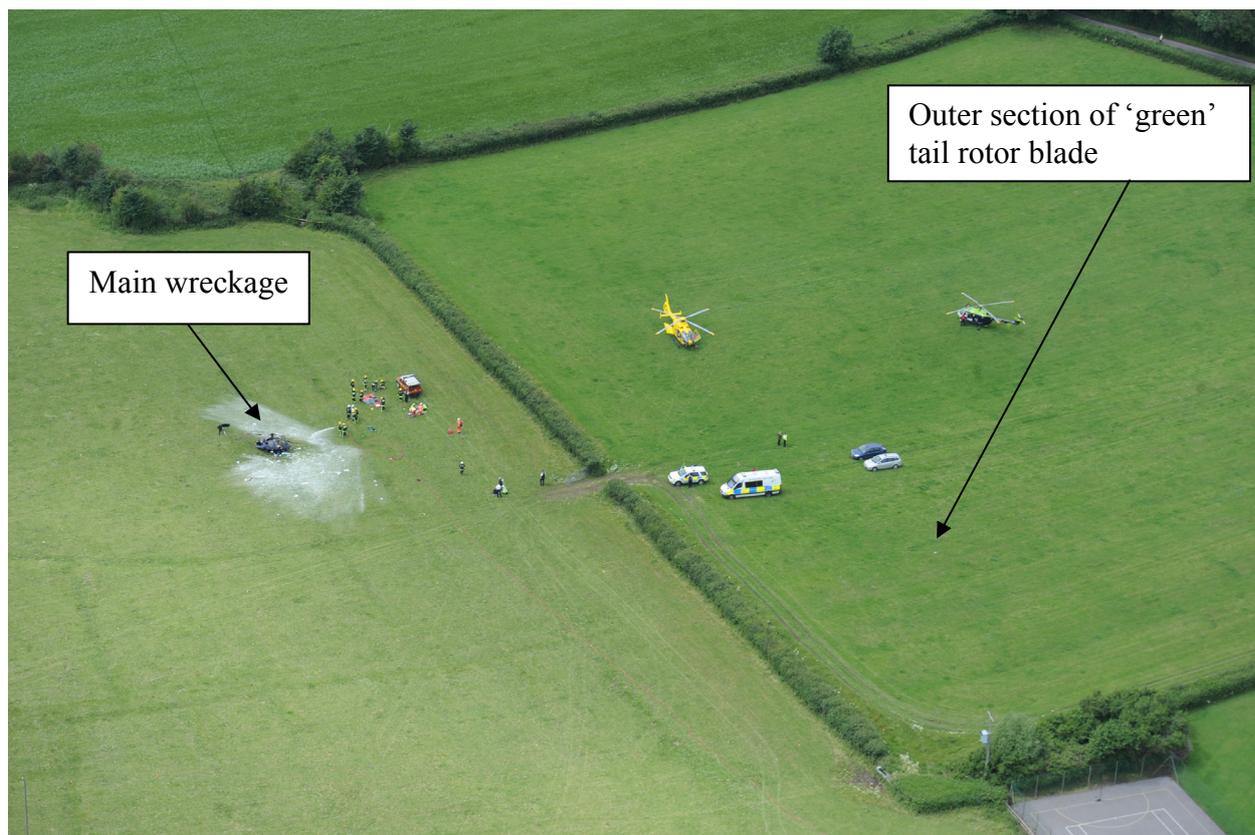
Figure 4
Accident site

from the fuselage and was found with the ‘blue²’ tail rotor blade resting on the ground (see Figure 5). The section of the tail cone still attached to the fuselage had bent approximately 90° in an anti-clockwise direction. The rear section of the left skid had broken away from the helicopter and the shattered transparency from the left side of the cockpit was scattered approximately 10° to 20° to the right of the aircraft. Debris from the tail cone, drive shaft and tail rotor pitch control rods

were found up to 30 m to the right of the helicopter across an arc of 160°. The outer section of the ‘green’ tail rotor blade was found approximately 90 m away and 40° to the right of the helicopter (see Figure 4). The grass in the area of the engine exhaust had been burnt and there was a strong smell of aviation fuel around the aircraft.

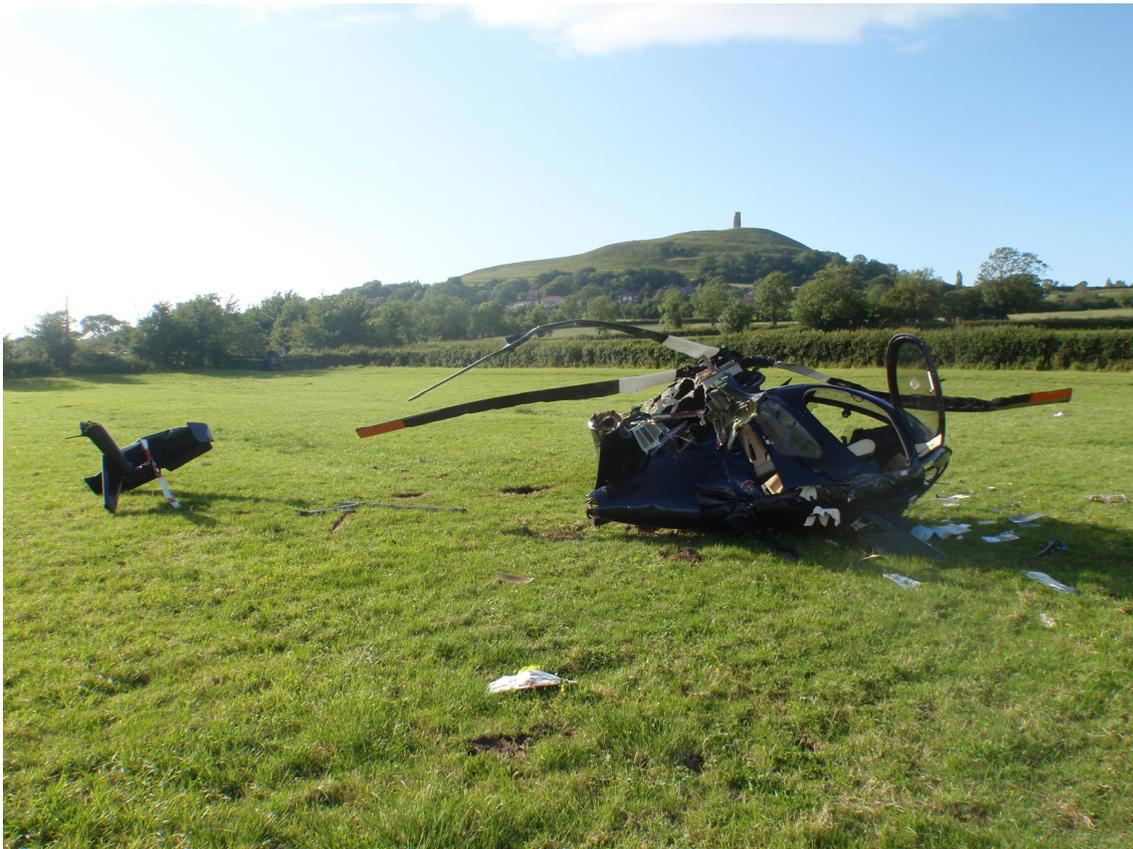
Figure 5

Helicopter wreckage, as found

The left skid tube had fractured just aft of the forward saddle mount, with the forward supporting strut having twisted and bent forward; the rear section of the broken skid had been forced into the underside of the helicopter. The left side of the cabin had been extensively deformed and there was deformation to all the major structural frames and floor, consistent with a relatively high speed vertical impact. The aircraft skin below the cabin had been torn and forced upwards, puncturing the flexible fuel tank linings in several places. The transparencies in both doors on the left side of the aircraft and the

windscreen in front of the pilot had broken into a number of pieces. The pilot's harness, which had been released by the emergency services, was intact. His seat base had deformed. Overall, the left side of the helicopter had sustained more damage than the right side.

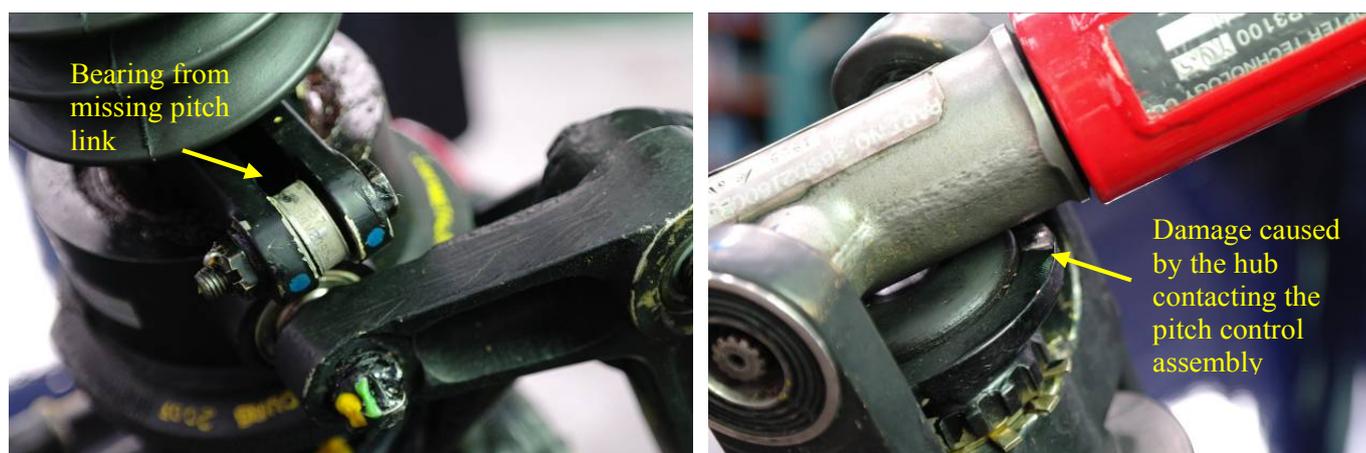
Figure 7
Tail rotor assembly

Apart from the damage to the tail rotor blades and the missing pitch link, there was no other significant damage to the tail rotor assembly. See Figure 7.

The bearing from the missing 'blue' pitch link, which connects the pitch link to the pitch control assembly fork end, had been retained by the securing bolt. Apart from some slight play, the bearing was found to be in relatively good condition and was free to rotate with no evidence of it having seized. There was some mechanical damage and missing paint at the end of the fork end that was believed to have occurred during the accident sequence.

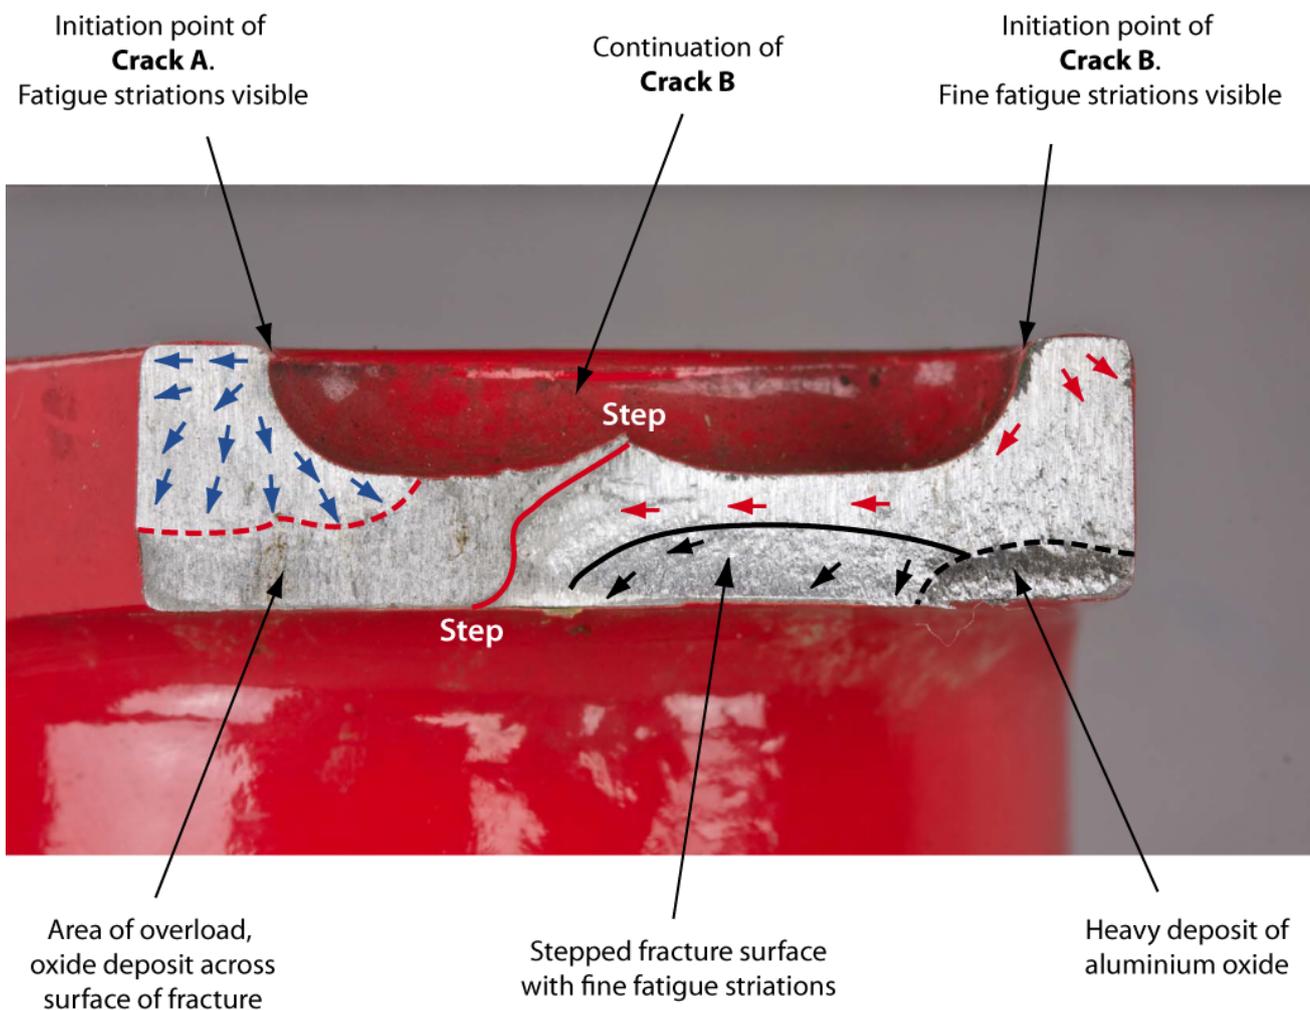
Figure 8
Significant features on the fracture face of the pitch horn

The fracture surface on the ‘blue’ tail rotor blade pitch horn was examined by metallurgists at QinetiQ, using high magnification optical devices and a Scanning Electron Microscope (SEM). The following six significant features, which are highlighted in Figure 8, were identified:

- A fatigue crack, identified as ‘Crack A’, which started at a corrosion pit on the lip of the pocket. The fracture surface in this area was flat with visible striations, from which it was possible to identify the direction of propagation that is highlighted by the blue arrows. The corrosion pit was 0.146 mm deep and 0.153 mm wide at the widest point.
- A fatigue crack, identified as ‘Crack B’, which started at a corrosion pit on the lip of the pocket. The fracture surface in this area

was flat, with visible signs of heavy and fine striations which were difficult to resolve. The direction of propagation is highlighted by the red arrows. The corrosion pit was 0.487 mm deep and extended 1.8 mm around the radius into the pocket and 0.9 mm along the external surface.

- A step, which ran across the fracture face and is marked by the solid red line.
- An area that had failed in overload and was covered in an oxide deposit. When examined by the AAIB, within four hours of the accident, this section had the same bright appearance as the remainder of the fracture; therefore, the oxidisation must have occurred in the days following the accident. This area is bounded by the dashed and solid red lines.

- A rough, stepped, fractured surface with fine striations associated with fatigue cracking. Due to the nature of the surface it was difficult to resolve the striation marks with any great confidence. This area is bounded by the solid black line and the direction of propagation is highlighted by the black arrows.

- A dark area that was identified as a heavy deposit of aluminium oxide, approximately 5 mm long and up to 1.7 mm deep, which appeared to run from an area of mechanical damage; there was no evidence of any fatigue cracking in this area. The blade manufacturer advised the investigation that this section of the blade root is normally subject to a compressive load and it is not

unusual to see damage to the surface finish in this area as a result of slippage of the tools used to tighten the pitch link attachment bolt. This corrosion was present four hours after the accident and would have been present prior to the failure of the pitch horn. This area is bounded by the dashed black line.

The striations associated with 'Crack A' were more clearly defined in the region 1.47 mm to 6.15 mm from the initiation point; it was also noted that some of the striations in this region were stronger than others. The total number of striations in the region between 1.47 mm and 6.15 mm was calculated as 52,300, which,

The number of strong striations was calculated as 2,461 in the region between 1.47 mm and 6.15 mm, which by extrapolation back to 0.13 mm from the initiation point, gave an estimated 8,713 striations. At two loading cycles per tail rotor revolution this would give a crack propagation time of 1.48 minutes.

Despite the presence of thousands of striations, there was no evidence of any beach-marks on the fracture face. Beach-marks can contain thousands of striations and form when the load is removed for a sufficient period to allow corrosion products to form. The lack of beach-marks suggests that crack growth was rapid and probably occurred during the accident flight.

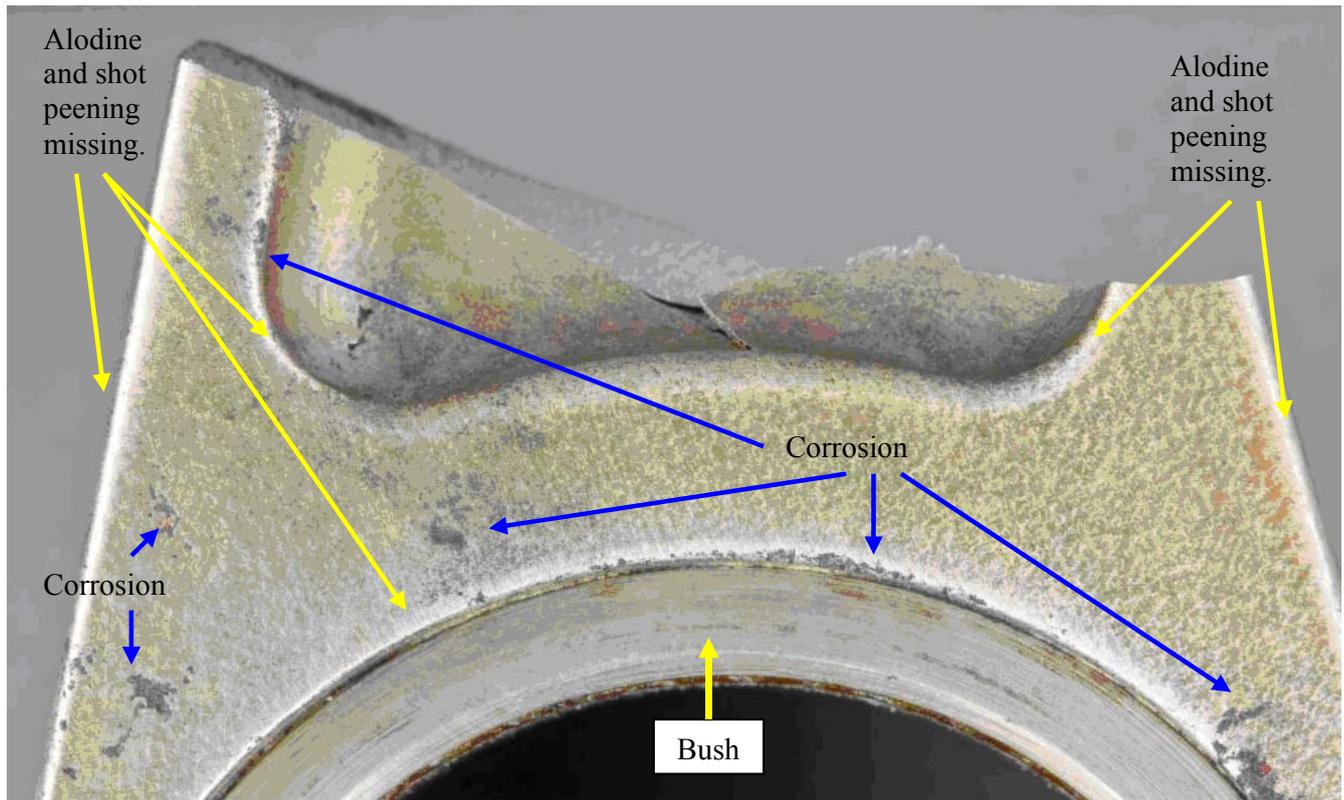
Figure 9

The paint layer was removed with a chemical paint stripper and a more detailed inspection of the pitch horn was carried out; abrasive products were not used in order to ensure that the process did not damage the surface of the metal or remove any products of corrosion. A photograph of the pitch horn after the paint had been removed is at Figure 9.

The examination revealed evidence of corrosion up to several hundred microns deep, in several places, including around the lip of the pocket and the bush: this corrosion had not been evident before the paint had been removed. There was evidence that the surface of the pitch horn had been shot peened and a chromate treatment, such as Alodine 1200, had been applied to provide protection against corrosion. However, the Alodine had been mechanically abraded away along the edges of the pitch horn, inner bush and part of the lip of the pocket. The dimples from the shot peening also appeared to have been abraded away in these areas. Optical micrographs of polished micro-sections, that had been etched with Keller's reagent, and strain maps, using Electron Backscatter Diffraction, were produced. These indicated that, where there was visible evidence of dimpling, on average the shot peening had affected the microstructure up to a depth of 0.075 mm. Where the dimpling had been abraded away the effect of the shot peening had reduced to a depth of around 0.04 mm.

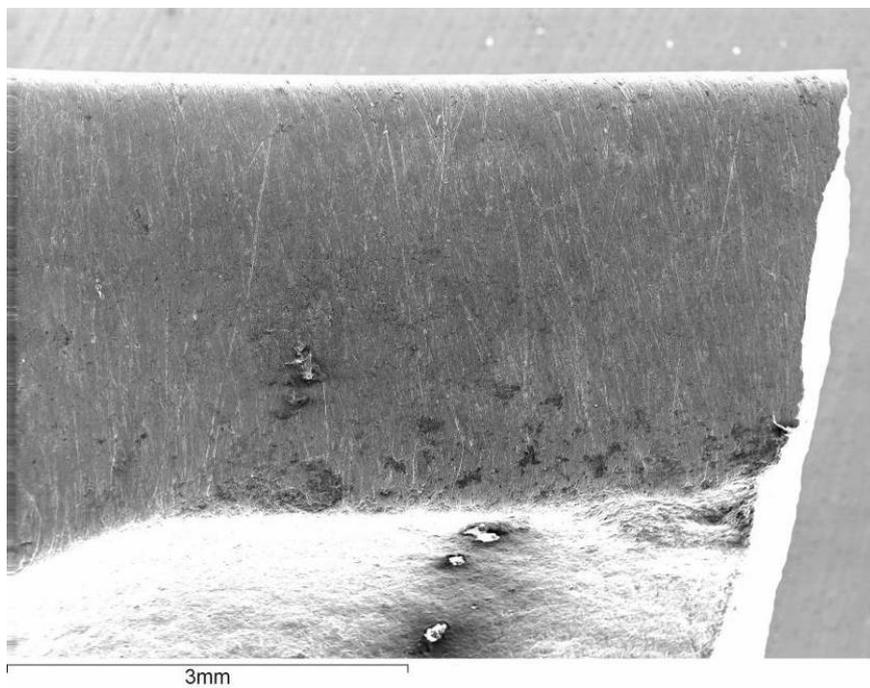
Figure 10

It could also be seen from the SEM image, reproduced at Figure 10, that the surface of the pitch horn was covered with scratch marks that appear to have

SEM image showing scratch marks on the surface of the pitch horn

penetrated through the Alodine surface finish. The sharp edges of these scratches could act as stress concentrators. The scratches were consistent with the surface having been rubbed with an abrasive material.

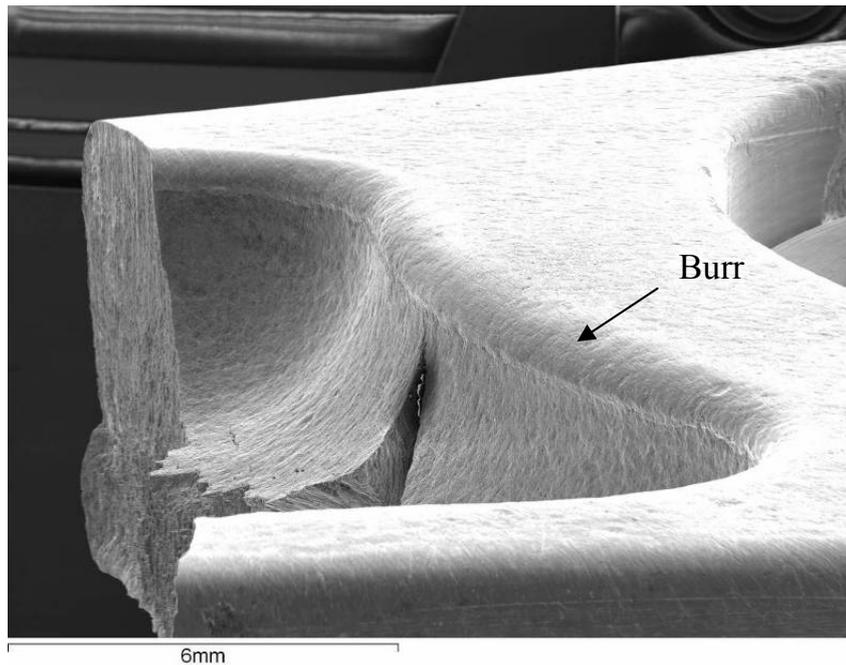
Figure 11

There was also a burr around the lip of the pocket where, in places, the metal appeared to have folded over on itself: it was from this area that 'Cracks A' and 'B' appear to have originated. See Figure 11. The blade manufacturer advised the investigation that the burr can be formed during the shot peening process.

SEM image showing burr around the edge of the pocket

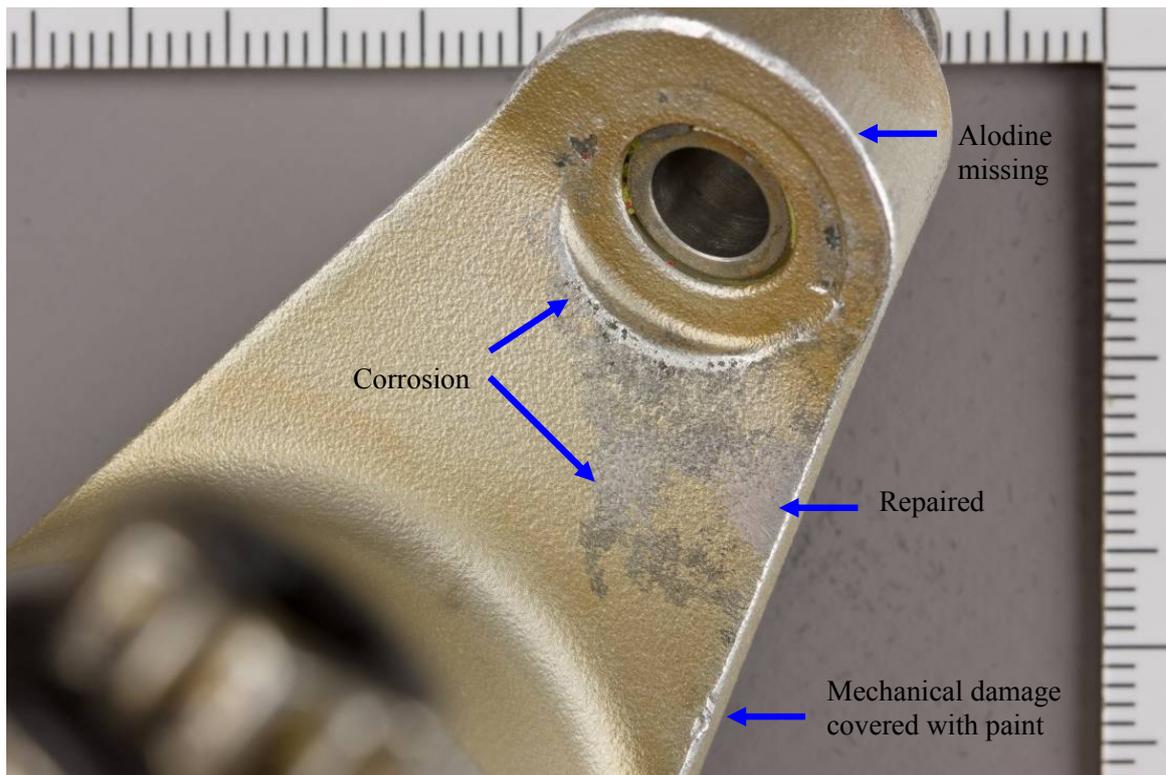
Figure 12

The paint was chemically removed from the ‘green’ tail rotor blade (serial number B391) which was then examined using high magnification optical devices. With the exception of one small area, see Figure 12, there was evidence that all of the pitch horn, including the edges and radius had been shot peened. The surface was free of scratches and apart from the radius at the end of the pitch horn it was evenly covered in Alodine. There were a number of areas of corrosion, particularly around the bush and the insert for the pitch link securing bolt. In addition there was an area of mechanical damage that was covered with an intact layer of paint.

There was also a small repaired section where the Alodine and the dimples from the shot peening had been rubbed away leaving scratches in the surface. The aircraft documentation recorded that corrosion had been removed, in the field, on 17 June 2009 at 3,053.5 airframe hours. This was prior to the blade

Damage on 'green' blade pitch horn

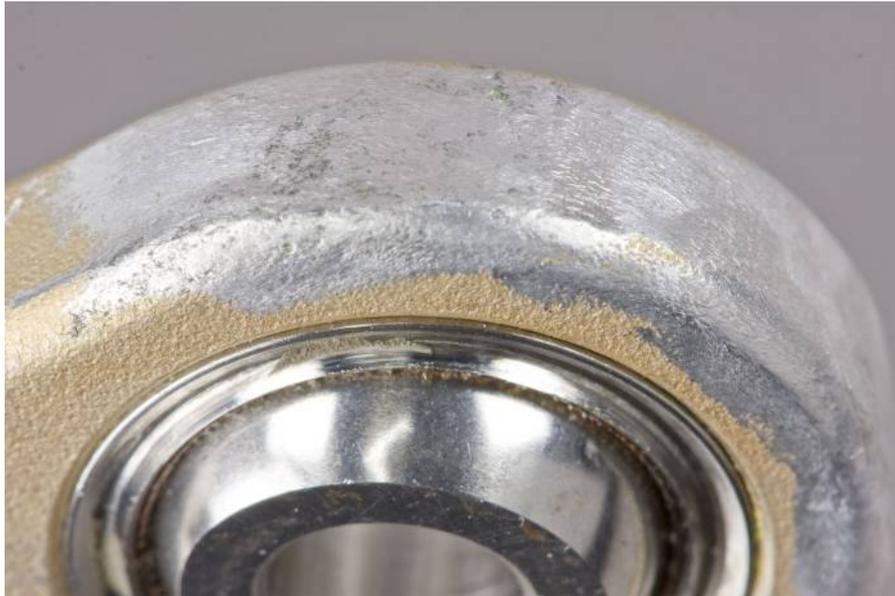
Figure 13

there was no evidence of the Alodine surface finish and the tops of the dimples, caused by the shot peening, had been removed by a coarse abrasive that had left scratches in the surface. Corrosion products were present in this area. (See Figure 13.)

Section of 'green' pitch link with paint removed

the pitch link with 600 grade followed by 1500 grade silicon carbide paper. He then cleaned the surface with Alumiprep 33 before applying Alodine 1201 with a paper cloth and brush. Finally, he applied two coats of zinc chromate primer and a top coat of matt black paint. The technical sheet for Alumiprep 33 states that it is a phosphoric acid based cleaner, brightener and pre-paint conditioner that should not be used on high copper bearing aluminium alloys. The manufacturer of Alumiprep 33 advised the investigation:

aluminium as it leaves concentrations of copper rich precipitates. As copper is less reactive than aluminium, a galvanic cell could be established that leaves the surface susceptible to subsequent corrosion; moreover, the copper rich surface may reduce the effectiveness of the Alodine treatment.

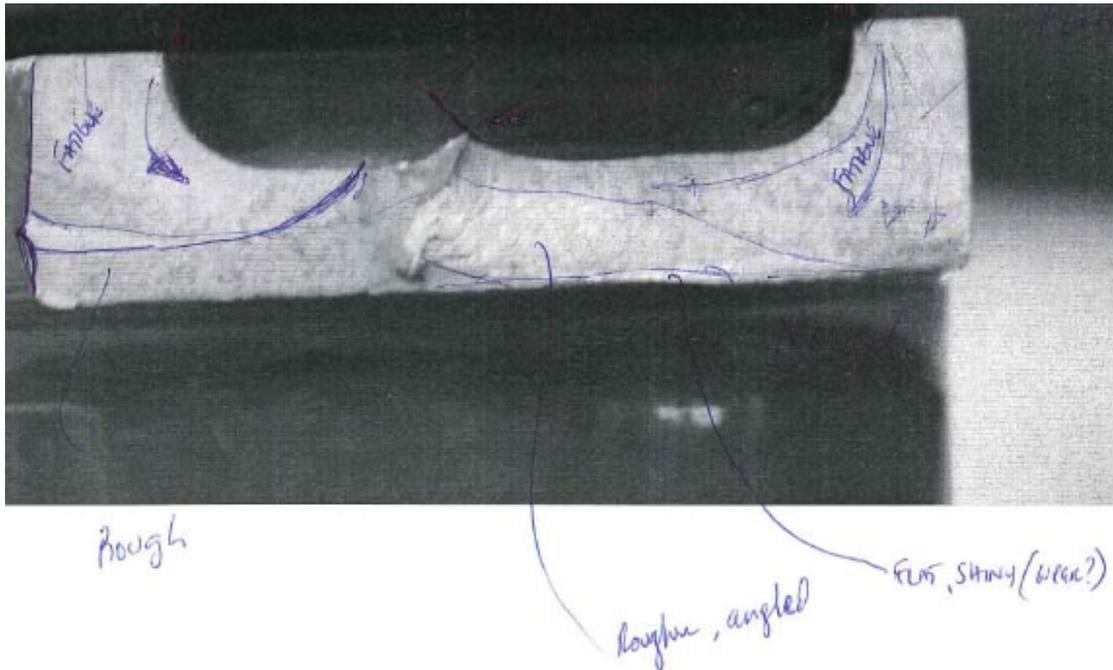
Figure 14

The field notes for this accident included a photograph of the failed tail rotor blade pitch horn fracture surface, annotated with the significant features (see Figure 14). The features were very similar to those seen on the fracture face of the tail rotor blade from G-KSWI, with two fatigue cracks emanating from the lip of the pocket.

Fracture face of pitch horn that failed on N234RF in February 2003

As a result of these findings, the blade manufacturer reviewed the stresses in the area of the pockets. This resulted in the FAA issuing an Emergency Airworthiness Directive (2003-08-51), in April 2003, to reduce the service life of these blades from 5,140 hours to 400 hours. In June 2003, the FAA issued an alternative means of compliance that allowed the original life to be restored.

This required blades that had zero time to be shot peened in the area of the pitch horn and identified with the letter 'M' painted on the blade root fitting. Blades in-service were returned to the manufacturer to have the paint removed around the area of the pitch horn, which then had to undergo an eddy current inspection to ensure that it was free of cracks. On blades that passed this check the inside edge of the pocket was machined to provide a corner radius of 0.254 mm (0.01"). The surface was then shot peened and the surface finished restored. These blades were identified with the letter 'I'. In addition, the design of newly manufactured blades was changed so that they no longer incorporated the pocket.

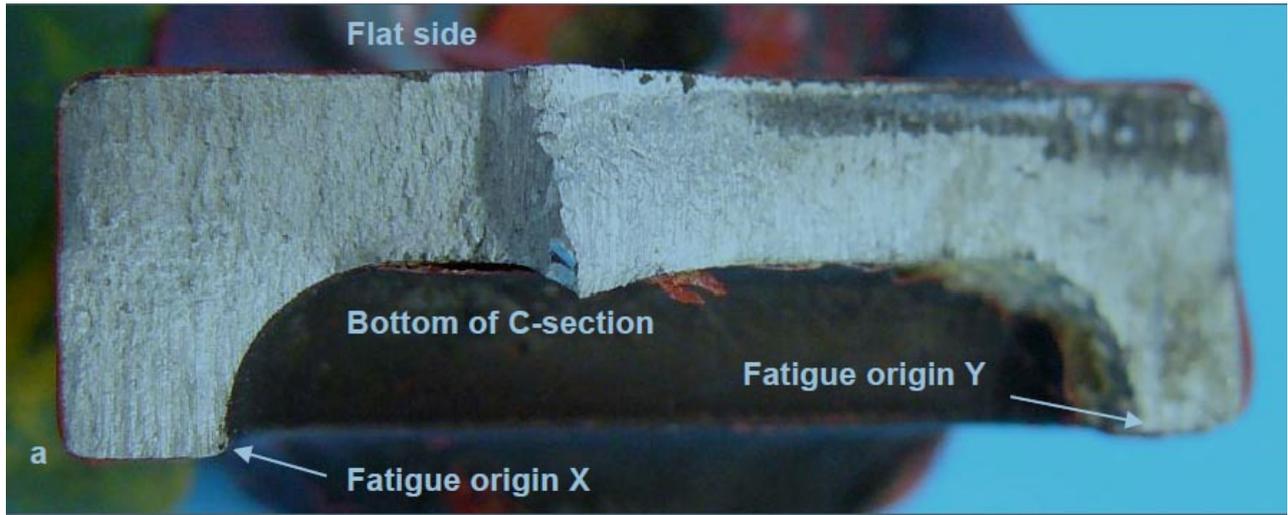
Figure 15

Fracture face of pitch horn that failed on the 24 February 2010

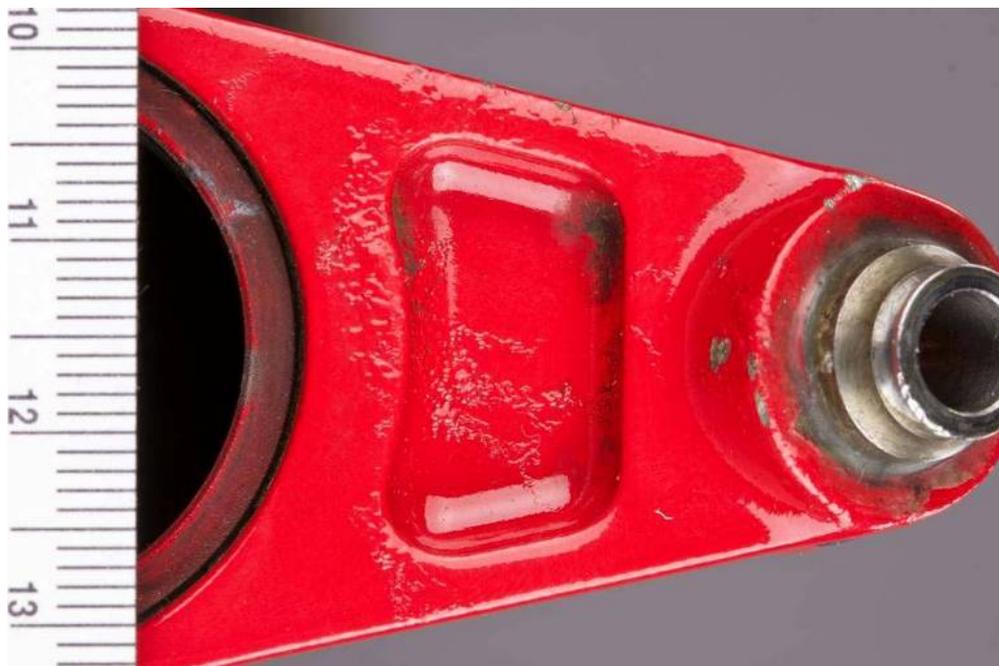
Figure 17

The paint finish was removed from the pitch horn on one of the blades using a chemical paint stripper in order not to damage the metal surface or remove any of the corrosion products. The majority of the corrosion discovered in the area of the pocket had been visible through the paint layer as blisters. However, there were patches that were not detectable with the

Corrosion in the area of the blade pocket
