ACCIDENT

Aircraft Type and Registration:	Scheibe SF25B motorglider, G-BLZA	
No & Type of Engines:	1 Sauer 1800 ESI piston engine	
Year of Manufacture:	1970	
Date & Time (UTC):	4 March 2006 at 1000 hrs	
Location:	2.5 miles WNW of RAF Halton, Buckinghamshire	
Type of Flight:	Private	
Persons on Board:	Crew - 1	Passengers - None
Injuries:	Crew - None	Passengers - N/A
Nature of Damage:	Loss of propeller	
Commander's Licence:	Private Pilot's Licence	
Commander's Age:	70 years	
Commander's Flying Experience:	1,927 hours (of which 219 were on type) Last 90 days - 6 hours Last 28 days - 4 hours	
Information Source:	Aircraft Accident Report Form submitted by the pilot and examination of propeller and engine by the AAIB

Synopsis

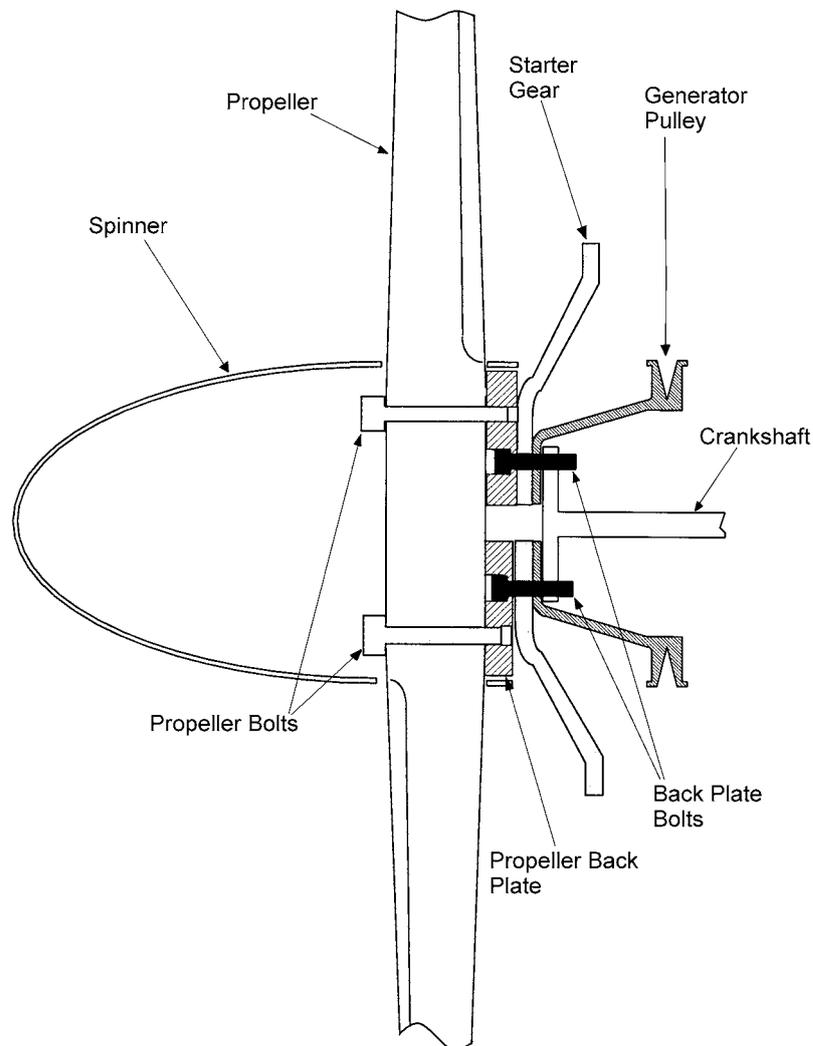
Figure 1

Diagram of 'Mt' propeller attachment to Sauer 1800 ESI engine, G-BLZA

This event was the first propeller loss for this engine type. Initial inspection revealed that the bolts holding the back-plate, starter ring gear and generator pulley to the crankshaft had failed. The propeller, together with spinner and back-plate, was located several days after the event and these, and the remains of the bolts held in the crankshaft, were examined in detail. The propeller was found to be securely attached to the back-plate, with all bolts correctly torque tightened and wirelocked; the remains of the bolts which held the back-plate to the crankshaft were also found wirelocked.

All six of the failed bolts were 8 mm in diameter, with the corresponding holes in the back-plate being 8.1 mm in diameter. Four of the bolt heads were marked 's 8.8' and were unthreaded along the first 1.8 mm of the shank. The remaining two were marked 'e D 8.8' and were unthreaded for the first 6.5 mm of the shank. Two adjacent bolts marked 's 8.8', had failed approximately 5 mm along the shank from the head, with the remaining four failing at approximately 17 mm. The fracture surfaces of each bolt showed clear signs of high cycle fatigue across approximately 95% of their surface areas.

The remains of the bolt shanks retained by the crankshaft flange were also examined and found to be between 17 mm and 18.5 mm long. Four of the shanks had failed in fatigue, and matched the four longer bolt heads from the propeller; measurement gave a complete bolt length of approximately 36 mm. The remaining two shanks showed signs of overload failures, which did not match the failure surface of the two shorter bolt heads. Further measurements indicated that approximately 13 mm was missing from each bolt shank. Given that these two bolts had initially failed by fatigue closer to the bolt head than the remaining four bolts, the portion of their shanks retained by the crankshaft would have projected approximately 13 mm further forward than the other four shanks. Distortion of two bolt holes on the starter ring gear indicated that after separation of the propeller, the ring gear had been held in place for a short while by these two longer shanks, until the rotational forces on the gear caused overload failures. The bores of the bolt holes in the back-plate, used to secure the plate to the crankshaft, showed evidence of damage caused by bolt threads.

Damage to the bores of the back-plate holes, caused by the bolt threads, showed that there had been relative movement between the propeller assembly and the

crankshaft. It was also apparent that the drive to the propeller was being transmitted across the threaded portion of the bolts where their cross sectional area is at its minimum. The damage also indicated that the torque loading of the bolts was insufficient to prevent movement of the back-plate. This may have been the result of either insufficient installation torque or a 'backing off' of the bolts in operation, possibly due to the differential contraction of the back plate, starter gear and generator pulley in the low temperatures experienced on the previous days flight, or both. The possibility of minor torque fluctuations, as a result of operating with spark plugs of the incorrect reach, may also have been a contributory factor to the failure of the bolts.

- Replacement of the current bolts with items that are unthreaded for the first 10 mm, thus preventing contact between the back-plate hole bores and the bolt threads
- Changing the specification of the bolts from 'M 8.8' to 'M 10.9'; this gives a 25% increase in their minimum tensile strength to 150,000 psi
- Increasing the installation torque of the back-plate bolts to 25 Nm
