Aircraft Type and Registration:	Boeing 737-59D, G-BVKC	
No & Type of Engines:	2 CFM56-3C1 turbofan engines	
Year of Manufacture:	1990	
Date & Time (UTC):	21 February 2004 at 2300 hrs	
Location:	Cardiff Airport, Wales	
Type of Flight:	Public Transport (Passenger)	
Persons on Board:	Crew - 6	Passengers - 114
Injuries:	Crew - None	Passengers - N/A
Nature of Damage:	Damage to left main landing gear	
Commander's Licence:	Airline Transport Pilot's Licence	
Commander's Age:	49 years	
Commander's Flying Experience:	8,160 hours (of which 3,800 were on type) Last 90 days - 203 hours Last 28 days - 71 hours	
Information Source:	AAIB Field Investigation

Synopsis

The left main landing gear (MLG) began a violent shimmy (yaw oscillation) when the wheelbrakes were applied after a normal landing touchdown, probably damaging the MLG lower torsion link. The shimmying stopped when braking was reduced but restarted when braking was increased, causing the torsion link to fracture. Further higher amplitude shimmying of the left MLG ensued, resulting in severe MLG tyre, wheel and brake damage and substantial oscillatory loads on the aircraft structure. Steering difficulties were experienced during both

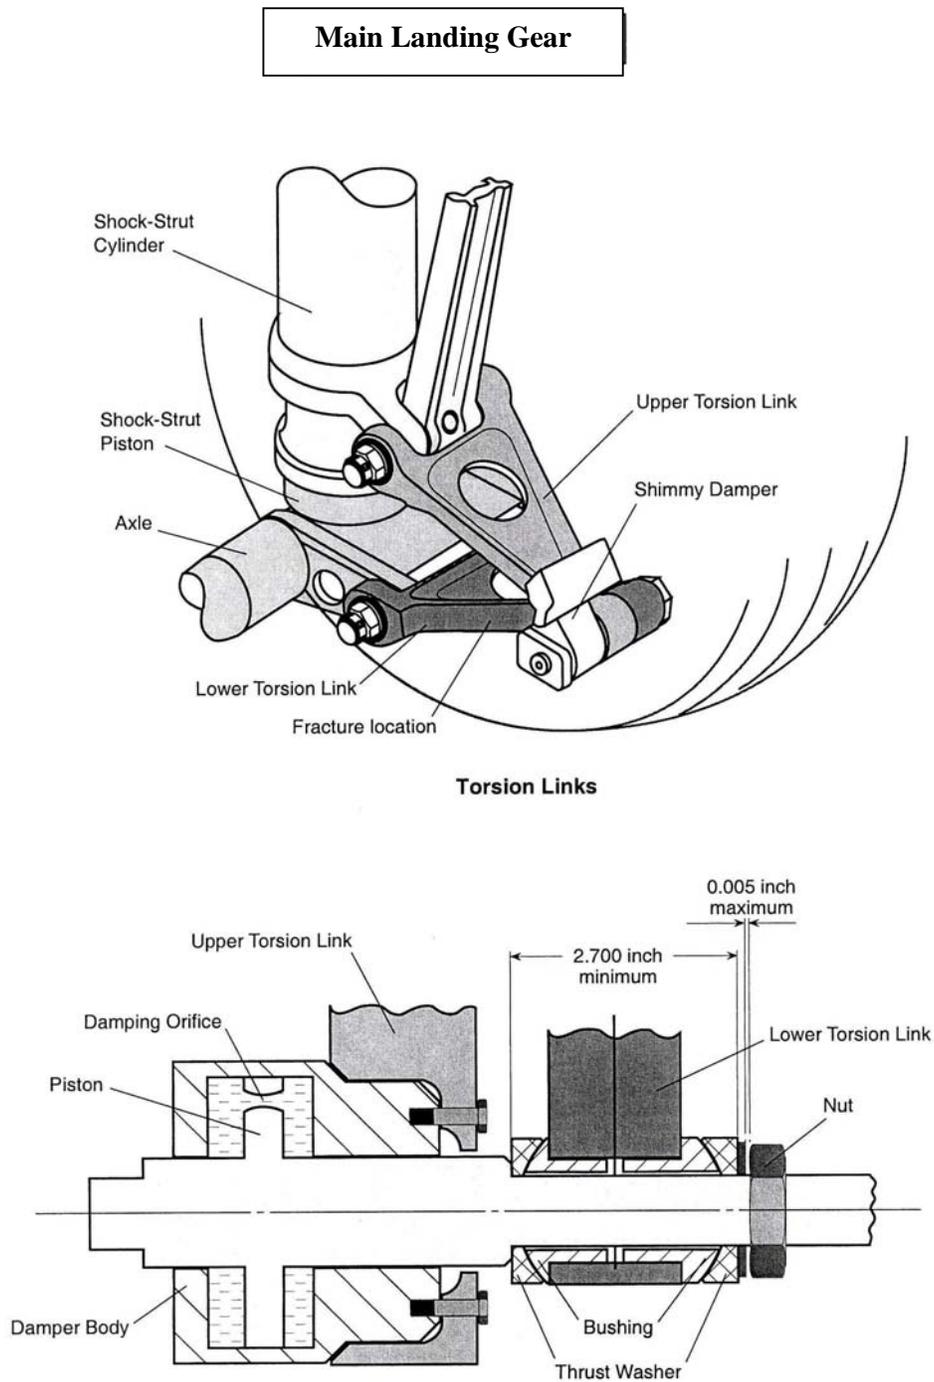
Figure 1

A damper is connected between the apexes of the upper and lower torsion links in order to control the rotary oscillation of the shock-strut piston relative to the cylinder and thereby prevent excessive MLG vibration during high-speed taxi and under heavy braking. The damping action is effected by a piston fitted in a fluid-filled cylinder in the damper body; a damping orifice in the piston controls the rate of displacement. The apex of the upper torsion link is bolted to the damper body and the apex of the lower link is connected to the damper piston rod via a bearing assembly. This consists of spherical bushes sandwiched between two thrust washers and is clamped against a shoulder on the rod by an end nut. Thus the torsion links can pivot relative to each other but horizontal displacement between their apexes is controlled by the damper action.

The left MLG lower torsion link (Part Number 65-46102-21) had broken mid-way along its length, at a point where a cut-out in the flange of the link formed two 'T' section limbs, both of which had fractured. Specialist examination concluded that the fractures had resulted from overload, approximately in the plane of the link, with the left limb having failed first and the right limb fracture showing signs of very low cycle, very high stress load reversals. One of the five bolts attaching the upper torsion link to the damper body had fractured and the damper piston rod had bent. The inner part of the rod had been gouged and the apex joint spherical bushings had suffered local compression collapse, with bronze material from the bushings smeared onto the mating surface of the thrust washers. These features were consistent with the damage to both the torsion link and the damper having resulted from excessive loads associated with MLG shimmying.

Shimmy Damper Schematic

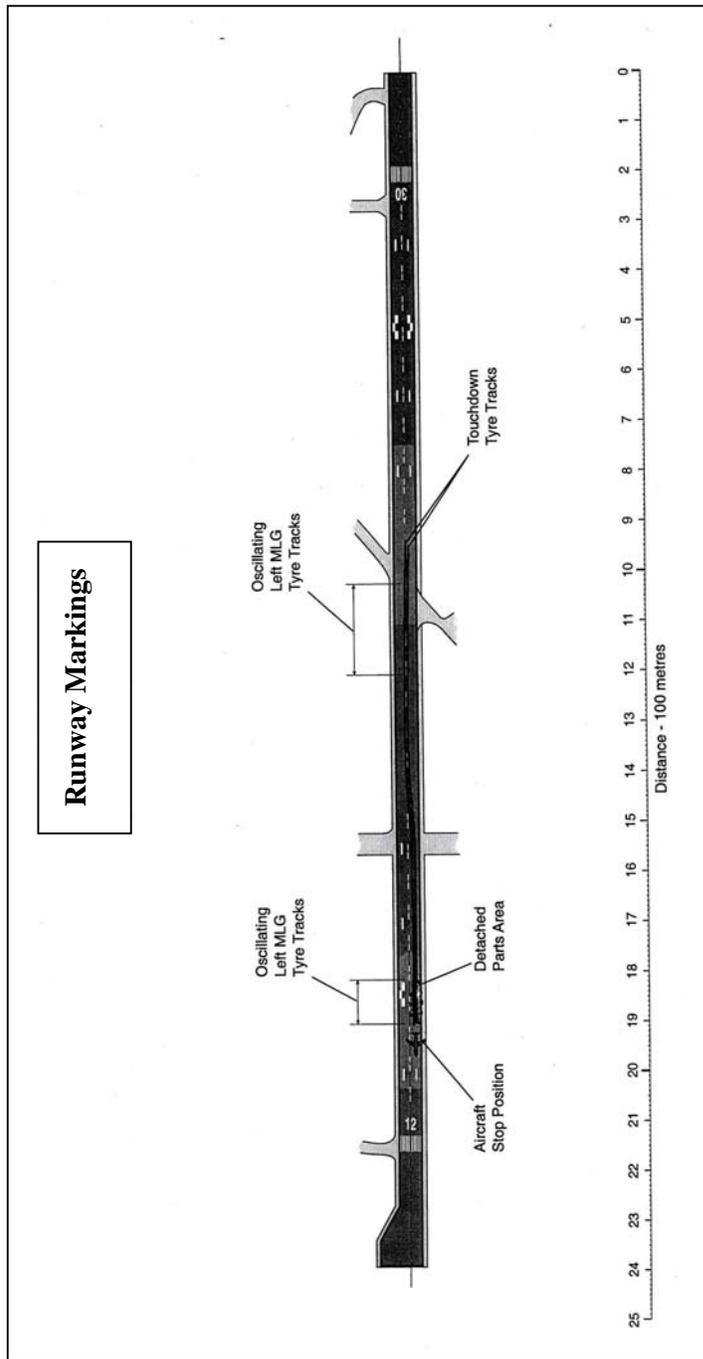
Figure 2

Runway 30 is 2,392 metres long and 46 metres wide, with a Landing Distance Available of 2,201 metres. The surface is generally concrete but tarmac in places. The aircraft had been removed by the time of AAIB arrival but runway tyre track markings, clearly associated with G-BVKC's landing roll, were apparent on the runway. These were continuous from touchdown to the point at which the AFS reported that G-BVKC had come to rest, Figure 2. Runway access was limited by heavy traffic and the measured distances were approximate.

The left MLG tyre tracks then began a sinusoidal oscillation, with a wavelength of 4.8 metres and a half-amplitude of 5 to 10 cm, that continued for 183 metres. After this the left MLG tracks became straight for 609 metres, with the aircraft diverging somewhat left of the centreline, before curving sharply to the right and commencing a second period of oscillation. The subsequent tracks were generally sinusoidal, with a wavelength of 2.3 metres and a half-amplitude of 15-20 cm, but part way through each swing to the left the wave was distorted and a dense black scrub mark was apparent. This was consistent with restraint of the yaw oscillation by contact of the No 2 wheel/tyre/brake assembly with the torque link/shimmy damper assembly as the axle approached its peak left yaw angle. The detached brake unit parts were found in the region of these second oscillation markings.

The apparently vigorous oscillation continued for 88 metres, to close to the point at which G-BVKC had come to rest, approximately 439 metres from the end of the runway. The total ground roll distance was around 1,008 metres.
