Piper PA-34-200 Seneca, G-TEST

AAIB Bulletin No: 8/2004	Ref: EW/G2004/01/07	Category: 1.3
Aircraft Type and Registration:	Piper PA-34-200 Seneca, G-TEST	
No & Type of Engines:	2 Lycoming IO-360-C1E6 piston engines	
Year of Manufacture:	1974	
Date & Time (UTC):	21 January 2004 at 1533 hrs	
Location:	Stapleford Aerodrome, Essex	
Type of Flight:	Training	
Persons on Board:	Crew - 3	Passengers - None
Injuries:	Crew - None	Passengers - N/A
Nature of Damage:	Right wing, landing gear and propeller damaged	
Commander's Licence:	United Kingdom Basic Commercial Pilot's Licence	
Commander's Age:	52 years	
Commander's Flying Experience:	3,200 hours (of which 990 were on type)	
	Last 90 days - 60 hours	
	Last 28 days - 20 hours	
Information Source:	Aircraft Accident Report Form submitted by the pilot and additional AAIB investigation

Examination of the right main landing gear oleo strut

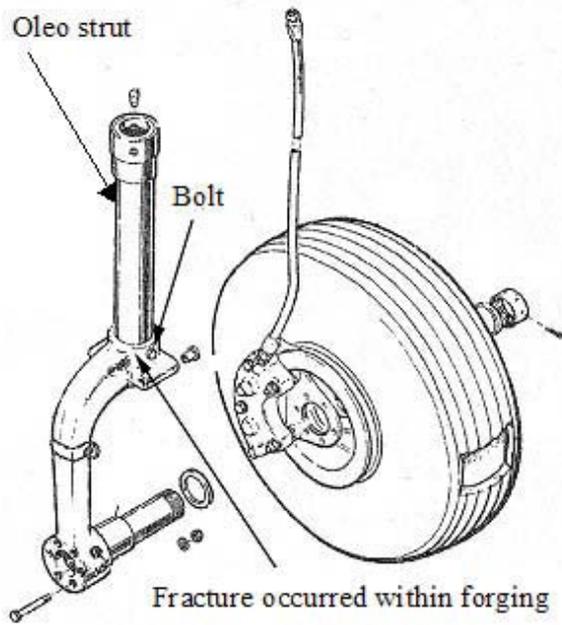
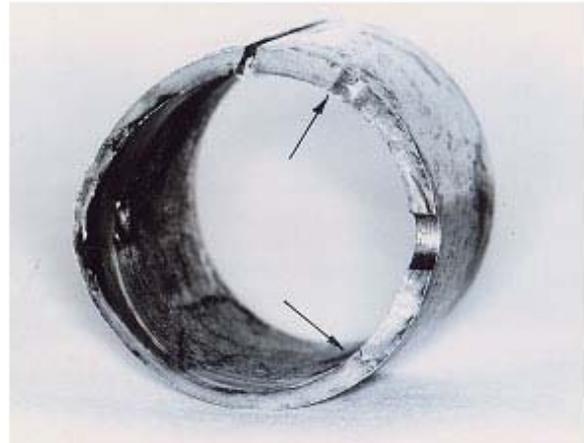
It was found that the right main landing gear oleo strut, which consisted of a cylindrical tube, had fractured close to its lower end, within the 'half fork' assembly that mounted the wheel axle (see Figure 1). This had allowed the wheel and half fork assembly to break away, with the remaining portion of the oleo tube contacting the runway.

retained within the forging, and it was apparent that the plane of the fracture passed through the forward bolt hole and just above the aft hole. The mating fracture surface on the upper portion of the strut had been heavily abraded by the runway surface.

The components were subjected to a metallurgical examination, although most of the evidence had been removed from the upper fracture face due to abrasion damage. The separated lower portion was removed from the half fork, which had protected it from damage. It was found that the failure had resulted from a fatigue mechanism originating at the forward bolt hole. This had propagated around 25% of the circumference of the strut before separation occurred as a result of a rearwards bending overload. The fatigue cracking had initiated in the bore of the hole from multiple sites, with progression initially being slow. It was considered that the process could have started shortly after the component entered service.

Lower portion of oleo strut after removal, showing extent of fatigue either side of forward bolt hole

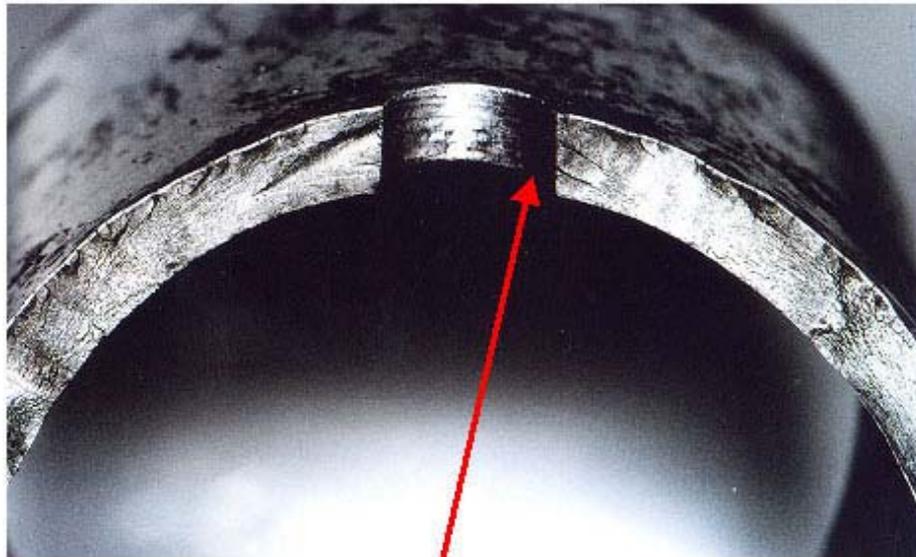
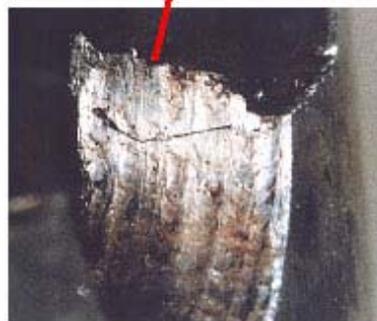
Figure 1. Details of G-TEST oleo strut failure

Examination of the bore revealed that the surface finish was very poor as a result of 'abusive machining' that had occurred during the drilling of the hole (see photograph in Figure 1). Such abuse could have taken the form of a blunt drill, lack of machining lubricant, or too fast a feed speed. The effect of this would have been to considerably reduce the fatigue resistance of the component. The surface finish of the aft bolt hole was similarly poor, although no fatigue cracks were evident.

Details of fatigue failure (above) and poor surface finish of hole bore (left), due to machining abuse

forward ones, primarily due to the landing and breaking elements. In the absence of any evidence of abnormal loading, it was concluded that the failure of the tube resulted from long-term service loads acting on a component with considerably reduced fatigue resistance due to machining abuse.
