**SERIOUS INCIDENT**

<b>Aircraft Type and Registration:</b>	Socata TB10 Tobago, G-RIAM	
<b>No &amp; Type of Engines:</b>	1 Lycoming O-360-A1AD piston engine	
<b>Year of Manufacture:</b>	1982	
<b>Date &amp; Time (UTC):</b>	27 July 2011 at 1545 hrs	
<b>Location:</b>	Coventry Airport	
<b>Type of Flight:</b>	Private	
<b>Persons on Board:</b>	Crew - 2	Passengers - 2
<b>Injuries:</b>	Crew - None	Passengers - None
<b>Nature of Damage:</b>	Smoke and heat damage to windscreen and underneath inspection panel	
<b>Commander's Licence:</b>	Private Pilot's Licence	
<b>Commander's Age:</b>	21 years	
<b>Commander's Flying Experience:</b>	86 hours (of which 15 were on type) Last 90 days - 3 hours Last 28 days - 3 hours	
<b>Information Source:</b>	Aircraft Accident Report Form submitted by the pilot and additional AAIB inquiries

**Synopsis**

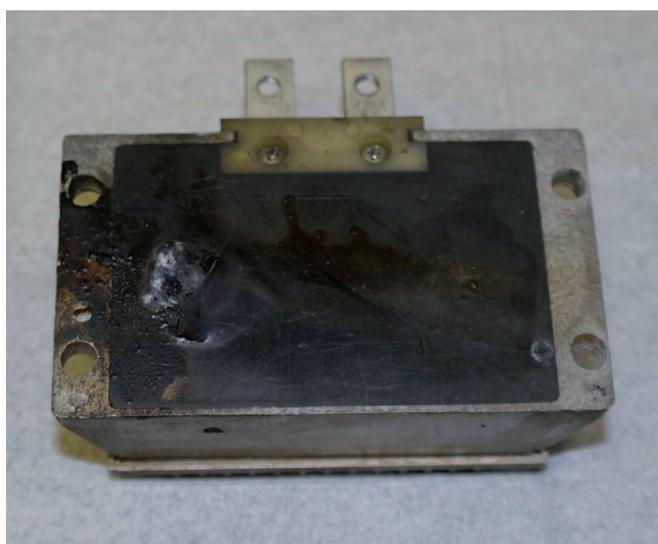
**Figure 1**

Examination of the aircraft revealed that there had been an internal failure of the alternator regulator, with the underside of the casing having sustained visible heat damage (Figure 1). The regulator was located behind the engine compartment firewall and in front of the instrument panel. Access was gained by means of a panel in the nose close to the right side of the windscreen. It was apparent that the smoke had originated from a layer of cabin insulation material that was in close proximity to the regulator. This material exhibited extensive charring, with the smoke having left visible residue on the inside of the windscreen.

An examination of the regulator was limited as the cavity that contained the internal circuitry had been filled with potting resin at manufacture, a process often used on this type of component. Whilst the resin, after setting, is intended to protect the electronic components against moisture and vibration, it effectively renders them subsequently inaccessible. It was thus not possible to identify the failure mode of the regulator, although the depth of charring that had occurred within the resin was indicative of the high temperatures that had been generated.

View of underside of regulator, showing heat damage

This event occurred following the failure of the alternator regulator, which generated sufficient heat to cause charring in an adjacent layer of cabin insulation. The resulting smoke presented a genuine emergency for the inexperienced pilot, who was fortunately able to hand control of the aircraft to his front seat passenger, an experienced professional pilot. The latter's experience may have contributed to his decisive handling of the emergency, which included expediting the landing at Coventry after the smoke increased in intensity. But for his intervention, the outcome may have been more serious. In order to limit the extent of any fire, it is important to perform the items listed in the Emergency Checklist. Although this document was not referred to during the incident, it was apparent that many of the items were actioned.

It is recommended that the European Aviation Safety Agency review the alternator regulator installation of the SOCATA TB series of single-engine aircraft, with a view to reducing the risk to the operation of the aircraft as a result of smoke/fire arising from a failure of this component.
