**INCIDENT**

<b>Aircraft Type and Registration:</b>	BAe ATP, G-BTPD	
<b>No &amp; Type of Engines:</b>	2 Pratt & Whitney PW-126 turboprop engines	
<b>Year of Manufacture:</b>	1988	
<b>Date &amp; Time (UTC):</b>	22 February 1995 at 1747 hrs	
<b>Location:</b>	Aberdeen (Dyce) Airport	
<b>Type of Flight:</b>	Public Transport	
<b>Persons on Board:</b>	Crew - 4	Passengers - 33
<b>Injuries:</b>	Crew - 1 Minor	Passengers - 1 Minor
<b>Nature of Damage:</b>	Damage to main landing gear tyres	
<b>Commander's Licence:</b>	Airline Transport Pilot's Licence	
<b>Commander's Age:</b>	30 years	
<b>Commander's Flying Experience:</b>	2,555 hours (of which 2,290 were on type) Last 90 days - 73 hours Last 28 days - 46 hours	
<b>Information Source:</b>	AAIB Field Investigation

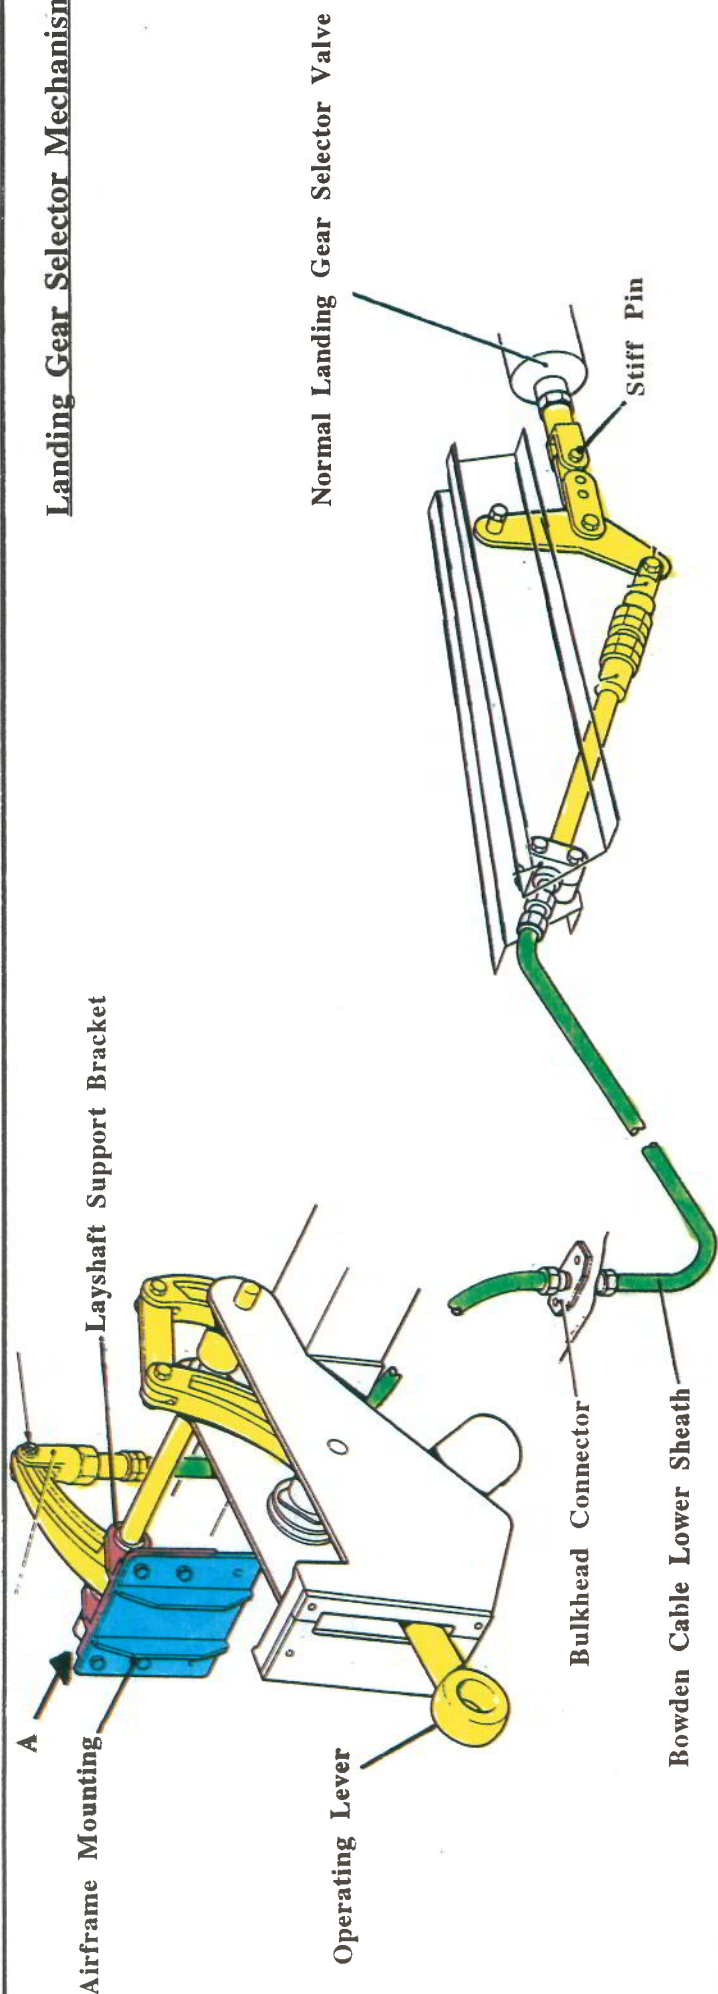
Figure 1

In an attempt to locate the cause of the stiffness, it was decided to progressively disconnect parts of the system, starting with the final pin joint at the selector valve input. However, attempts to remove this pin (Figure 1) were unsuccessful since it was an extremely tight fit in the fork end of the valve. Rather than risk disturbing this joint, the pin connecting the lower end of the Bowden cable was removed. However, operating loads at the cockpit lever only reduced slightly. It was intended that the next joint to be disconnected would be that at the upper end of the cable to the mechanism in the cockpit but, as access was being gained to this area behind the central instrument panel, it was noticed that the

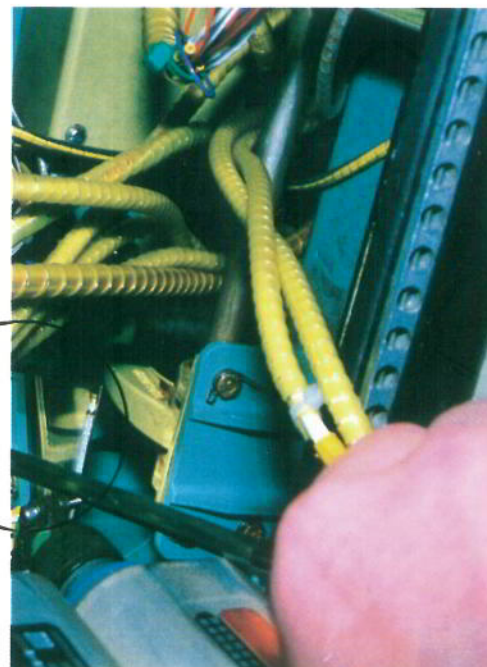
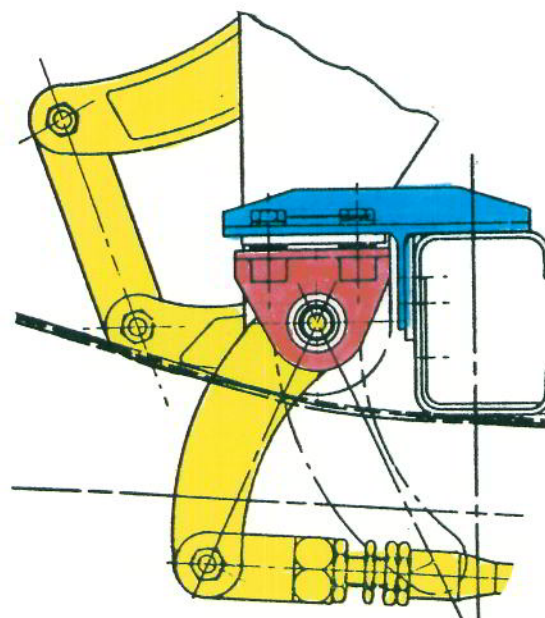
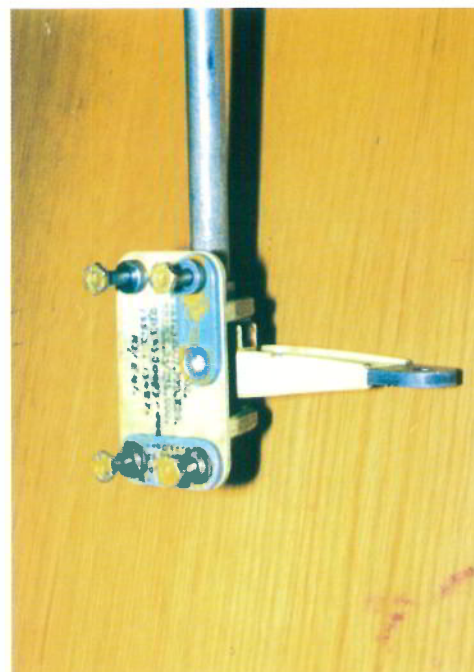
Figure 2

mounting for the Bowden operating lever was not 'square' to the airframe mounted bracket to which is shimmed and bolted. It was apparent that this mounting had been incorrectly shimmed, one of the two spacer plates being found as shown in Figure 2. Upon loosening the bolt causing the distortion, the threads of which were found to have been stripped, the mounting resumed its correct position and the lever operating loads, with the cable attached, were measured at 2.5/3 kg. After disconnecting the upper end of the cable, lever operating loads fell to very low levels and its operation became quite smooth.

Mirror Image of Bracket Distortion

Arrangement of Shims, as Installed

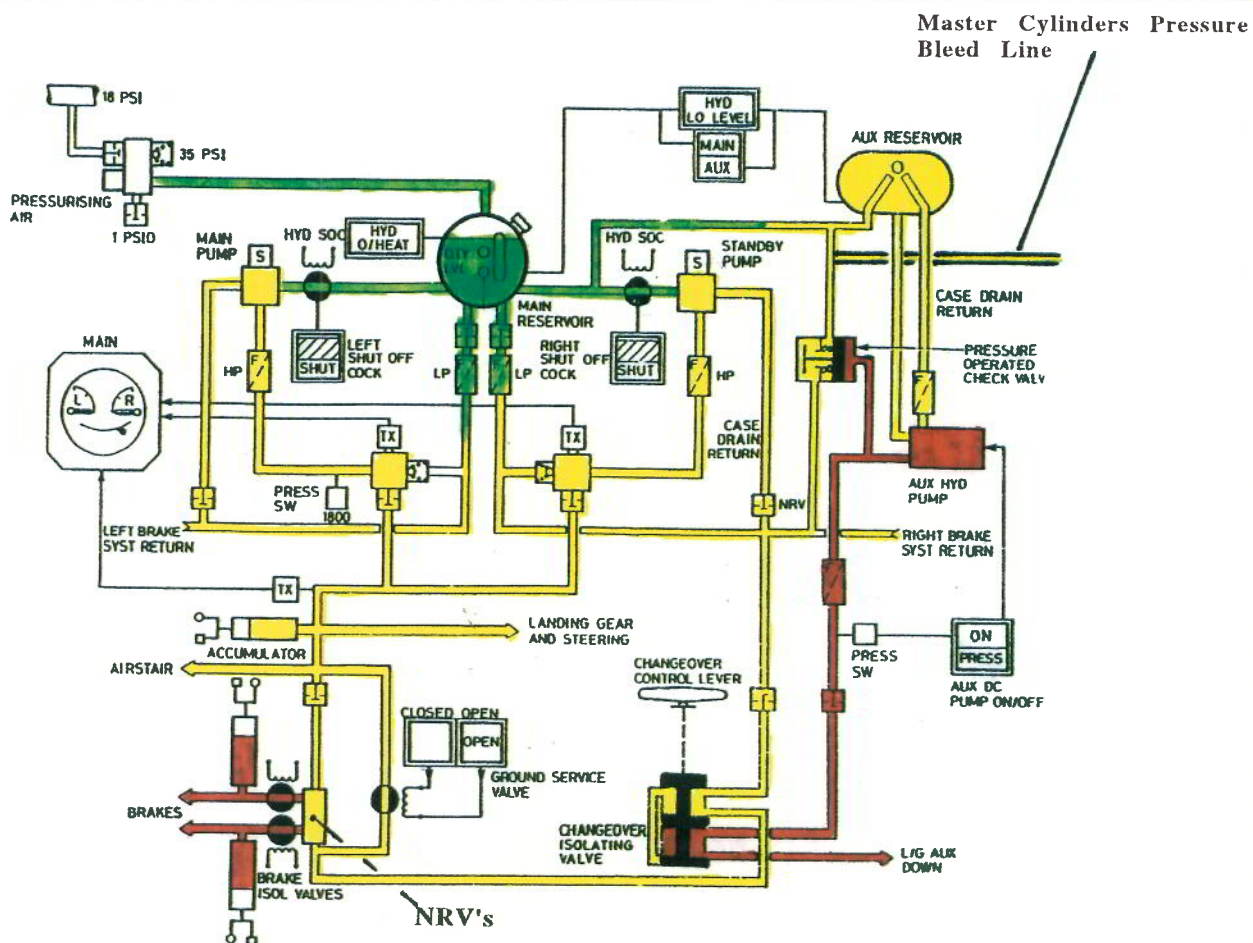
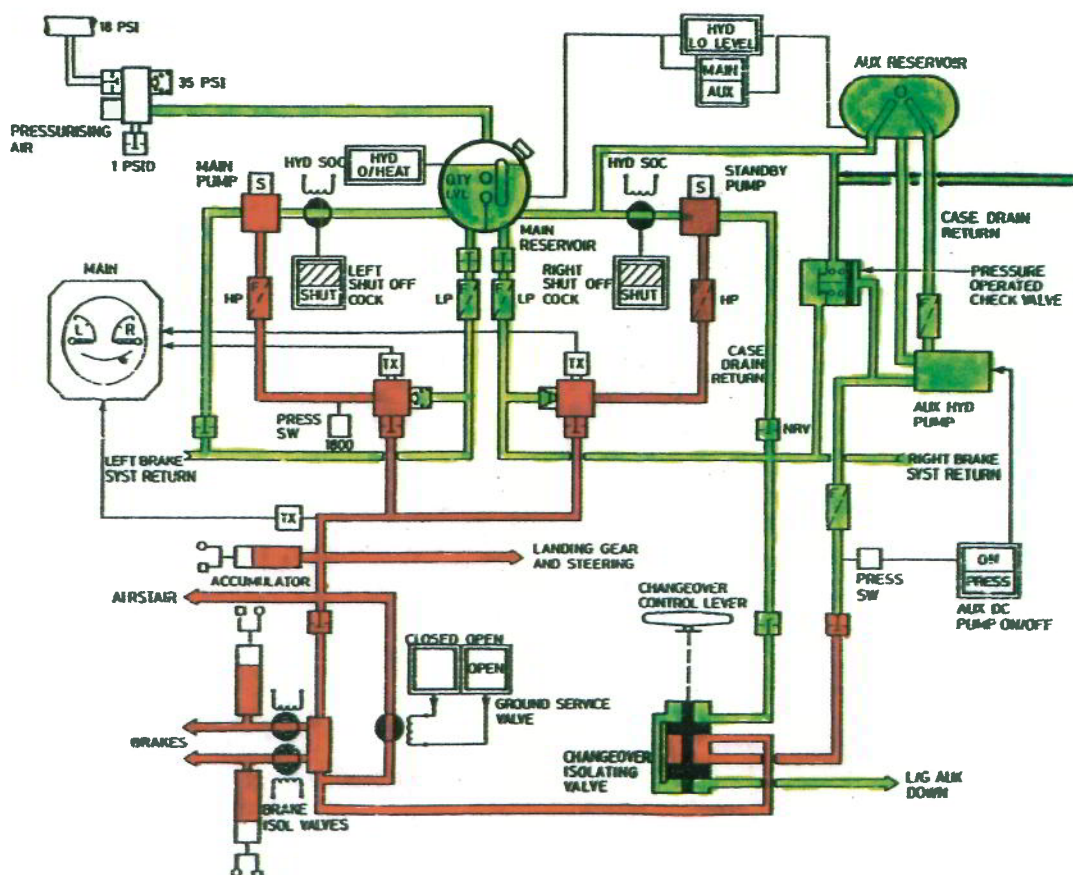
**Hydraulic System Configuration, Changeover Control Lever Pulled**

Two schematic diagrams of the hydraulic system are included at Figure 3 showing status in the changeover and normal modes.

When first examined, the aircraft's hydraulic system had no apparent leaks, there was sufficient fluid in the main reservoir and the landing gear changeover lever had been operated. Subsequent testing of the landing gear, using ground electrical and hydraulic power, showed that the aircraft's hydraulic system operated correctly. During this testing, the inflight sequence of events was repeated, ie the gear was lowered by operation of the landing gear changeover lever, and with the DC pump selected on. The gear successfully lowered and locked down, brake pressures of approximately 700 psi were seen on the indicators for all four wheels and, after some 7 to 8 minutes, a hydraulic overheat warning occurred. This procedure was repeated on another ATP aircraft of the same operator, with the same result. Subsequently, the manufacturer also repeated the above phenomenon on their development aircraft, both on the ground and in flight. From these tests it was confirmed that this was a system characteristic, not peculiar to 'PD', and that the elevated pressure in the hydraulic system return lines was sufficient to cause the brake pedal foot motors to signal the brake control valves to apply pressure

to the wheelbrakes. Pressures of up to 200 psi have been recorded at the auxiliary reservoir by the manufacturer during tests after operation of the changeover lever when following the procedure detailed in the un-amended QRH. Such pressure, applied to the master cylinders, is reported as being consistent with the observed wheelbrake pressures of 700/1,000 psi.

The manufacturer is carrying out a technical investigation which will lead to a modification of the hydraulic system to ensure that there is no possibility of residual brake pressure following the use of the landing gear changeover lever. It has been indicated that this modification will be made mandatory by the CAA.

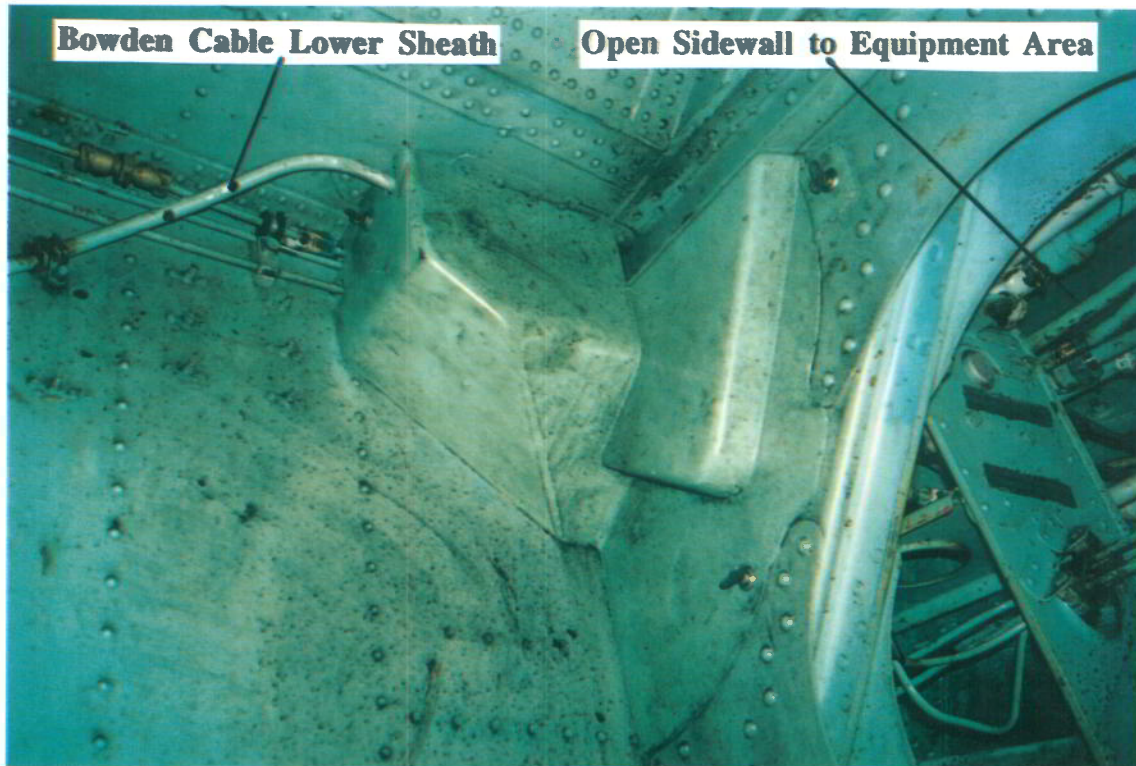
Figure 4

Installation of Landing Gear Selector Mechanisms Cover, Top Right Forward  
Corner of the Nose Gear Bay

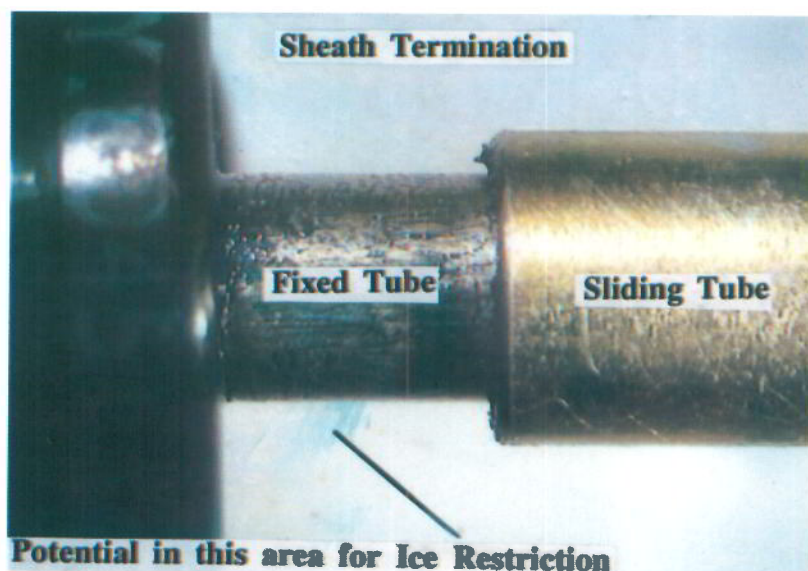
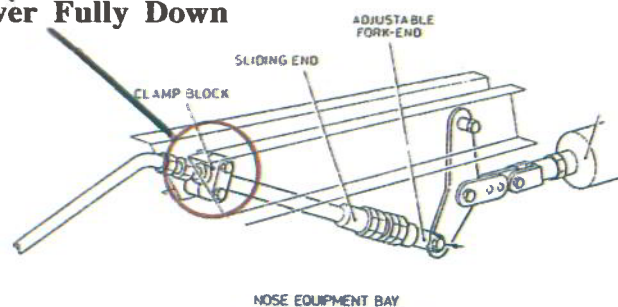
Figure 5

The examination of this system, whilst revealing several defects which helped to explain the stiffness and rough action felt when operating the lever, did not indicate any positive evidence as to why the lever could not, in flight, be moved fully down into the lower detent. However an assessment of the system by the AAIB and the manufacturer revealed an area where, potentially, if ice or frost were to form, a restriction to the travel of the cable might occur. This area was at the lower end of the fixed portion of the sheath, where its end fitting is clamped to the airframe. From this fitting a fixed tube protrudes, within which the cable itself slides, the cable being attached to the moveable end fitting, the larger diameter tube of which slides over the smaller diameter fixed tube. This outer tube moves towards the airframe clamp upon a gear DOWN selection such that, should there be any build up of ice

in this area, a restriction to the full normal travel of the cable might occur (Figure 5). The manufacturer has conducted icing trials in the laboratory, using the cable end fittings from 'PD' mounted onto a specially constructed test rig, but so far has been unable to substantiate this possibility. Following previous problems with ice contamination of the normal landing gear and changeover valve input mechanisms in the nose gear equipment bay, a modification was introduced to fit a cover over these mechanisms in the top right corner of the bay (Figure 4) to prevent direct contamination by water/slush thrown off by the nosewheels. This was fitted to 'PD' in September 1991. As may be seen, the mechanisms are protected from direct contamination and, although the area in which they are mounted is open to the general nose gear bay environment, no clear indications were seen of any residue that might have been deposited by water spray. A review of the complete gear selection system is being conducted by the manufacturer.
