ACCIDENT

Aircraft Type and Registration:	Boeing 757-200, TF-ARE	
No. and Types of Engines	2 Rolls Royce RB211-534E4-37 turbofan engines	
Year of Manufacture	2005	
Date & Time (UTC):	11 June 2005 at 2030 hrs	
Location:	Manchester International Airport	
Type of Flight:	Public Transport (Passenger)	
Persons on Board:	Crew - 8	Passengers - None
Injuries:	Crew - 1	Passengers - None
Nature of Damage:	None	
Commander's Licence:	Airline Transport Pilot's Licence	
Commander's age:	N/A	
Commander's Flying Experience:	Last 90 days - N/A Last 28 days - N/A	
Information Source:	Aircraft Accident Report Form, Airline internal investigation and AAIB inquiries

Synopsis

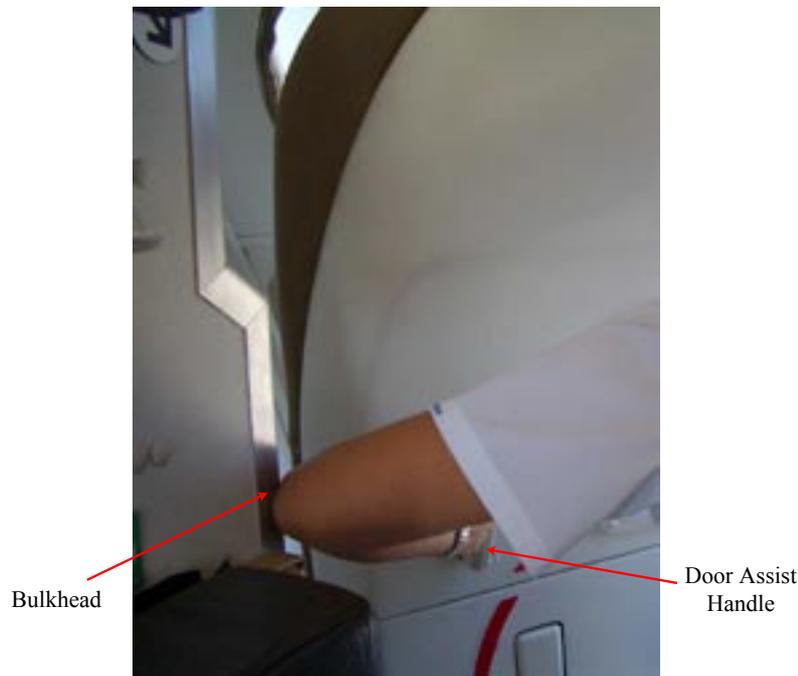
her left hand to bend around the door assist handle and her wrist to fracture. Figure 1 shows a reconstruction of how a person’s arm may become trapped. It was only once the door had moved into the fully closed position that the attendant was able to free her arm. Paramedics treated her at the aircraft before she was taken to hospital by the Duty Station Officer.

Reconstruction of a cabin crew member’s arm trapped between bulkhead and door assist handle
