No: 10/86

Aircraft type and registration: Hoffman H-36 Dimona D-KAFH

Location: North Connell Aerodrome, Nr Oban, Scotland

Nature of damage: Broken landing gear and propeller

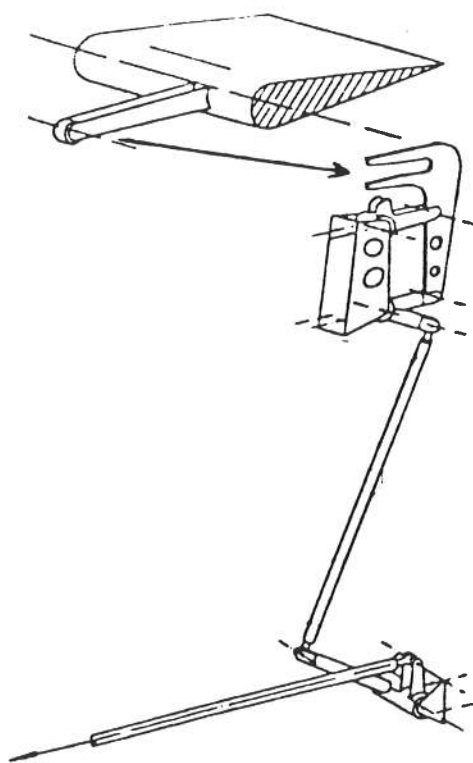
Elevator Controls in vertical Fin

On approach to land the aircraft suffered loss of elevator response resulting in a heavy landing. Permission was given for the aircraft to be returned to Germany for repair and an investigation was undertaken by the German authorities.

No technical defect was found and it is believed that during the accident flight the elevator had not been correctly attached to the push-rod in the vertical fin at its disassembly point. The elevator actuating mechanism is designed to engage automatically when the tailplane is assembled onto the fin but it was found that it was in fact possible to attach the tailplane without engaging the elevator control.

The aircraft manufacturer amended the flight manual for the aircraft to augment the controls checks and the Civil Aviation Authority issued an Emergency Airworthiness Directive (No 010-08-85) on this subject.
