Sikorsky S76C, G-SSSE

AAIB Bulletin No: 7/2003	Ref: EW/G2002/12/09	Category: 2.2
INCIDENT		
Aircraft Type and Registration:	Sikorsky S76C, G-SSSE	
No & Type of Engines:	2 Turbomeca Arriel 1S1 turboshaft engines	
Year of Manufacture:	1993	
Date & Time (UTC):	12 December 2002 at 1737 hrs	
Location:	Trent Platform, North Sea	
Type of Flight:	Public Transport	
Persons on Board:	Crew - 2	Passengers - 10
Injuries:	Crew - None	Passengers - None
Nature of Damage:	Nil	
Commander's Licence:	Airline Transport Pilot's Licence	
Commander's Age:	48 years	
Commander's Flying Experience:	7,305 hours (of which 950 were on type)	
	Last 90 days - 104 hours	
	Last 28 days - 44 hours	
Information Source:	Aircraft Accident Report Form submitted by the pilot, a report by the operating company and AAIB inquiries

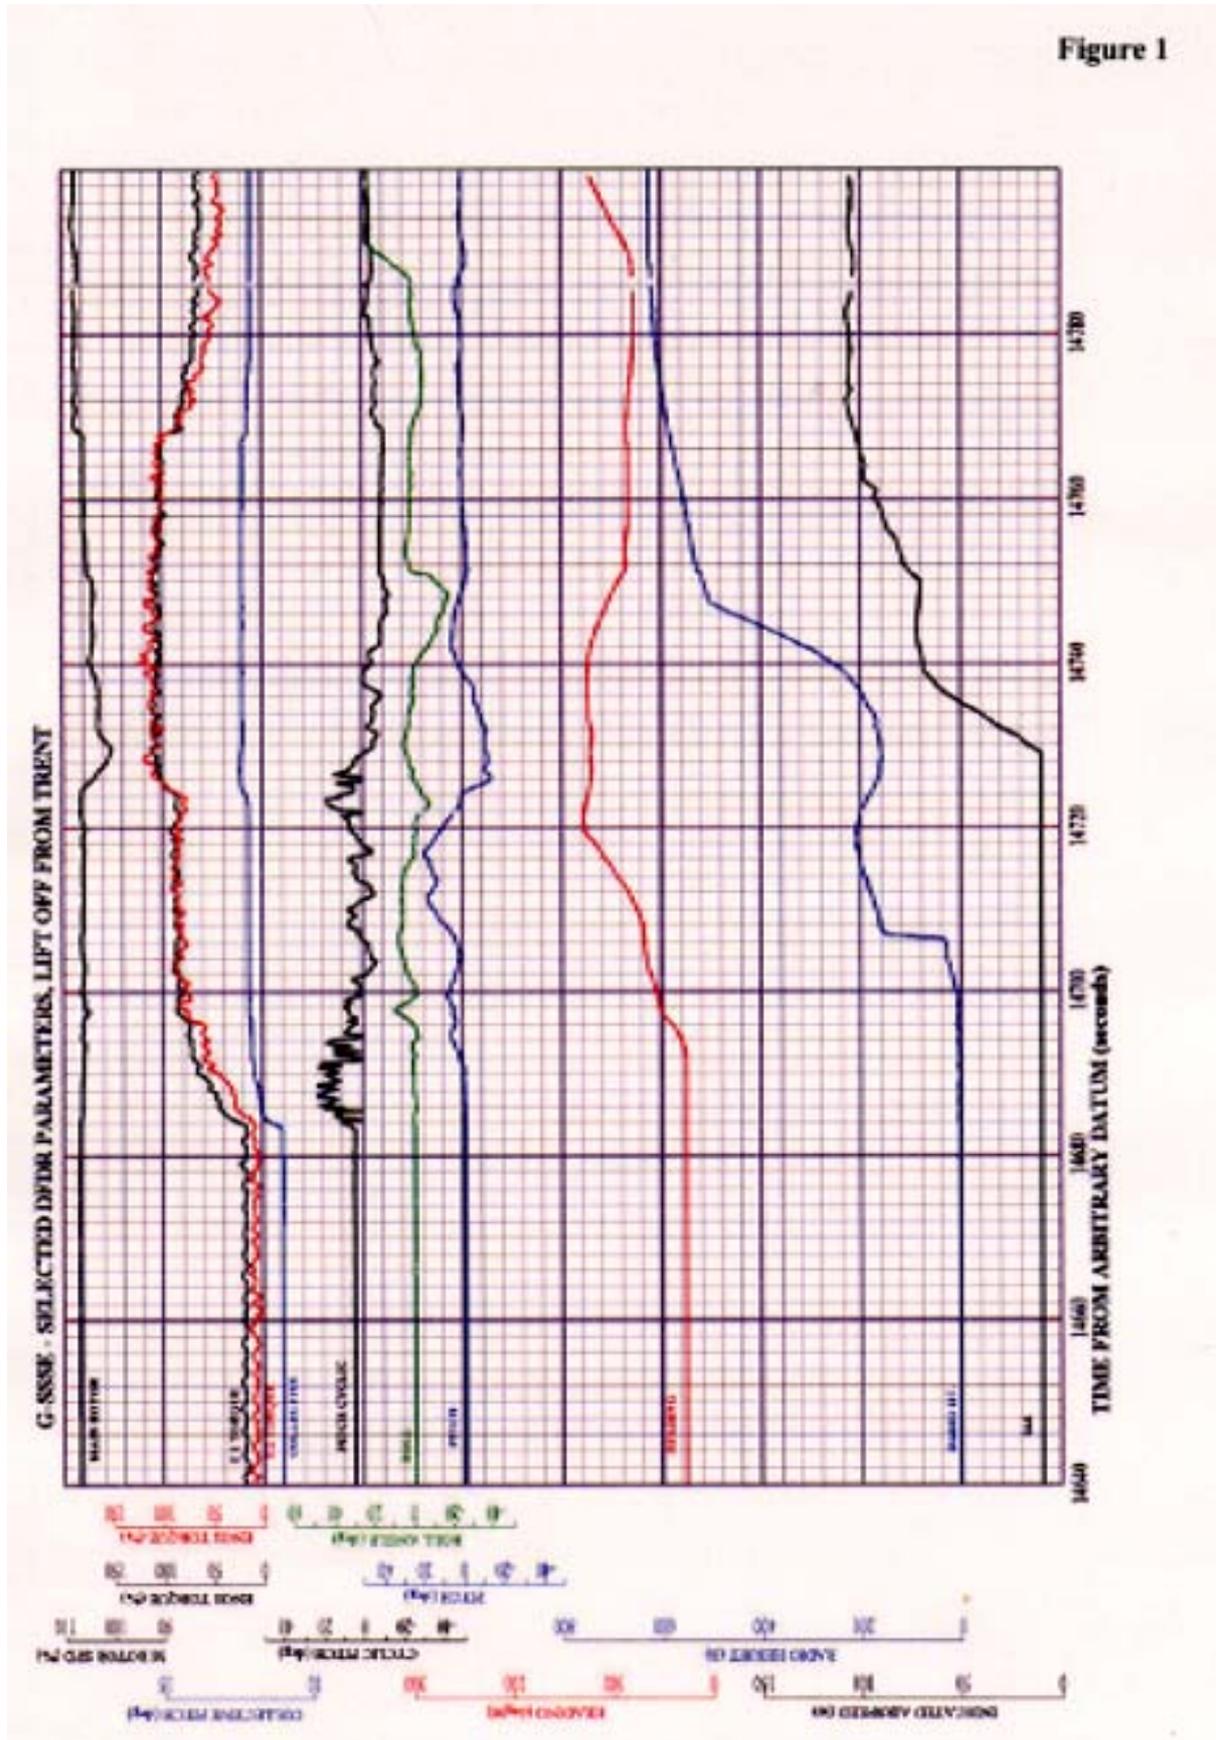
Figure 1

Selected parameters from the Digital Flight Data Recorder (DFDR), produced by the AAIB, are shown in Figure 1. This indicated that G-SSSE lifted into a low hover for about 6 seconds, during which time the pitch attitude remained between approximately 3° and 7° nose-up and the heading changed from 025° M to 050° M. Over the next six seconds, the radio height increased steadily to 31 feet with the pitch attitude decreasing to about 2° to 3° nose-up and the heading changing from 050° M to 068° M. Over the next second, the radio height increased to 160 feet, with the pitch attitude increasing, as the aircraft crossed the boundary of the deck. During the subsequent 5 seconds, the radio height slowly increased to 175 feet, with the pitch attitude reaching 17° nose-up and the heading changing to 080° M. The pitch attitude then reduced momentarily to 12° nose-up, before increasing to 19° over the next six seconds. Heading increased further to 110° M and the radio height reached 210 feet. At this point, the pitch started to reduce and reached 0° after 8 seconds; the aircraft descended to 180 feet and stabilised on a heading of 123° M. The collective pitch was increased and the engine torques increased to approximately 107%. Pitch was then reduced to 15° nose-down. Up to this point, there was no indication of airspeed above the recording cut-off level of 10 kt. However, the airspeed as sensed by the DFDR uses an independent transducer, which in some installations can be regarded as unreliable below about 30 kt, and would not have recorded the actual airspeed displayed to the pilots.

Then, as the aircraft descended to 160 feet radio height, the DFDR recorded airspeed started to register and the main rotor speed reached its minimum value of 100%, with heading remaining constant. Airspeed then increased quickly to 70 kt and radio height increased to 500 feet. At that height, the rate of climb reduced and the airspeed further increased before the aircraft climbed away at approximately 0° pitch attitude and turned left onto a heading of 085° M.
