ACCIDENT

Aircraft Type and Registration:	Rans S6-ESD, G-MWTT	
No & Type of Engines:	1 Rotax 503 piston engine	
Category:	1.4	
Year of Manufacture:	1991	
Date & Time (UTC):	26 June 2005 at 1300 hrs	
Location:	Insch, Aberdeenshire	
Type of Flight:	Private	
Persons on Board:	Crew - 1	Passengers - 1
Injuries:	Crew - None	Passengers - None
Nature of Damage:	Right wing damaged, nose landing gear collapsed	
Commander's Licence:	Private Pilot's Licence	
Commander's Age:	62 years	
Commander's Flying Experience:	260 hours (of which 150 were on type) Last 90 days - 5 hours Last 28 days - 2 hours	
Information Source:	Aircraft Accident Report Form submitted by the pilot and subsequent telephone enquires by AAIB

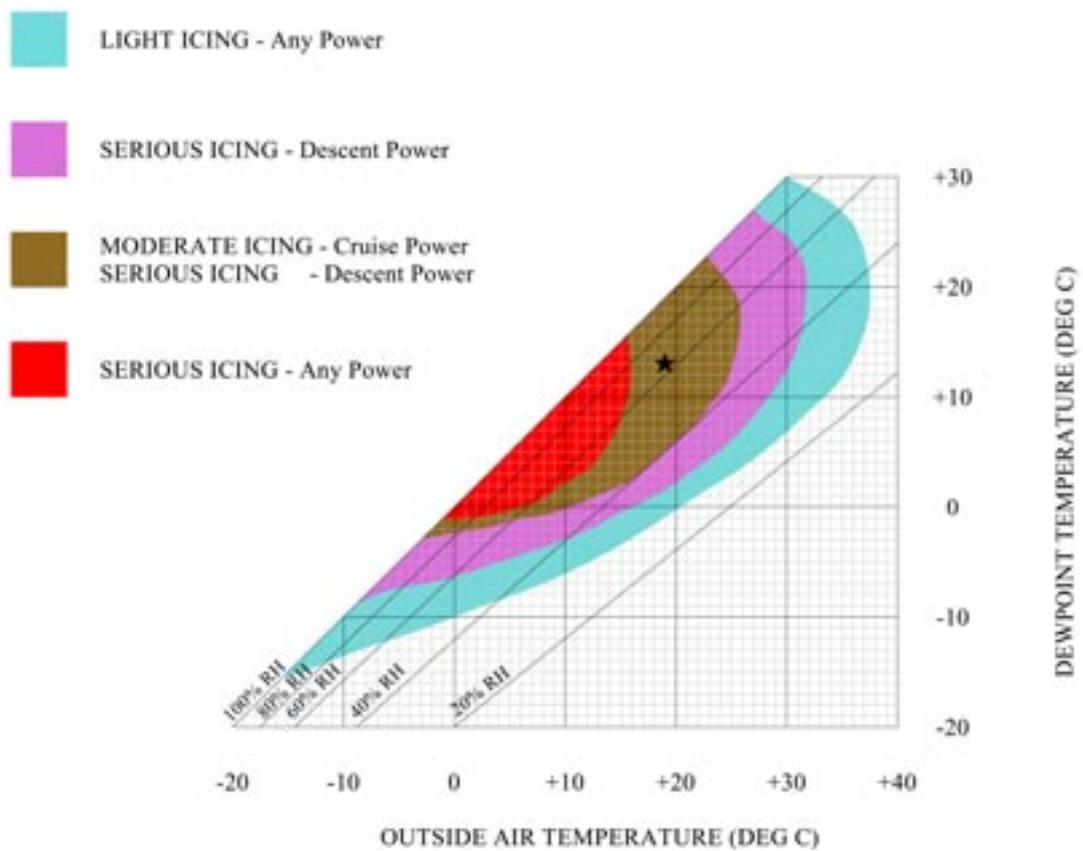
CARB ICING PREDICTION CHART

The weather at the time of the accident was observed as being a wind of 5 kt from 135° with good visibility. The temperature was 19°C with a dew point of 13°C, and this placed the engine in the '*moderate icing at cruise power and serious icing at descent power*' area of the carburettor icing prediction chart.
