BAe 146-200, G-MIMA

AAIB Bulletin No: 6/2004	Ref: EW/C2003/09/02	Category: 1.1
INCIDENT		
Aircraft Type and Registration:	BAe 146-200, G-MIMA	
No & Type of Engines:	4 Lycoming ALF502R-5 turbofan engines	
Year of Manufacture:	1987	
Date & Time (UTC):	8 September 2003 at 1435 hrs	
Location:	Gatwick Airport, West Sussex	
Type of Flight:	Public Transport (Passenger)	
Persons on Board:	Crew - 5	Passengers - 52
Injuries:	Crew - None	Passengers - 2 (Minor)
Nature of Damage:	Internal damage to the APU	
Commander's Licence:	Airline Transport Pilot's Licence	
Commander's Age:	53 years	
Commander's Flying Experience:	9,730 hours (of which 5,289 were on type)	
	Last 90 days -162 hours	
	Last 28 days - 43 hours	
Information Source:	AAIB Field Investigation

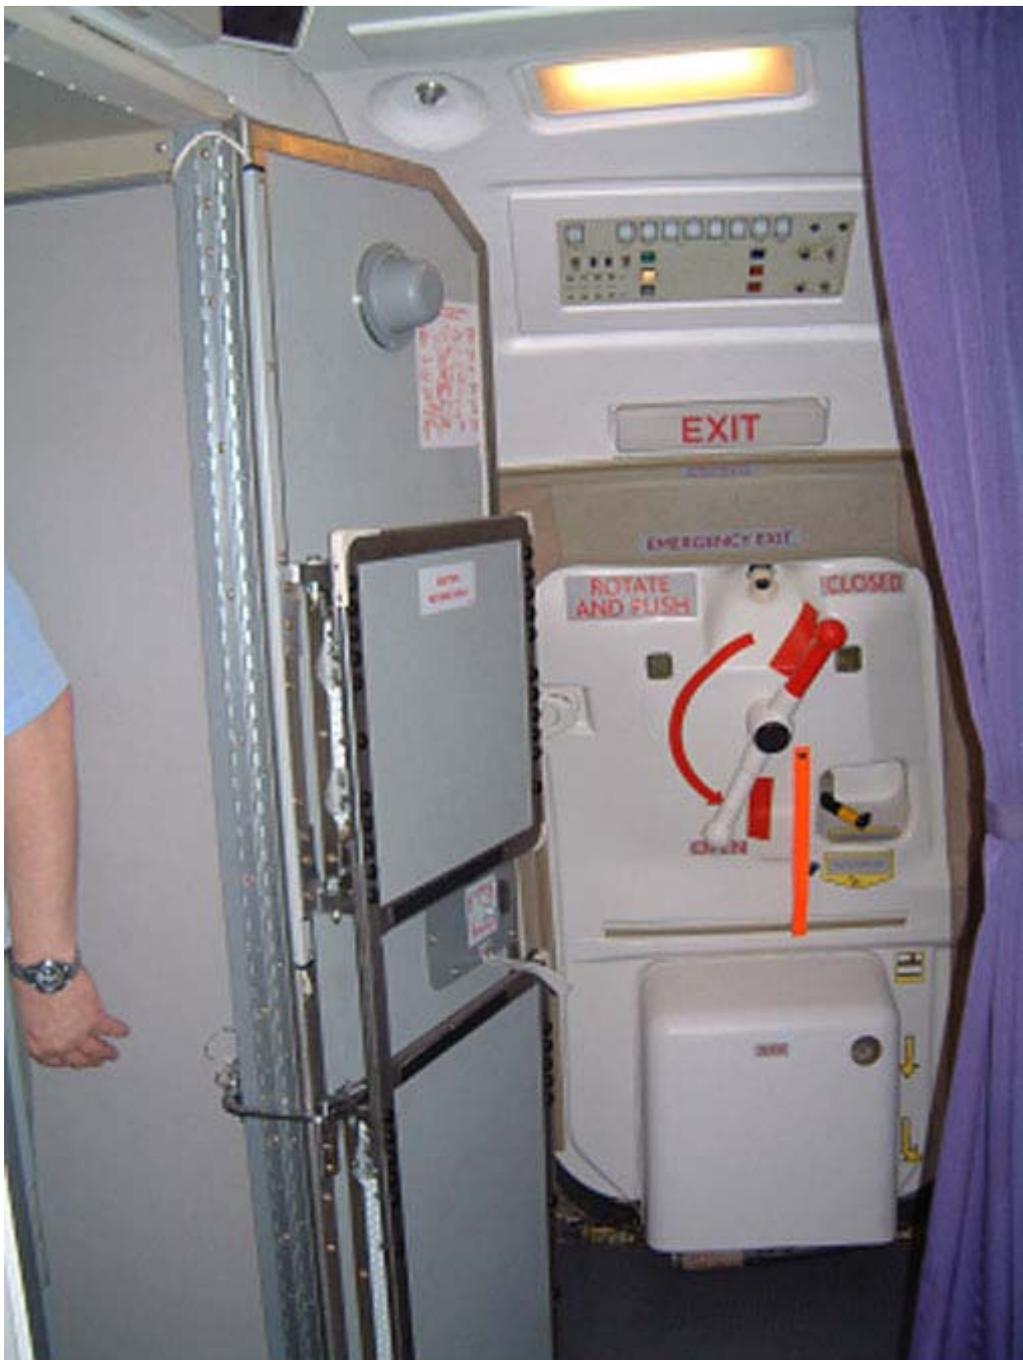
Figure 1: New door design

way for the commander to establish how much of the disembarkation had taken place and decide whether an evacuation was necessary. The introduction of the new design of flight deck door will offer greater flexibility to crews in deciding whether to keep the door open or closed after engine shutdown.

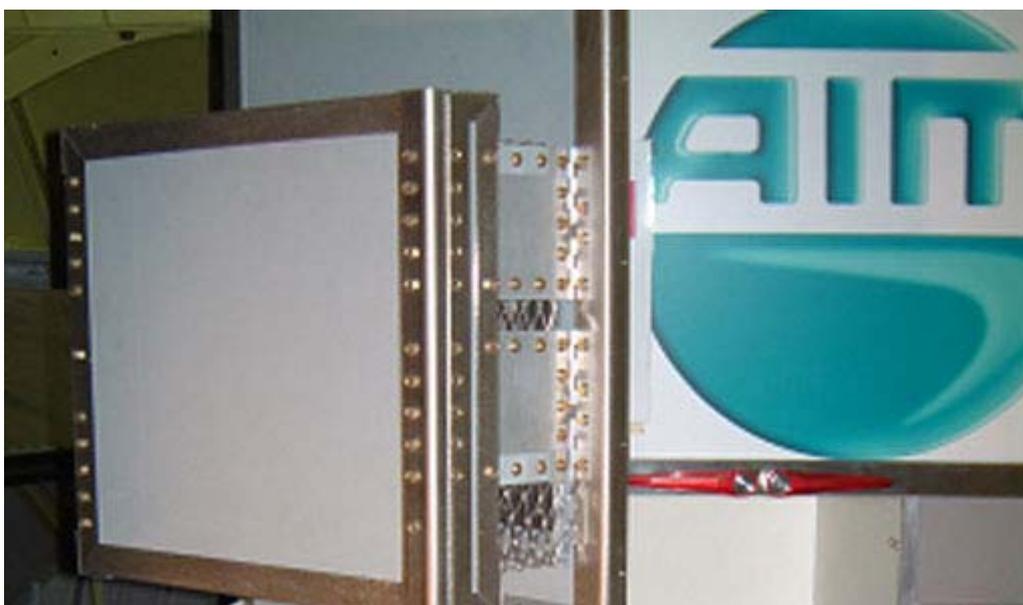
Figure 2: Standard of door fitted to G-MIMA

The requirement to lock the flight deck door only applies until engine shutdown and the company does not have a Standard Operating Procedure (SOP) as to when it is opened after shutdown occurs. The bulkiness of the particular door fitted to G-MIMA and the consequent limited aisle space means that, in practise, it is awkward to open the door once the passengers have started to disembark. It is usual to leave it closed until disembarkation is complete, as happened in this incident. However, with the door closed and passengers disembarking, the cabin crew are unable to stand in a position where they can easily see along the aisle to the rear of the aircraft. This problem is not limited to the BAe 146 aircraft with this type of door fitted. A new flight deck door, Figure 1, has been designed with a hinged decompression panel which is automatically closed as the door is opened, rather than the current decompression 'cage' of the existing door, Figure 2, and this considerably reduces the door's bulk and will ease current aisle congestion. The first of these doors on the BAe 146 should be introduced in April 2004.
