No: 7/90

Ref: EW/C1109

Aircraft Type and Registration: Sikorsky S-61N, G-BFFJ

Nature of Damage: Severe damage to No. 1 drive train and main gearbox

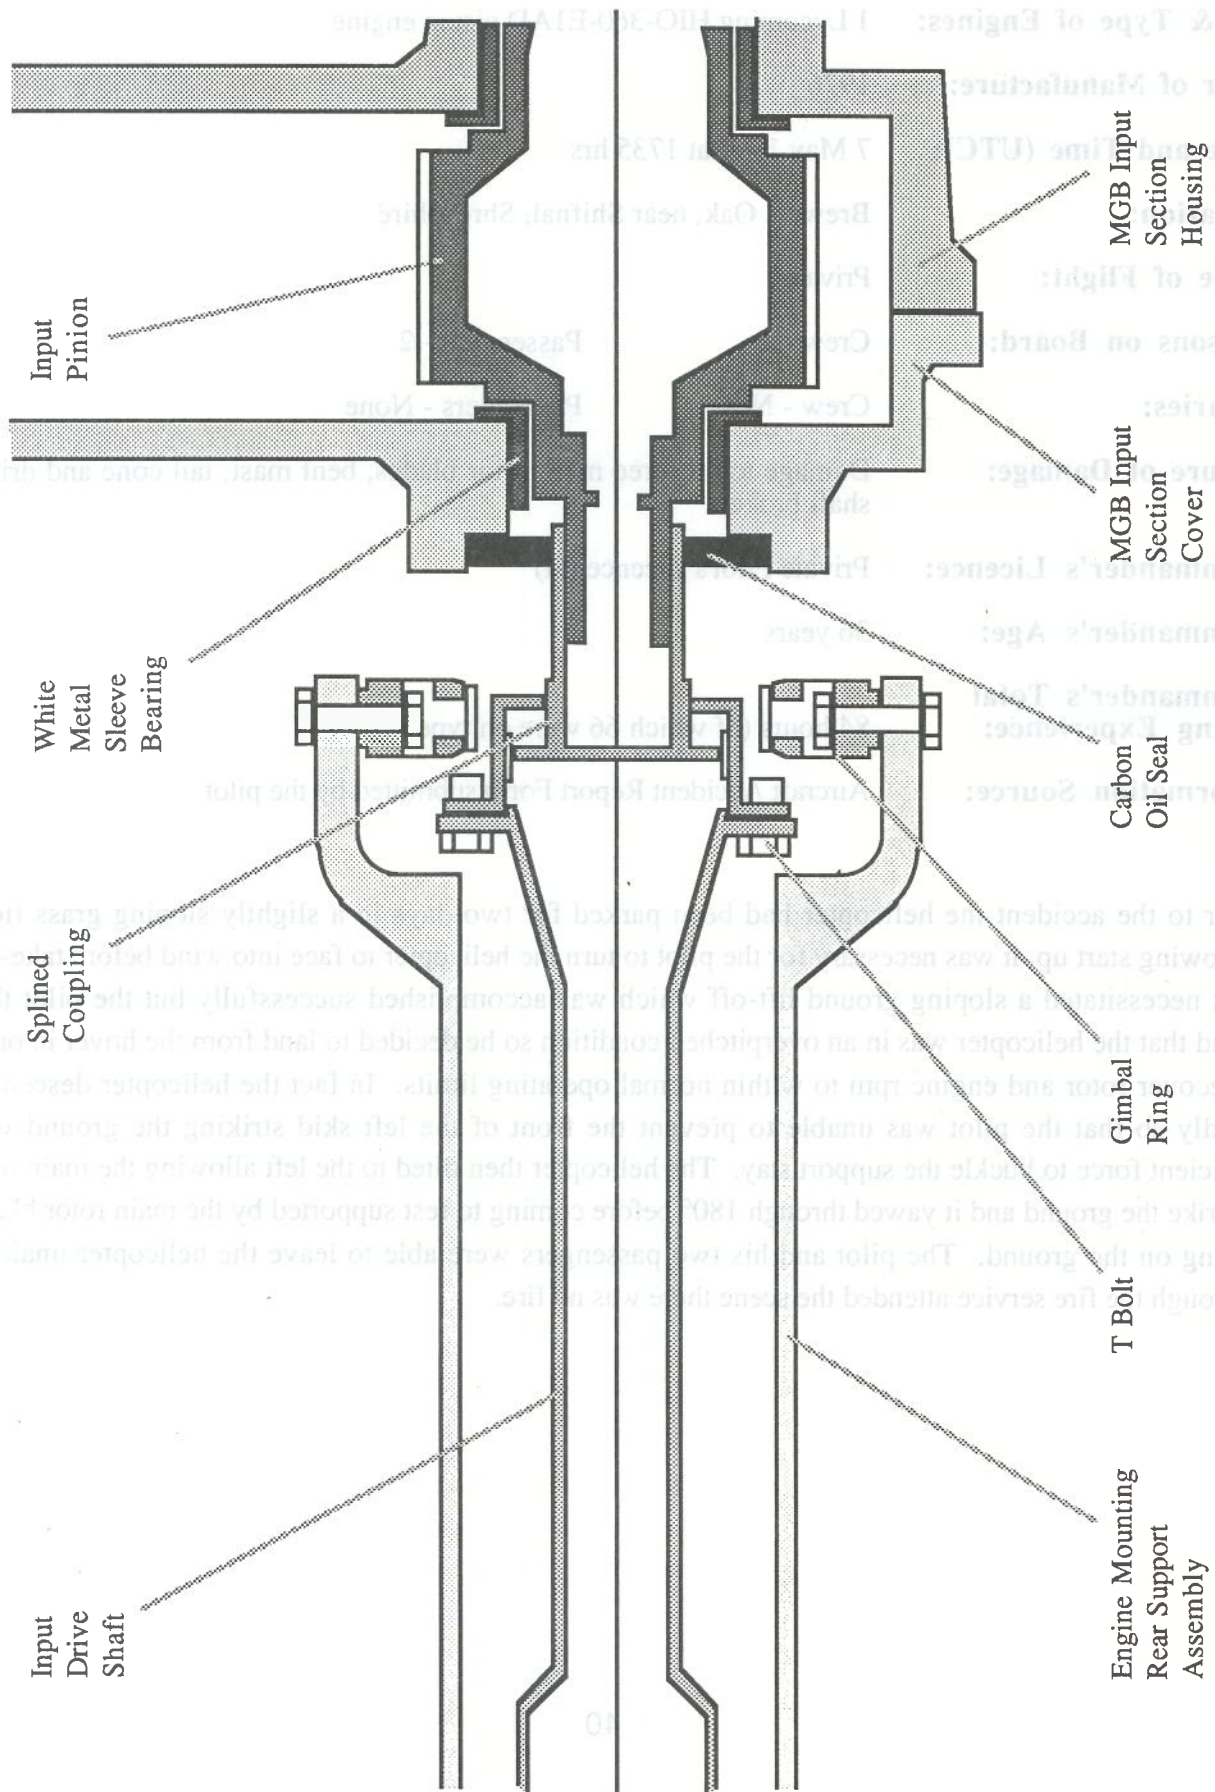
Fig 1

The S-61N is a twin-engined helicopter of conventional layout, with engines mounted on the cabin roof forward of the MGB bay. A free power turbine in each engine drives a MGB input section, comprising a combining geartrain in a magnesium alloy housing and cover, via an input drive shaft (IDS), (Fig 1). The drive is transmitted via a Thomas flexible coupling at the forward end of the IDS and a splined input coupling at its aft end, both catering for up to 0.5 degrees of continuous axial misalignment.

DRIVE TRAIN LAYOUT
