Grob G115E Tutor, G-BYXJ

AAIB Bulletin No: S3/2004	Ref: EW/C2004/06/03	Category: 1.3
Aircraft Type and Registration:	Grob G115E Tutor, G-BYXJ	
Serial Number:	82170/E	
No & Type of Engines:	1 Lycoming AEIO-360-B1F piston engine	
Year of Manufacture:	2001	
Date & Time (UTC):	29 June 2004 at 1650 hrs	
Location:	4.5 nm Southwest of Salisbury, Wiltshire	
Type of Flight:	Training	
Persons on Board:	Crew - 2	Passengers - None
Injuries:	Crew - Nil	Passengers - N/A
Nature of Damage:	1 blade and part of propeller hub detached; substantial damage to engine and airframe	
Commander's Licence:	Royal Air Force Qualified Flying Instructor	
Commander's Age:	28 years	
Commander's Flying Experience:	1,450 hours (of which 215 were on type)	
	Last 90 days - 60 hours	
	Last 28 days - 20 hours	
Information Source:	AAIB Field Investigation

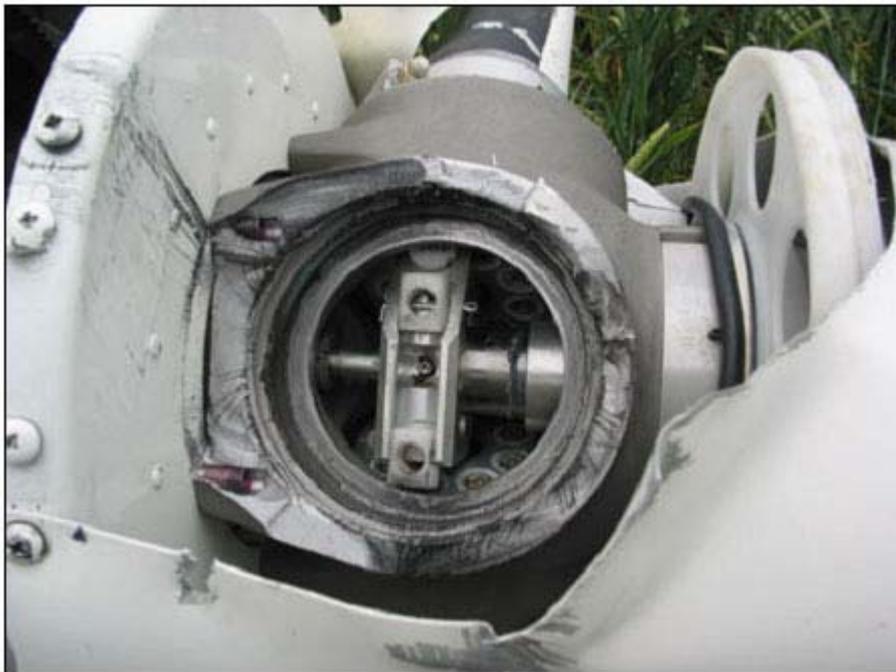
The aircraft was examined by the AAIB at the accident site. It was immediately apparent that the Number 1 propeller blade had detached due to a failure of the hub. The blade was found approximately 3.5 km from the aircraft location, with the fractured part of the hub attached to it. Examination of the fracture surfaces (Figure 1) suggested that the aluminium hub had failed due to high cycle fatigue cracking, originating at the front and back of the blade arm. This was later confirmed by the initial metallurgical examination findings.

Figure 1: Propeller hub showing fractured blade arm

The propeller manufacturer, Hoffmann Propeller GmbH & Co KG, issued Service Bulletin 61-10-03 SB E 15 requiring eddy current non-destructive testing of type HO-V343 propeller hubs to check for cracks in the blade arms. The Service Bulletin also requires the propeller blades to be checked for looseness ('blade shake') and calls for checks of the blade retention nut torque values. The procedure for accomplishing this is described in Hoffmann Service Instruction 61-10-05 SI E 4.

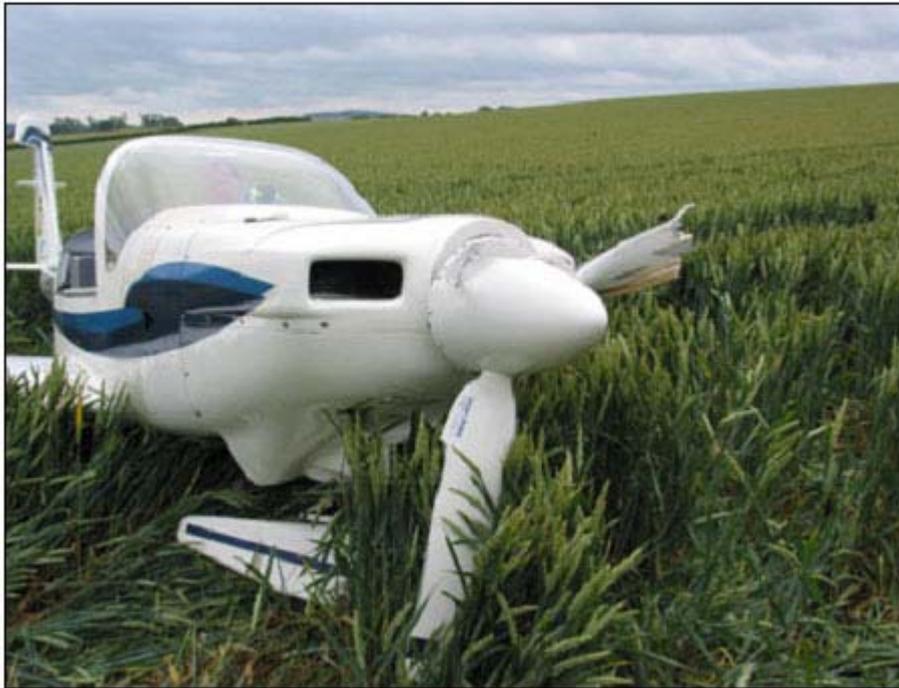
As the blade departed the hub it was struck by the following blade, causing the detachment of a large portion of the latter (Figure 2). The out of balance forces generated prior to engine shutdown caused the canopy to detach from the aircraft and also resulted in significant damage to the engine and its mountings. This included the severing of the left-hand upper engine mounting lug from the crankcase and cracking and severe distortion of the engine mounting frame. The left-hand magneto had pulled out of its mounting and the exhaust mufflers had severed from the exhaust down pipes. The left-hand main landing gear and the nose gear were extensively damaged during the forced landing.

Figure 2: General view of propeller damage
