**SERIOUS INCIDENT**

<b>Aircraft Type and Registration:</b>	Boeing 737-73V, G-EZKG	
<b>No &amp; Type of Engines:</b>	2 CFM56-7B20 turbofan engines	
<b>Year of Manufacture:</b>	2004	
<b>Date &amp; Time (UTC):</b>	11 August 2010 at 1640 hrs	
<b>Location:</b>	West of Nantes, France	
<b>Type of Flight:</b>	Commercial Air Transport (Passenger)	
<b>Persons on Board:</b>	Crew - 5	Passengers - 144
<b>Injuries:</b>	Crew - None	Passengers - None
<b>Nature of Damage:</b>	None	
<b>Commander's Licence:</b>	Airline Transport Pilot's Licence	
<b>Commander's Age:</b>	60 years	
<b>Commander's Flying Experience:</b>	17,950 hours (of which 13,430 were on type) Last 90 days - 236 hours Last 28 days - 82 hours	
<b>Information Source:</b>	Aircraft Accident Report Form submitted by the pilot and further enquiries by the AAIB

**Synopsis**

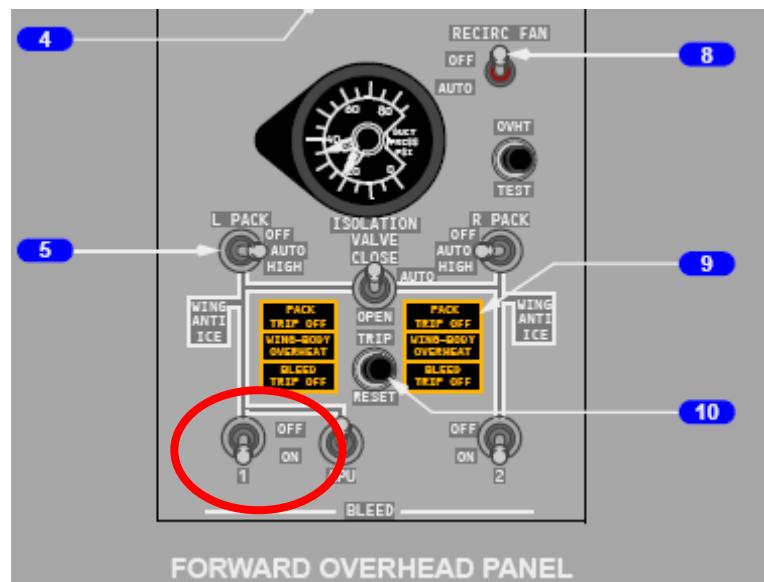
**Figure 1**

The co-pilot stated that he had incorrectly selected the bleed switch to OFF instead of the pack switch to OFF when he completed the left BLEED TRIP OFF checklist. Recorded data confirmed this. The bleed system was then configured with one engine bleed supplying two air conditioning packs. The right engine bleed was unable to meet the demand from two packs and tripped off, resulting in the loss of cabin pressure.

Bleed air section of Boeing 737-700 overhead panel.
