No: 6/90

Ref: EW/C1153

**Aircraft Type and Registration:**

Reims Cessna F150M, G-BCTV

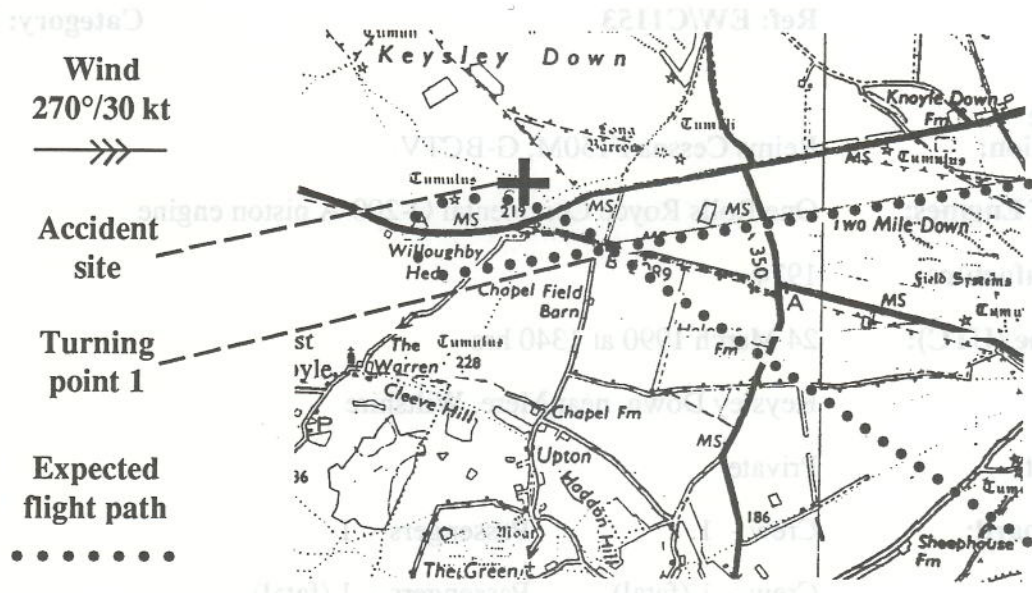
The weather was good with a strong westerly wind, estimated to be 270°/30 kt at 1,000 feet amsl. The route began near Boscombe Down and the first turning point was 14.3 nm to the west on a track of 262°T. The second leg left the turning point on a track of 125°T, requiring aircraft to change heading through approximately 137°. One minute was allowed on the flight plan for reorientation over this turning point, and it was customary for aircraft to use this time to turn the long way round and cross the turning point again close to the required outbound heading. On this day pilots could expect to perceive an increase in groundspeed of some 60 kt as they made this turn from into wind to downwind. A typical flight pattern is shown on the diagram below. It was usual for such routes to be flown at 1,000 feet agl at an airspeed which allowed for time to be gained or lost by changing speed, and for flap (or more flap) to be lowered when time had to be lost.
