ACCIDENT

Aircraft Type and Registration:	Jodel DR1050 Ambassadeur, G-ATGE	
No & Type of Engines:	1 Continental Motors Corp O-200-A piston engine	
Year of Manufacture:	1960	
Date & Time (UTC):	12 June 2009 at 2006 hrs	
Location:	Belmont Road, Kilkeel, Co Down, Northern Ireland	
Type of Flight:	Private	
Persons on Board:	Crew - 1	Passengers - 2
Injuries:	Crew - 1 (Fatal)	Passengers - 2 (Fatal)
Nature of Damage:	Aircraft destroyed	
Commander's Licence:	Private Pilot's Licence	
Commander's Age:	53 years	
Commander's Flying Experience:	1,022 hours (of which over 150 hours were on type) Last 90 days - 25 hours Last 28 days - 14 hours	
Information Source:	AAIB Field Investigation

Synopsis

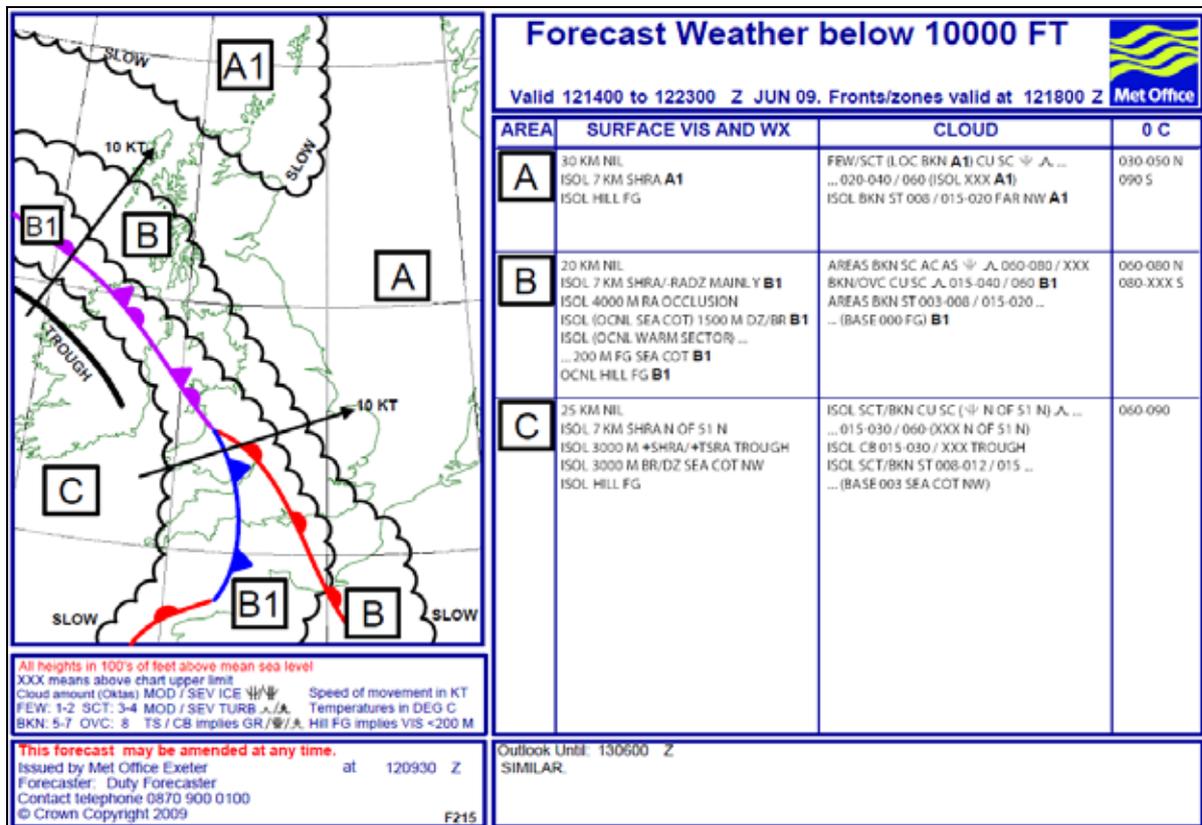
The weather forecast issued by the Met Office for the time of the flight is shown at Figure 1.

The flight took place predominately in area B1 where visibility was forecast to drop occasionally to 1,500 m in drizzle and mist. Isolated areas with visibility of 200 m were to be expected in coastal areas. Areas of broken stratus were forecast with bases between 300 ft and 800 ft amsl, although the base would be at ground level in any fog.

Figure 1
Met Office weather forecast valid at the time of the accident
