**INCIDENT**

<b>Aircraft Type and Registration:</b>	ATR 42-300, G-TAWE	
<b>No &amp; Type of Engines:</b>	2 Pratt & Whitney Canada PW120 turboprop engines	
<b>Year of Manufacture:</b>	1994	
<b>Date &amp; Time (UTC):</b>	20 January 2006 at 2107 hrs	
<b>Location:</b>	Runway 31 at Glasgow Prestwick Airport	
<b>Type of Flight:</b>	Public Transport (Passenger)	
<b>Persons on Board:</b>	Crew - 3	Passengers - 34
<b>Injuries:</b>	Crew - None	Passengers - None
<b>Nature of Damage:</b>	Nose gear uplock bent and five runway edge lights damaged	
<b>Commander's Licence:</b>	Airline Transport Pilot's Licence	
<b>Commander's Age:</b>	57 years	
<b>Commander's Flying Experience:</b>	13,233 hours (of which about 5,000 were on type) Last 90 days - 123 hours Last 28 days - 38 hours	
<b>Information Source:</b>	Aircraft Accident Report Form submitted by the pilot and report by Glasgow Prestwick Airport

**Synopsis**

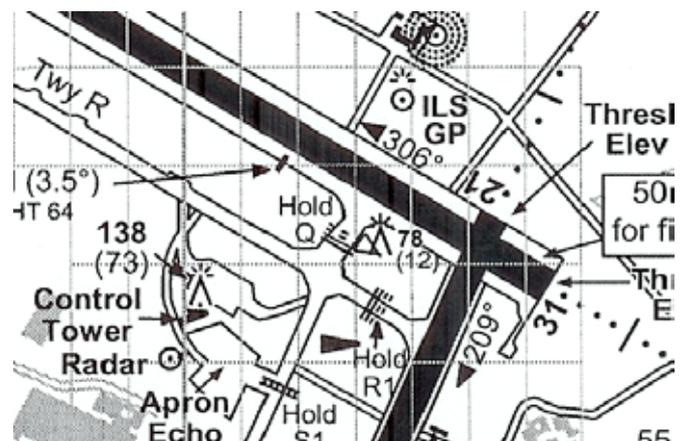
**Figure 1**

While taxiing for a departure from Runway 31, the commander was given clearance to enter the runway by either 'R1' or 'Q'. The disposition of these holding points is as shown in Figure 1. He elected to enter by 'Q' and lined up the aircraft in a position he thought was just to the left of the runway centreline. The first officer then commented that he did not think that the 'perspective' looked quite right and the commander taxied G-TAWE to the left until it was lined up exactly over lights.

Disposition of the holds for Runway 31

All taxiways have green centreline lights except for the entry to Runway 31 by holding point ‘Q’. There are blue edge lights on all taxiways. The lights were on at the time of the incident.

The UK AIP contains a warning about the possibility of mistaking the runway edge lights for the centreline lights. In the incident involving G-TAWE, the use of ‘Q’, which has no centreline lights as a lead-in to the runway was a contributing factor. Since the incident, ATC no longer allow aircraft to use ‘Q’ when entering the runway at night or in poor visibility.
