**INCIDENT**

<b>Aircraft Type and Registration:</b>	Thruster T600N 450, G-CBWJ	
<b>No &amp; Type of Engines:</b>	1 Jabiru Aircraft PTY 2200A piston engine	
<b>Year of Manufacture:</b>	2002	
<b>Date &amp; Time (UTC):</b>	2 August 2010 at 1530 hrs	
<b>Location:</b>	Bradley Lawn Farm, Heathfield, East Sussex	
<b>Type of Flight:</b>	Training	
<b>Persons on Board:</b>	Crew - 2	Passengers - None
<b>Injuries:</b>	Crew - None	Passengers - N/A
<b>Nature of Damage:</b>	Propeller detached	
<b>Commander's Licence:</b>	National Private Pilot's Licence	
<b>Commander's Age:</b>	47 years	
<b>Commander's Flying Experience:</b>	n/k hours (of which n/k were on type) Last 90 days - 55 hours Last 28 days - 11 hours	
<b>Information Source:</b>	AAIB Field Investigation

**Synopsis**

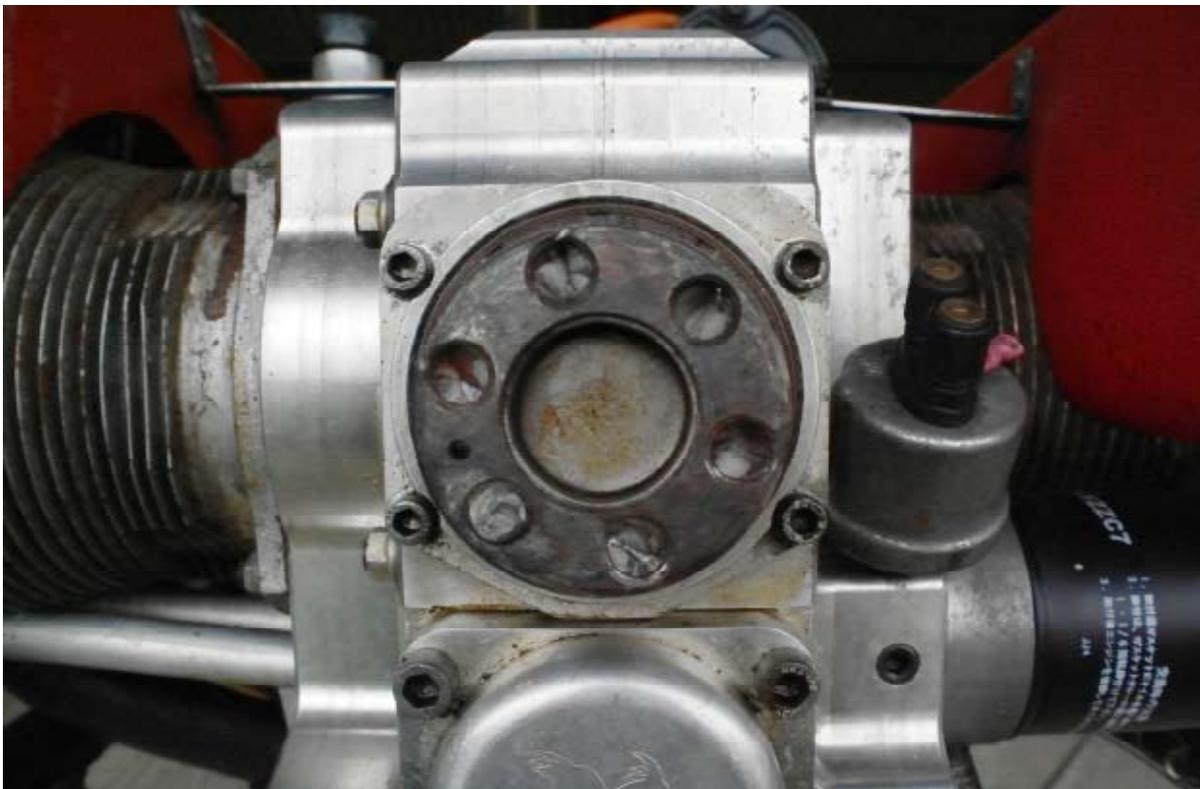
**Figure 1**

The pilot recovered the aircraft from the landing site to a hangar at the farm strip, prior to inspection by the AAIB. No damage was evident on the airframe. The engine propeller hub, flange and blades were detached, though the remains of the shanks from the six flange mounting screws were still present in the engine crankshaft (Figure 1). Replicas of the screw fracture surfaces were taken for forensic analysis and the remains of the screws, following extraction, were submitted for metallurgical examination. Aircraft documentation showed that a manufacturer approved

Front face of crankshaft showing shanks of failed screws still in-situ.

Therefore, the most likely cause of failure of the screws was a loss of clamping load on the flange, due to reduced torque load on the mounting screws. This would allow movement between the flange and the crankshaft and create an additional load cycle on the flange screws related to the engine rpm. HCF cracks developed from initiation points in areas of stress concentration within the screw threads, until the critical crack length was reached and the screws failed in overload. The flange and propeller then released during the incident flight.

This incident highlights the importance of installing the propeller mounting flange in accordance with the engine manufacturer's guidance detailed in service bulletin JSB 022-1 and inspecting the flange screws in accordance with the manufacturer's recommended maintenance schedule. Both of these documents are freely available on the manufacturer's website.

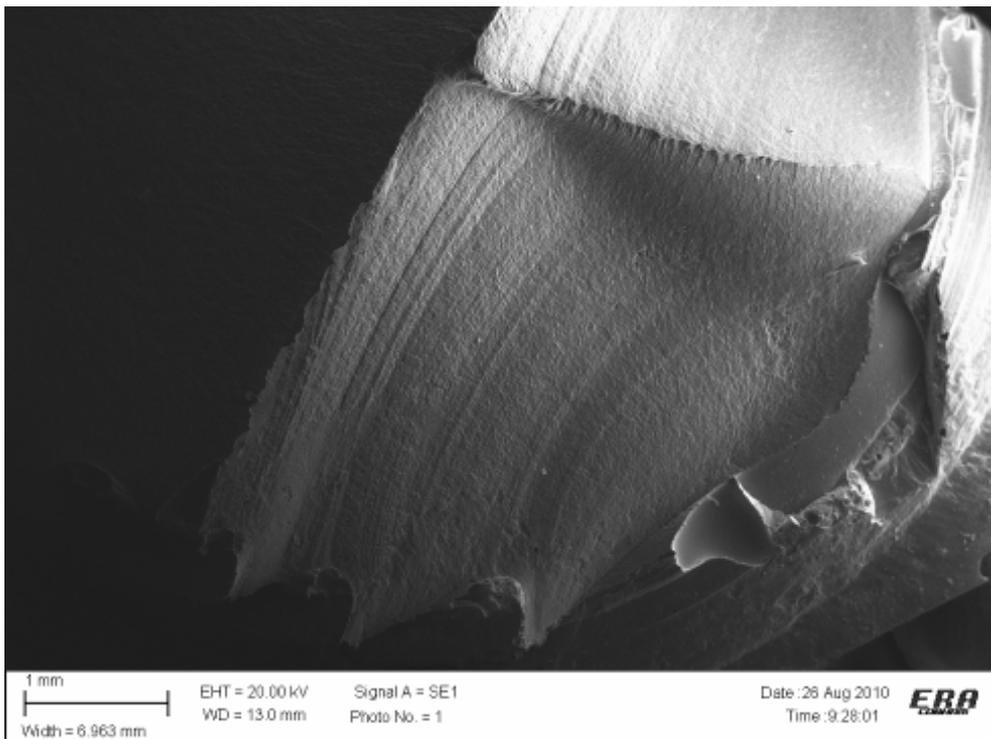
**Figure 2**

Scanning Electron Microscope (SEM) inspection revealed smooth, flat fracture surfaces, which exhibited clear beach marks; these confirmed High Cycle Fatigue (HCF)<sup>2</sup> as the fracture mechanism (Figure 2). Initiation occurred at multiple locations around the thread roots (a region of stress concentration). A region of possible intergranular fracture was found at one of the thread root

SEM image of beach marks indicating HCF with multiple initiations.

initiation sites, suggesting that some stress-corrosion cracking (SCC) might have contributed to fatigue initiation.
