INCIDENT

Aircraft Type and Registration:	Jetstream 4100, G-MAJE
No & Type of Engines:	2 Garrett Airesearch TPE331-14HR-805H turbprop engines
Year of Manufacture:	1992
Date & Time (UTC):	11 January 2007 at 0755 hrs
Location:	In the descent passing FL75, 27 nm north of Southampton
Type of Flight:	Commercial Air Transport (Passenger)
Persons on Board:	Crew - 3 Passengers - 17
Injuries:	Crew - None Passengers - None
Nature of Damage:	None
Commander's Licence:	Airline Transport Pilot's Licence
Commander's Age:	51 years
Commander's Flying Experience:	17,000 hours (of which 2,000 hours were on type) Last 90 days - 220 hours Last 28 days - 60 hours
Information Source:	AAIB Field Investigation

Synopsis

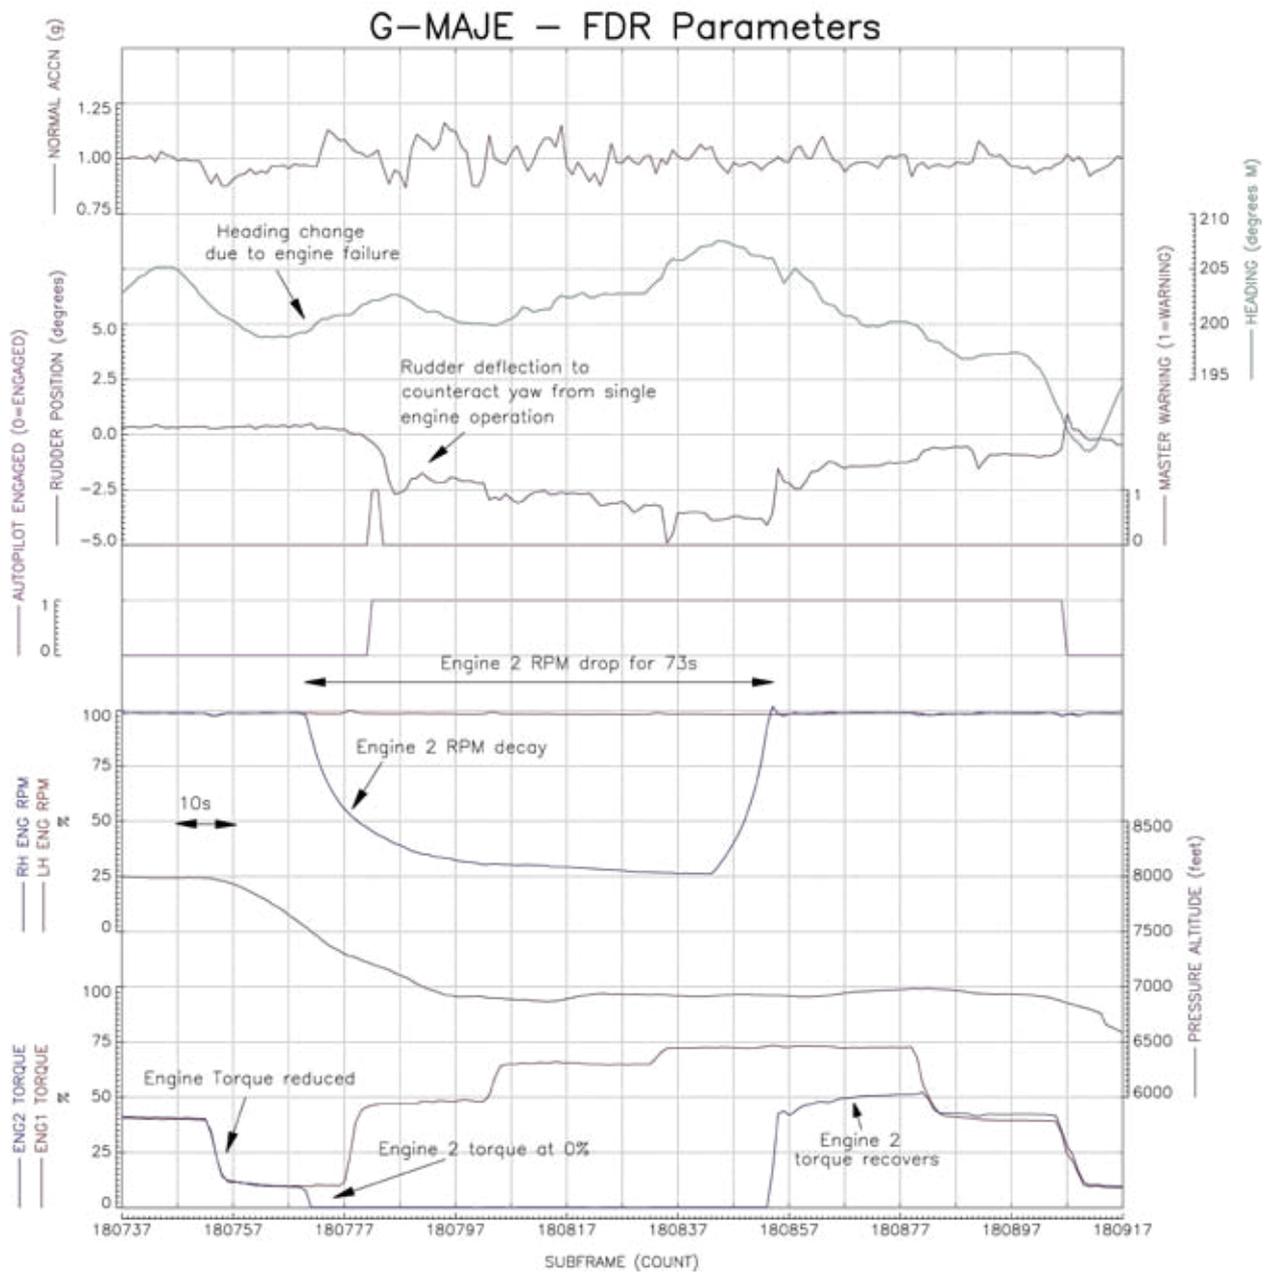
Figure 1

The relevant FDR parameters are illustrated in Figure 1. Whilst flying at an altitude of 8,000 ft and an indicated airspeed of around 200 kt, engine torque was reduced from 40% to around 10% on both engines. This initiated a descent rate of around 1,500 ft/min. Total air temperature at that time was recorded as being +8.5°C. As the aircraft passed through 7,500 ft, the right engine speed began to decrease and its torque reduced to 0%. At the same time, the PF noted "SOMETHING NOT QUITE RIGHT THERE". The PNF responded with "TORQUES GONE BOTH DOUBLE FLAME OUT". Four seconds later, the PF responded with "YEAH WE GOT TORQUE ON THE LEFT", which the PNF acknowledged, following which he transmitted a 'MAYDAY' call.

As the right engine speed reduced, the aircraft began to yaw to the right, but this was counteracted by the application of opposite rudder. Torque on the left engine was increased, the autopilot was disconnected and the aircraft levelled at just under 7,000 ft.

Around 73 seconds after the onset of the initial decay, the right engine speed increased from 25% back to 100%; after a further 10 seconds, the right engine torque increased to 44% and, 15 seconds later, torque levels on both engines became symmetrical at 40%. Throughout this incident, the left engine speed was recorded at 100%.
