Report by the Federal Republic of Germany  
relating to the Inquiry into the Accident to  
G - ALZU AS 57 Ambassador (Elizabethan)  
on 6th February, 1958 at Munich - Riem Airport

into the Accident to Aircraft G-ALZU

AS 57 Ambassador (Elizabethan) on

6th February, 1958, at Munich-Riem Airport

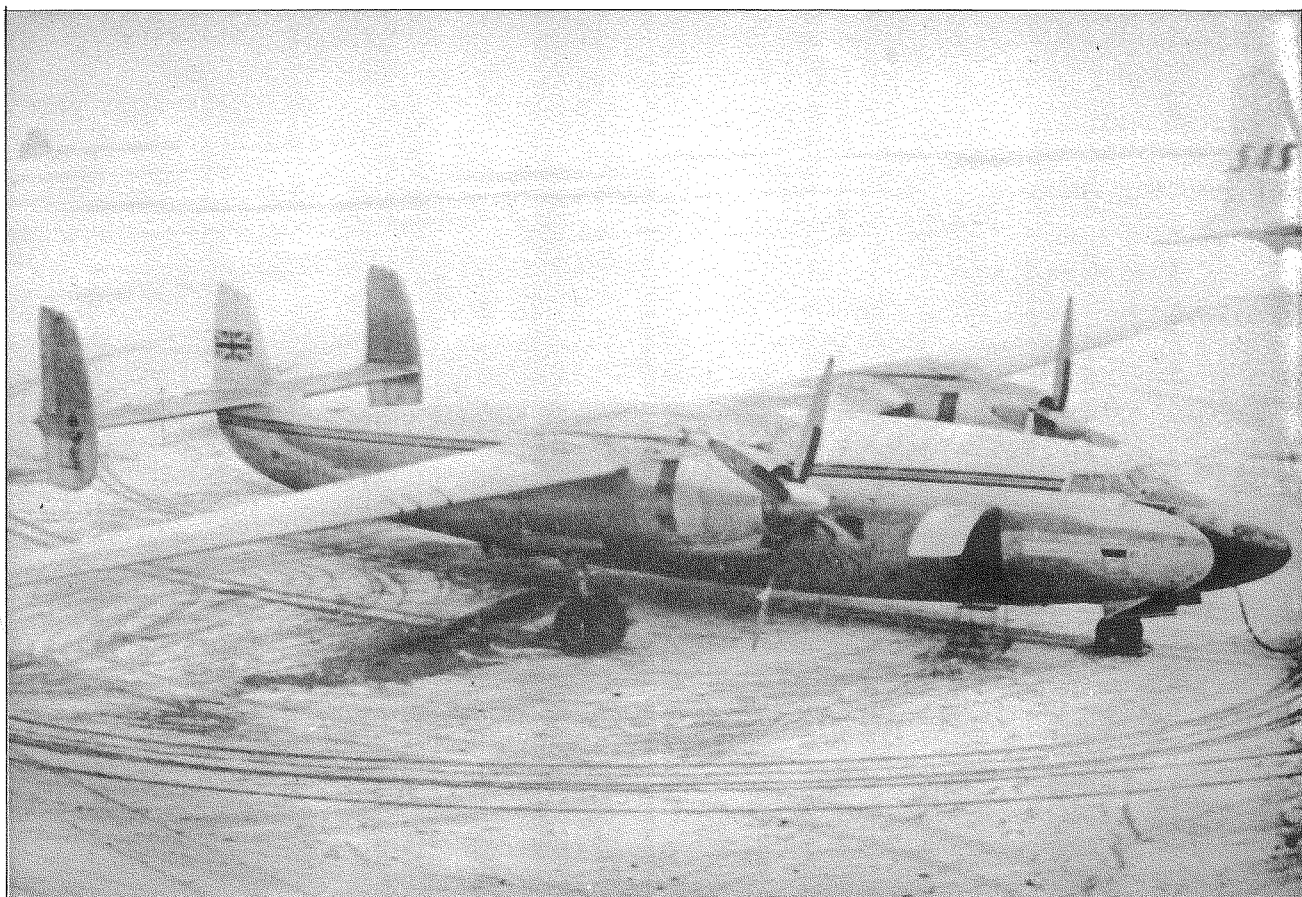
from the precipitation which fell after the accident and, for this reason, (b) whether it had indeed been fully established that icing was a cause of the accident. It is true that the snow falling after the accident at temperatures of  $-0.2^{\circ}$  (1600 hr.) to  $-3^{\circ}\text{C}$ . (2200 hr.) was dry. Thus it could not have turned directly into ice. The question to be investigated, however, was whether, as a result of the fires caused by the accident, the snow (dry, in itself) had melted whilst still in the air or on falling on wings possibly heated by the fires to above  $0^{\circ}$  and had only solidified into ice when the fires were extinguished. The idea that the wings were perhaps warmed by the heat still remaining from the engines or by the fuel in the wing tanks was suggested during the proceedings. These and similar theories regarding subsequent ice formation all fail, however, to stand up to closer investigation. Arguing against the theory of subsequent ice formation is the fact that with such a process of melting and refreezing the snow would probably have become more firmly blended with the ice-layer proper in the transitional zone. According to the report of the Inspector making the investigation (Untersuchungs-führer) and the statements (agreeing with this report) of the witnesses Graf zu CASTELL and GOETZ, the lack of cohesion between the ice layer and the powdery snow on top was, however, extraordinarily marked. The snow could be "blown away", whereupon a sheet of ice immediately came to light. The fires which occurred would not have been sufficient to melt the snow in the air or on the wings. The minor outbreaks of fire in the immediate vicinity of the aircraft were soon extinguished and do not come into consideration as sources of heat. The hut, on the other hand, burned for a longer time, viz, to about 1700 hr., according to the report of the Munich Airport Administration. This centre of fire, which was certainly considerable, was situated, however, 70 m. from the wreckage (see attached sketch-map). Added to this is the fact that the wind was blowing away from the wreckage, in the opposite direction (see photograph, Appendix 1 (sic)). In these circumstances it is extremely,

Aircraft G-ALZU on the apron at Munich-Riem Airport  
a few minutes before taxiing out to the third [attempted]  
take-off (i.e. the fatal attempt). The photograph was taken  
from a window fairly high up in the terminal building.

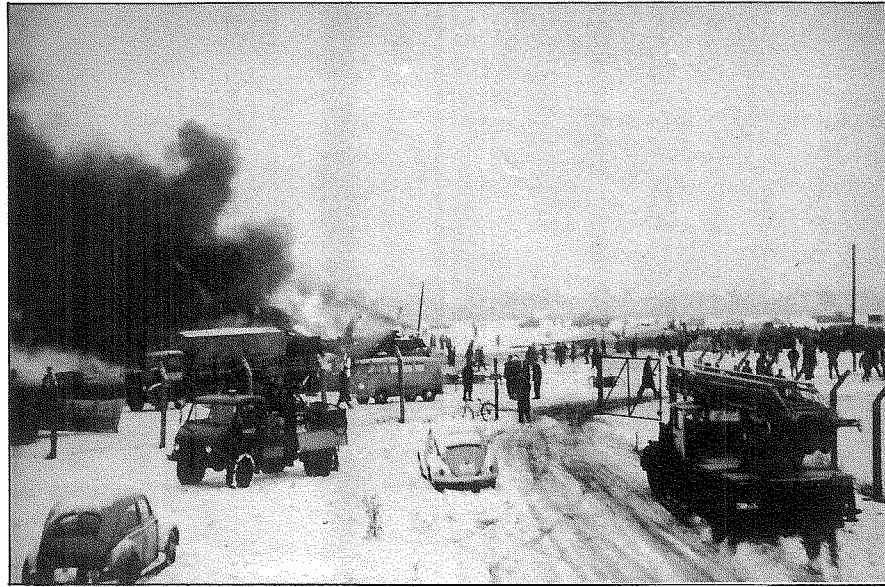
Fig. 1 The scene of the accident and the wrecked aircraft.

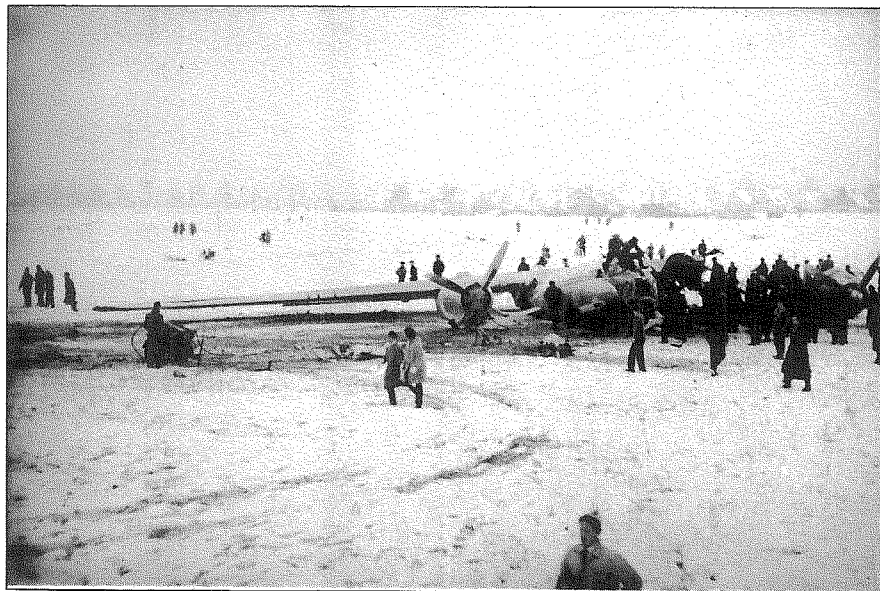
Fig. 2 The wrecked aircraft and the port engine.

Taken on the day after the accident, after thaw had set in.

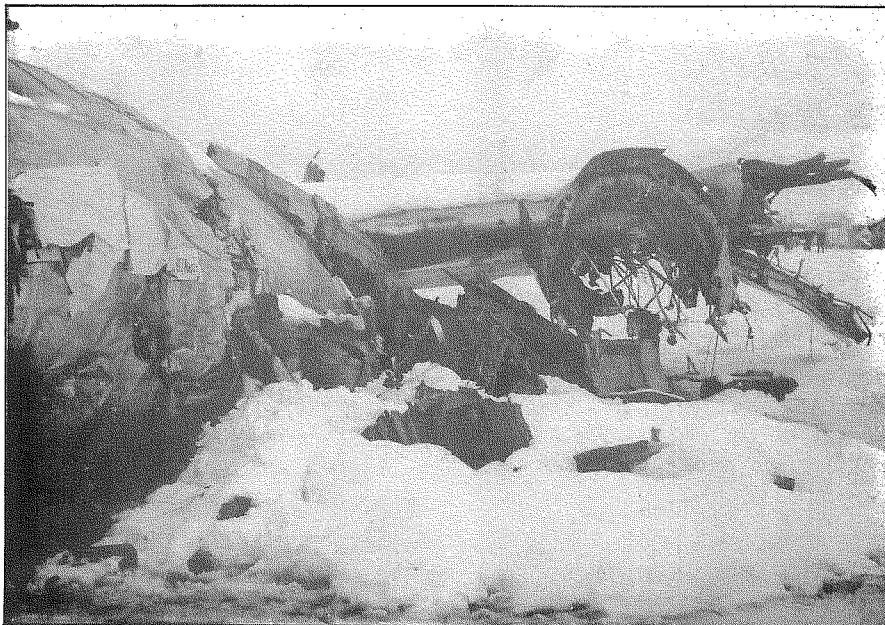
Fig. 3  
Left side of  
fuselage and  
port engine  
mounting.

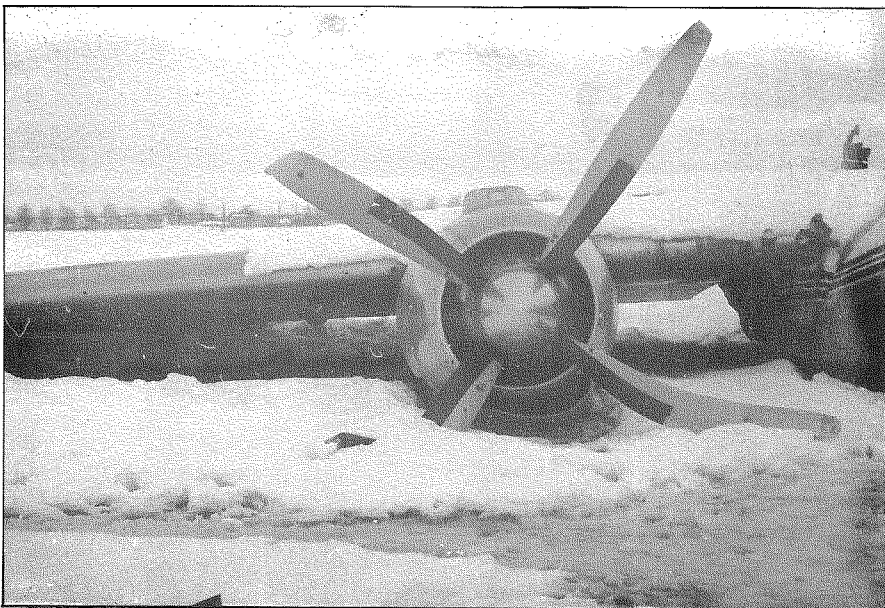
The right wing was only slightly damaged and the engine attached to it appeared to be completely undamaged. The blades of the two propellers

Fig. 4  
Starboard wing,  
with engine.

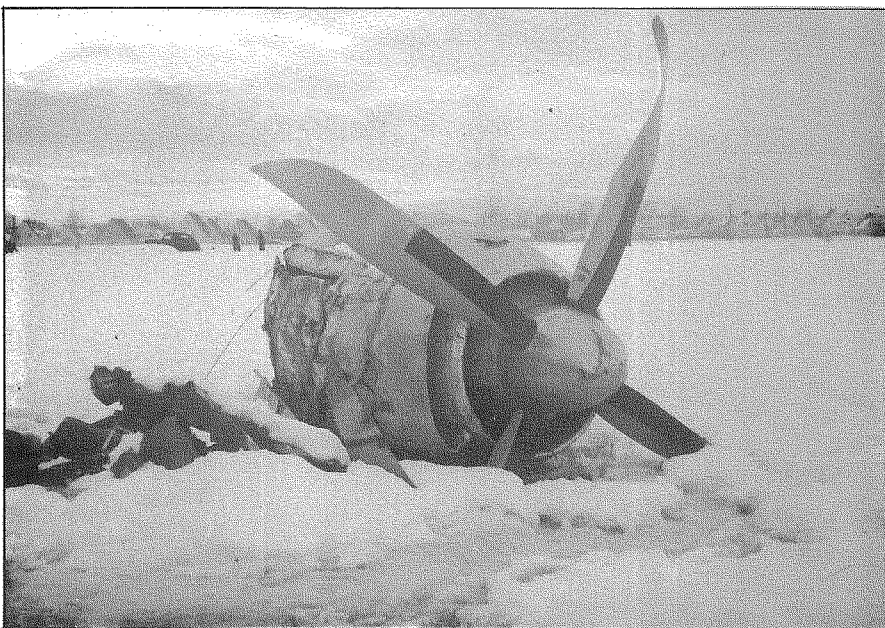
Fig. 5  
Port engine.

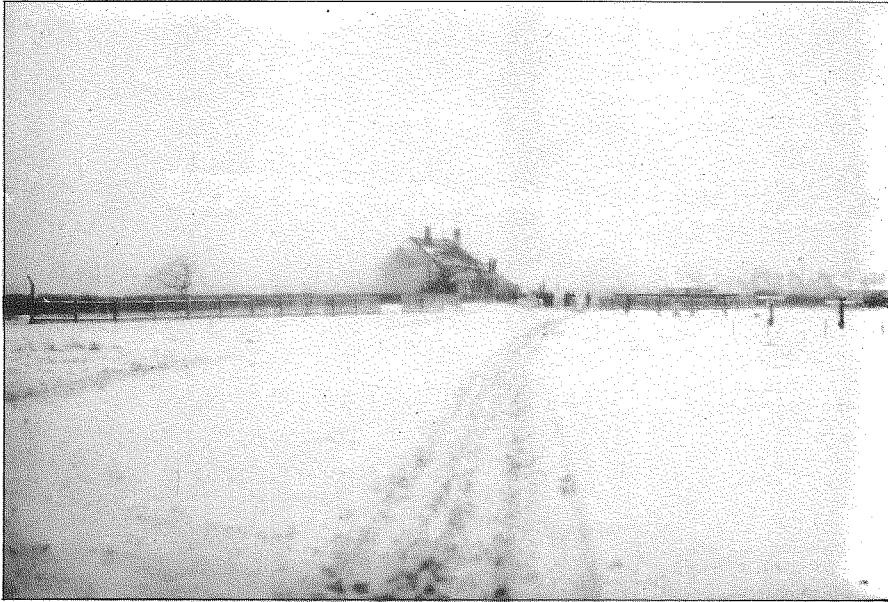
Next to the house which the aircraft had struck first there were trees which had been snapped off at a height of 3 m. or knocked down. From the point at which the aircraft had broken through the fence its tracks could clearly be discerned, extending back to the runway. The double track of the right side of the undercarriage could be followed back to the runway without difficulty. The left-hand wheel-track was interrupted in places. Nowhere was there any nosewheel track to be seen.

Fig. 6  
Photograph taken shortly after the accident. Wheel tracks (facing in the direction of take-off).

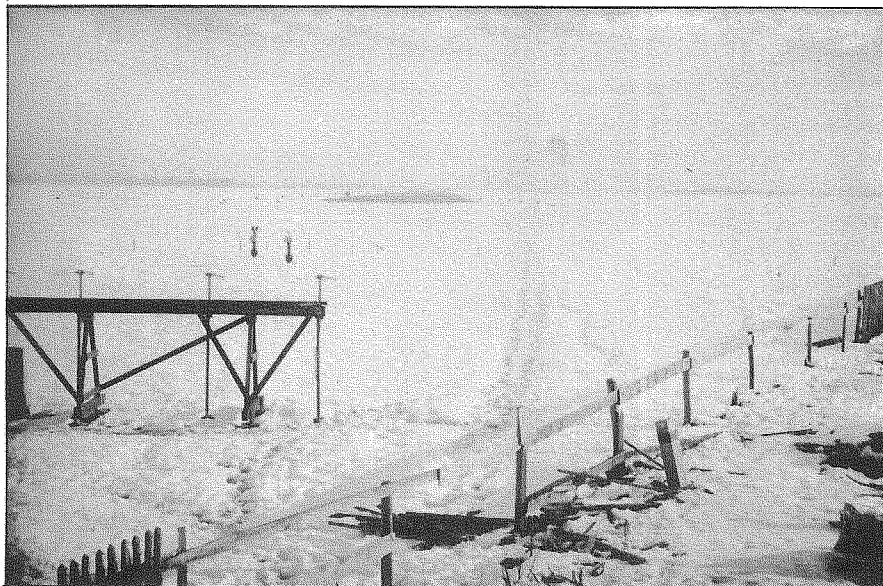
Fig. 7  
Photograph taken on day after the accident, during thaw. (Opposite direction.) Runway in the background. (Footmarks)

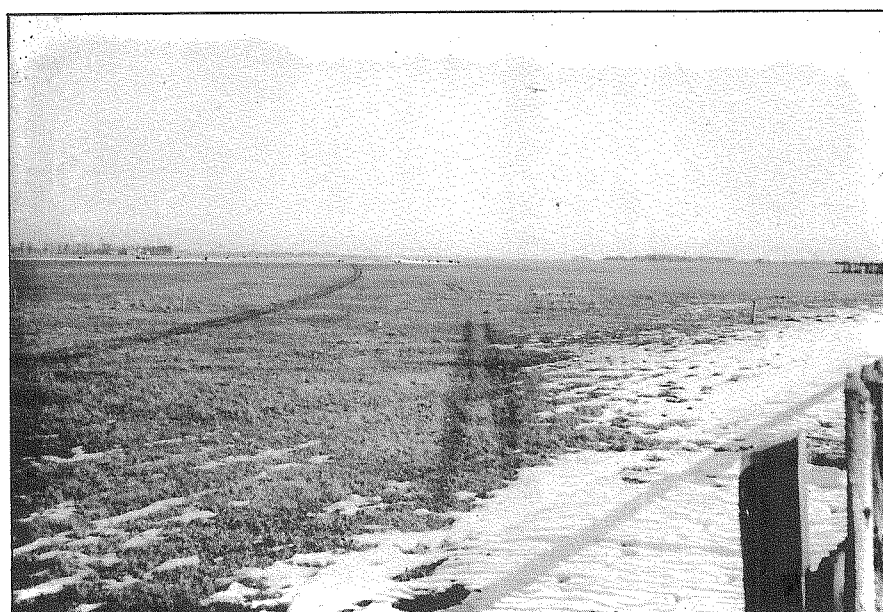
Fig. 8  
Photograph taken four days after the accident, when the snow had melted. (Direction as in 7). Runway in background.

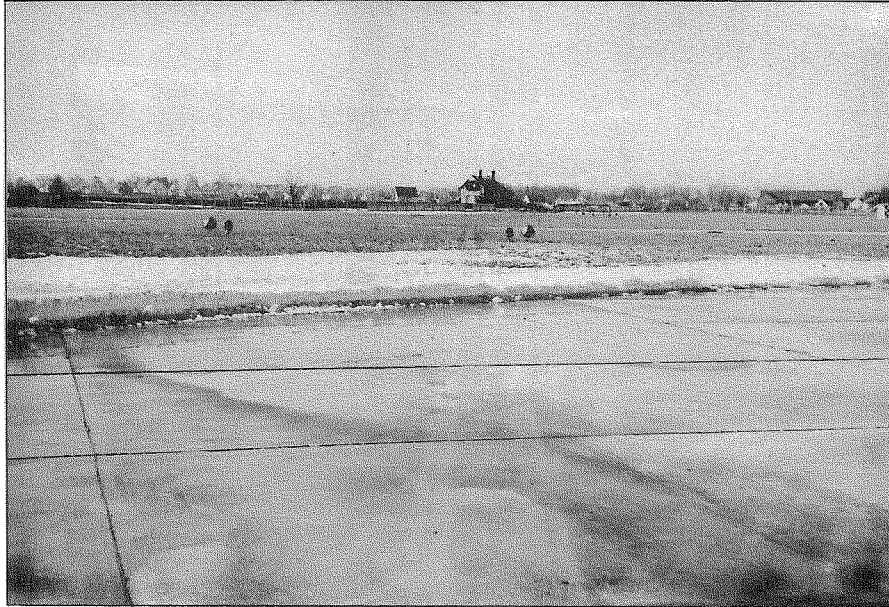
Fig. 9 Skid-marks left by right-hand undercarriage wheels at end of concrete runway.

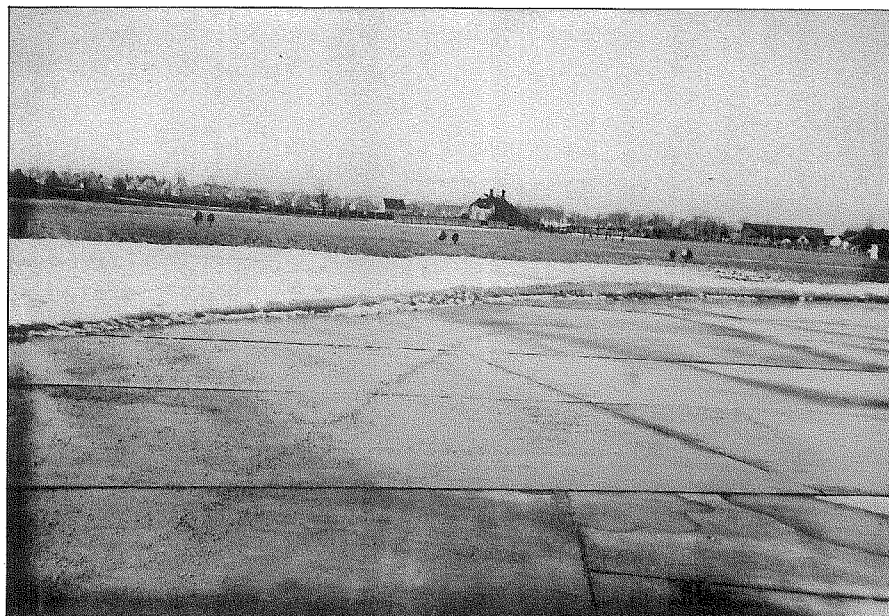
Fig. 10 Skid-marks left by left-hand undercarriage wheels at end of concrete runway.
