Midland Ultralights Sirocco 377GB, G-MNDW

AAIB Bulletin No: 11/2004	Ref: EW/C2004/01/04	Category: 1.3
Aircraft Type and Registration:	Midland Ultralights Sirocco 377GB, G-MNDW	
No & Type of Engines:	1 Rotax 377 piston engine	
Year of Manufacture:	1985	
Date & Time (UTC):	27 January 2004 at 1630 hrs	
Location:	1nm north-east of Ashby-de-la-Zouch, Leicestershire	
Type of Flight:	Private	
Persons on Board:	Crew - 1	Passengers - None
Injuries:	Crew - 1 (Fatal)	Passengers - N/A
Nature of Damage:	Aircraft destroyed	
Commander's Licence:	CAA Airline Transport Pilot's Licence	
Commander's Age:	53 years	
Commander's Flying Experience:	9,475 hours (of which 2 were on type)	
	Last 90 days - 80 hours	
	Last 28 days - 16 hours	
Information Source:	AAIB Field Investigation

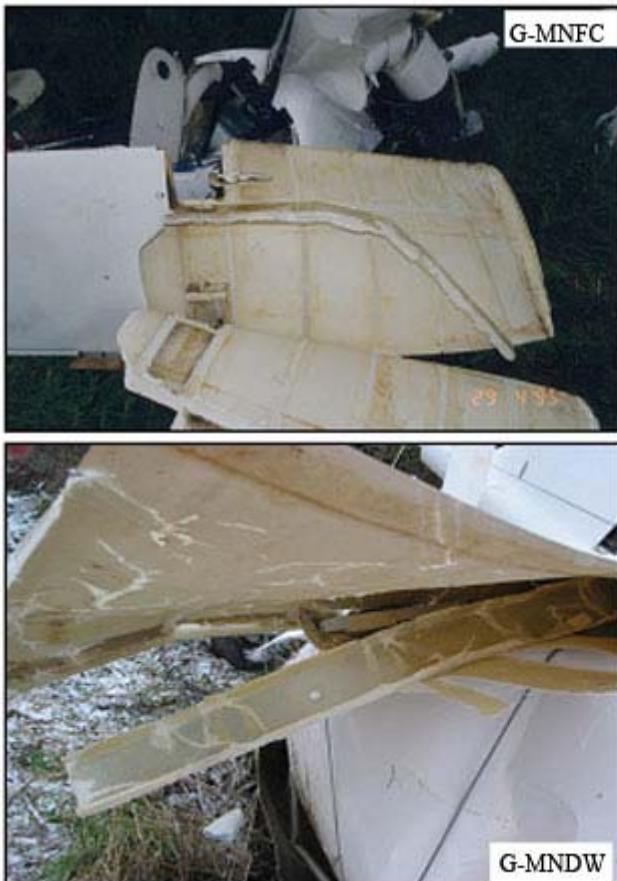
Figure 4 Comparison between tailplanes of G-MNFC and G-MNDW

The tailplane was still attached to the fuselage by its left-hand locating rib and the tailplane actuating tube. The right-hand locating rib had become detached from the surrounding structure. The top and bottom skins of the tailplane had parted from each other at the joint line along much of the leading edge, around the tips and at the trailing edge, except where the rivets of the trim tab hinge were still holding them together. All of the foam ribs had detached and were found loose inside the tailplane, lying on the ground at the crash site, or in the wreckage trail. The top and bottom skins had suffered extensive creasing and cracking in the spanwise and chordwise directions and had lost much of their stiffness. The spar had completely detached from the top and bottom skins and buckling failures due to spanwise bending were visible in several locations. The overall impression was one of the tailplane having shaken itself apart in the air. The damage was very similar to that seen on the tailplane of G-MNFC (Figure 4). It was noted that pins had been used to attach the tailplane, rather than bolts with wing nuts, as required by mandatory modification MAAN 1336.

Comparison between tailplanes of G-MNFC and G-MNDW showing similar failure characteristics with extensive disbonding of structure

Whilst the top and bottom skins had disbanded over much of the area of the tailplane, the leading edge joint was still intact in the vicinity of the locating and supplementary ribs, which suggested that the right-hand locating rib had been pulled out in a sideways rather than a forward direction.

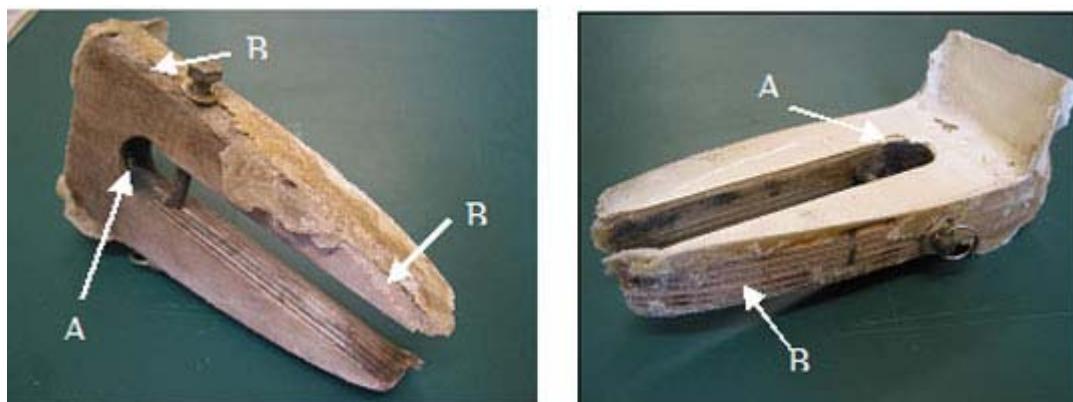
Figure 5 View on outboard and inboard faces of G-MNDW right-hand tailplane

The inboard face of the detached right-hand locating rib was protected with a layer of GRP, as required by mandatory modification MAAN 1336. However, the outboard face was unprotected and the wood was grey and weathered in appearance due to the effects of long term exposure to moisture (Figure 5). It was evident that moisture could enter the front of the tailplane through the slots in the locating ribs and become trapped between the locating and the supplementary ribs because no drain holes had been incorporated to allow accumulated moisture to escape.

View on outboard and inboard faces of G-MNDW right-hand tailplane locating rib showing general weathering of wood and areas of chafing (A) and poor adhesive coverage (B)

The QinetiQ report further highlighted erratic bonding of the right-hand tailplane retaining rib and supplementary rib, where the adhesive had been partially 'dragged' away from the ribs as they were slid into position inside the tailplane leading edge (Figure 5). The ribs had also been exposed to the prolonged effects of moisture, which had led to some degradation of the wood and reduced its bearing strength, allowing movement of the cross tube within the slots. Damage to the cross tube caused by the retaining pins suggested that significant movement of the tailplane had occurred at some time, possibly in flight.

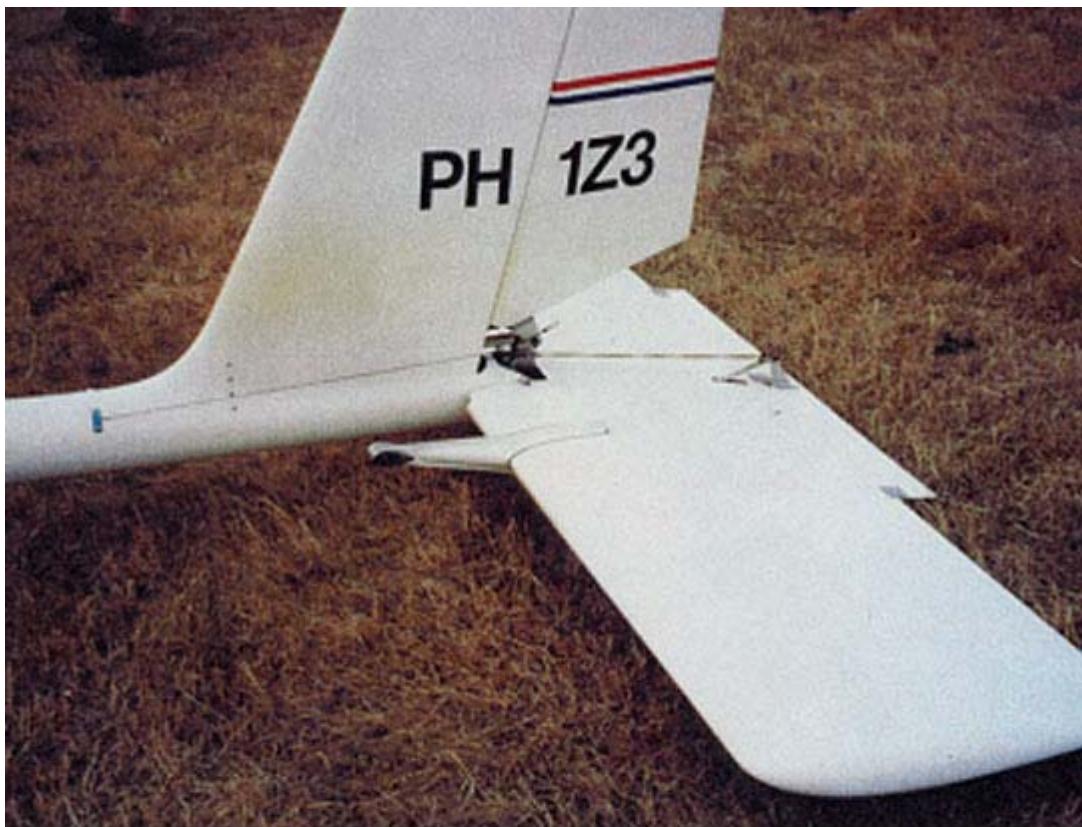
Figure 6 Sirocco tailplane with mass balance modification incorporated

Whilst it has been demonstrated that the aircraft normally has an acceptable flutter margin, the report received by the kit manufacturer of a flutter event at 65 mph suggests that this is not always the case. The aircraft kit manufacturer considered this problem to be so serious that the company issued a modification to mass balance the tailplane to improve its flutter protection. It also strongly recommended that all operators incorporated this modification on safety grounds but the exact distribution of this recommendation could not be determined because the manufacturer has ceased trading. The fact that UK registered Siroccos do not have this modification (see Figure 6) exposes them to a significantly greater risk of tailplane flutter.
