ACCIDENT

Aircraft Type and Registration:	Avro RJ100, HB-IYU
No & Type of Engines:	4 Honeywell ALF507-1F turbofan engines
Year of Manufacture:	2000
Date & Time (UTC):	18 August 2007 at 0940 hrs
Location:	Runway 28, London City Airport
Type of Flight:	Commercial Air Transport (Passenger)
Persons on Board:	Crew - 5 Passengers - 88
Injuries:	Crew - None Passengers - None
Nature of Damage:	Significant structural damage to the lower rear fuselage
Commander's Licence:	Airline Transport Pilot's Licence
Commander's Age:	47 years
Commander's Flying Experience:	9,000+ hours (of which 1,340 were on type) Last 90 days - 118 hours Last 28 days - 25 hours
Information Source:	AAIB Field Investigation

Synopsis

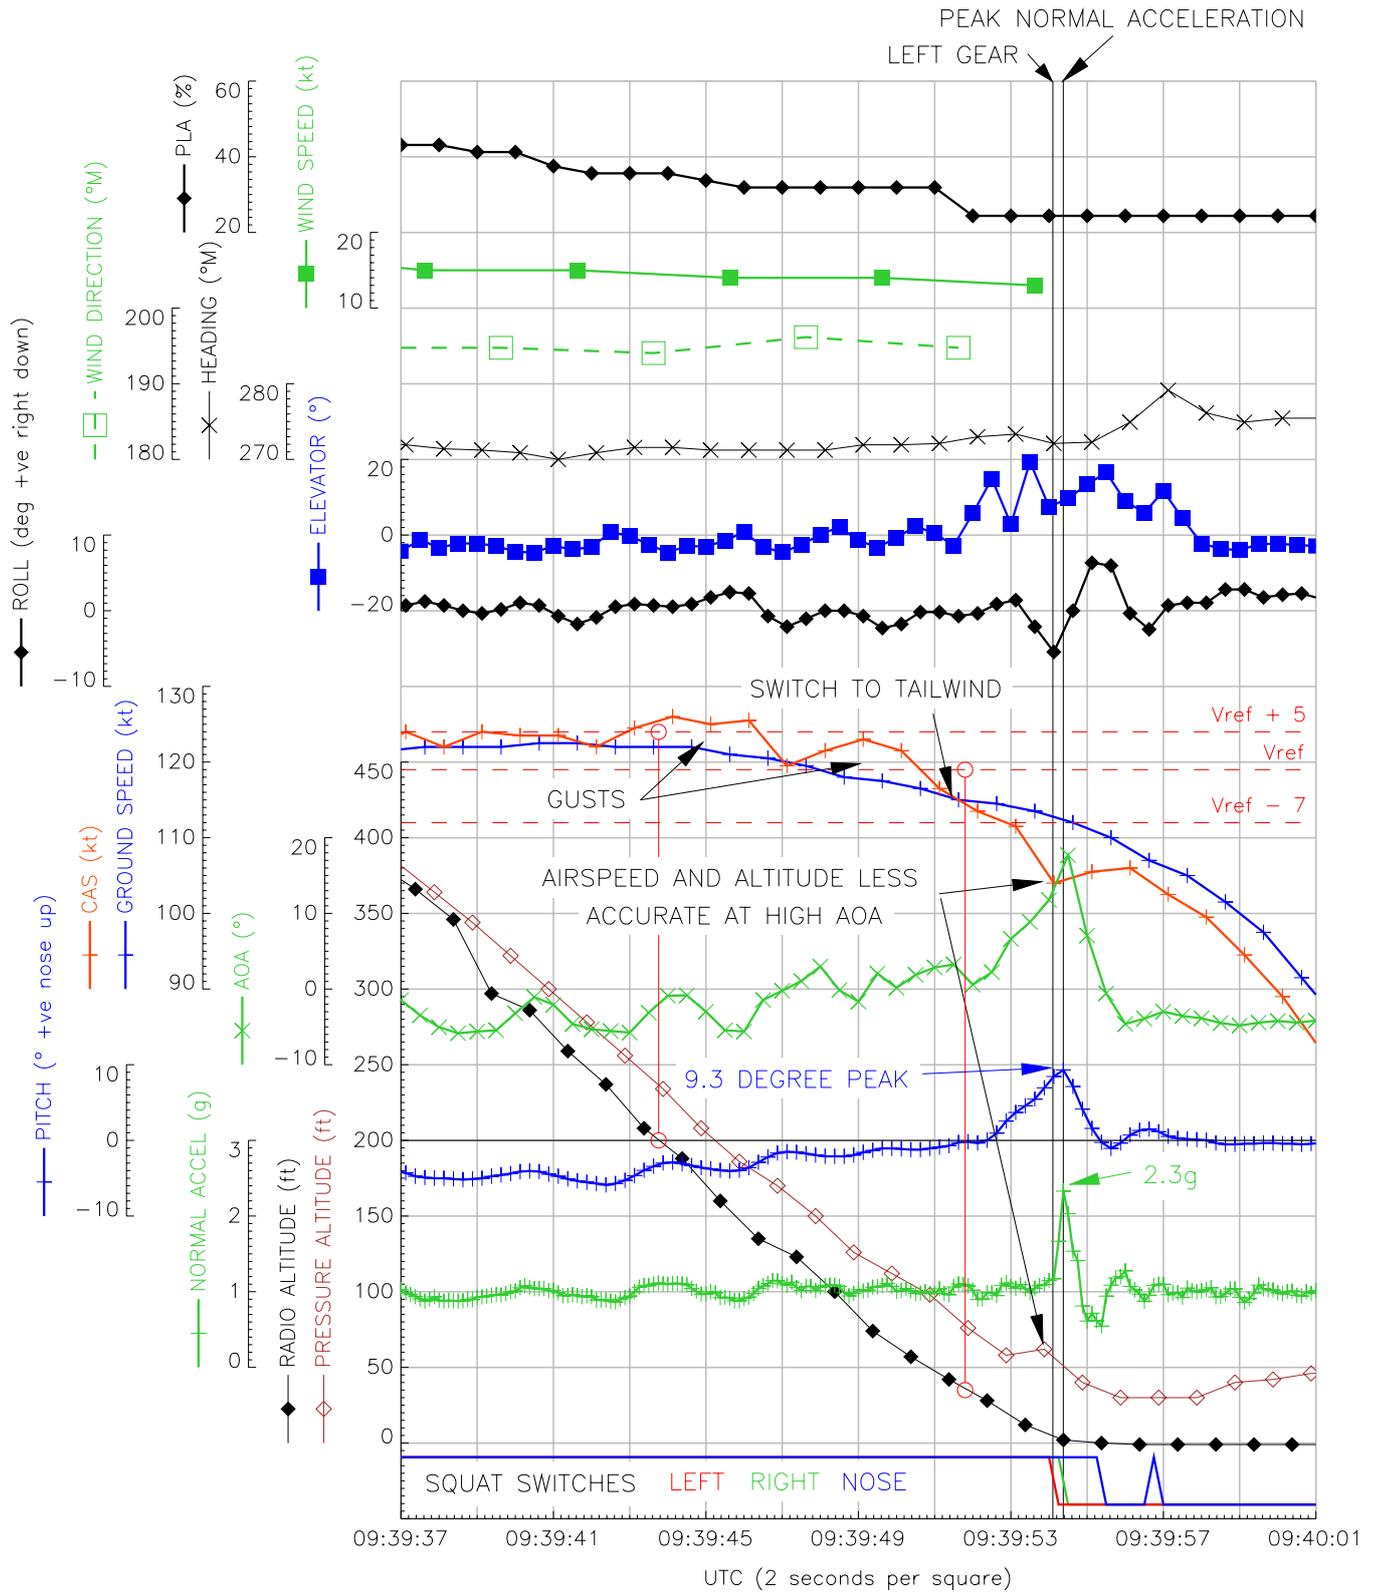
Figure 1
Salient FDR Parameter
(Accident to HB-IYU on 18 August 2007)

Figure 1 shows the salient parameters from the FDR, covering the approach from approximately 350 ft agl. This also shows the relevant target speeds for comparison.

With a radio height of between 50 ft and 30 ft agl, the power levers were retarded. A comparison of calibrated airspeed and groundspeed indicates that the aircraft had a variable and slight headwind component until approximately 50 ft agl, at which point it became a variable and slight tailwind. At this point the descent rate was approximately 900 ft/min and reducing smoothly. The FDR data showed no sudden drop in altitude, though the sample rate could be a limitation in capturing a short duration event.

Prior to 50 ft agl the aircraft had a nose-down pitch attitude that was slowly being brought level. As the power levers were moved back, large elevator inputs were recorded and during this period of increased elevator activity the aircraft developed an average nose-up pitch rate of 4.5°/sec. A left roll was also recorded; as this reached 5°, the left main gear weight-on-wheels sensor activated, and the roll direction reversed. At touchdown the pitch attitude reached 9.3° nose up and a 2.3g normal acceleration was recorded.

The co-pilot made a number of calls in the latter stages of the approach with reference to the target V_{REF} . These indicated that the aircraft was generally below the target speed and this is confirmed by the recorded data. Figure 1 shows that at 50 ft and 35 ft the aircraft was some 4 kt below target speed. At this point the thrust levers were retarded to idle and the recorded groundspeed reduced, without a corresponding decrease in the airspeed, indicating a loss of headwind or an increased tailwind component. The aircraft was already in a low energy state; then thrust was reduced and this reduction, and the loss of headwind component, both made the situation worse. A combination of these factors reduced the energy of the aircraft, which was felt as a 'sink' by the pilots, and the commander responded by pulling back to prevent a hard landing. It was this, probably instinctive, pull back on the column that caused the pitch attitude to increase to 9.3° at the point of touchdown.
