ACCIDENT

Aircraft Type and Registration:	ATR 42-320, G-DRFC	
No & Type of Engines:	2 Pratt & Whitney Canada PW121 turboprop engines	
Year of Manufacture:	1986 (Serial no: 7)	
Date & Time (UTC):	16 June 2012 at 0723 hrs	
Location:	Jersey Airport, Jersey, Channel Islands	
Type of Flight:	Commercial Air Transport (Passenger)	
Persons on Board:	Crew - 3	Passengers - 40
Injuries:	Crew - None	Passengers - 4 (minor)
Nature of Damage:	Left main landing gear, wingtip, fuselage skin, and left propeller damaged	
Commander's Licence:	Airline Transport Pilot's Licence	
Commander's Age:	49 years	
Commander's Flying Experience:	6,106 hours (of which 1,255 were on type) Last 90 days - 103 hours Last 28 days - 49 hours	
Information Source:	AAIB Field Investigation

Synopsis

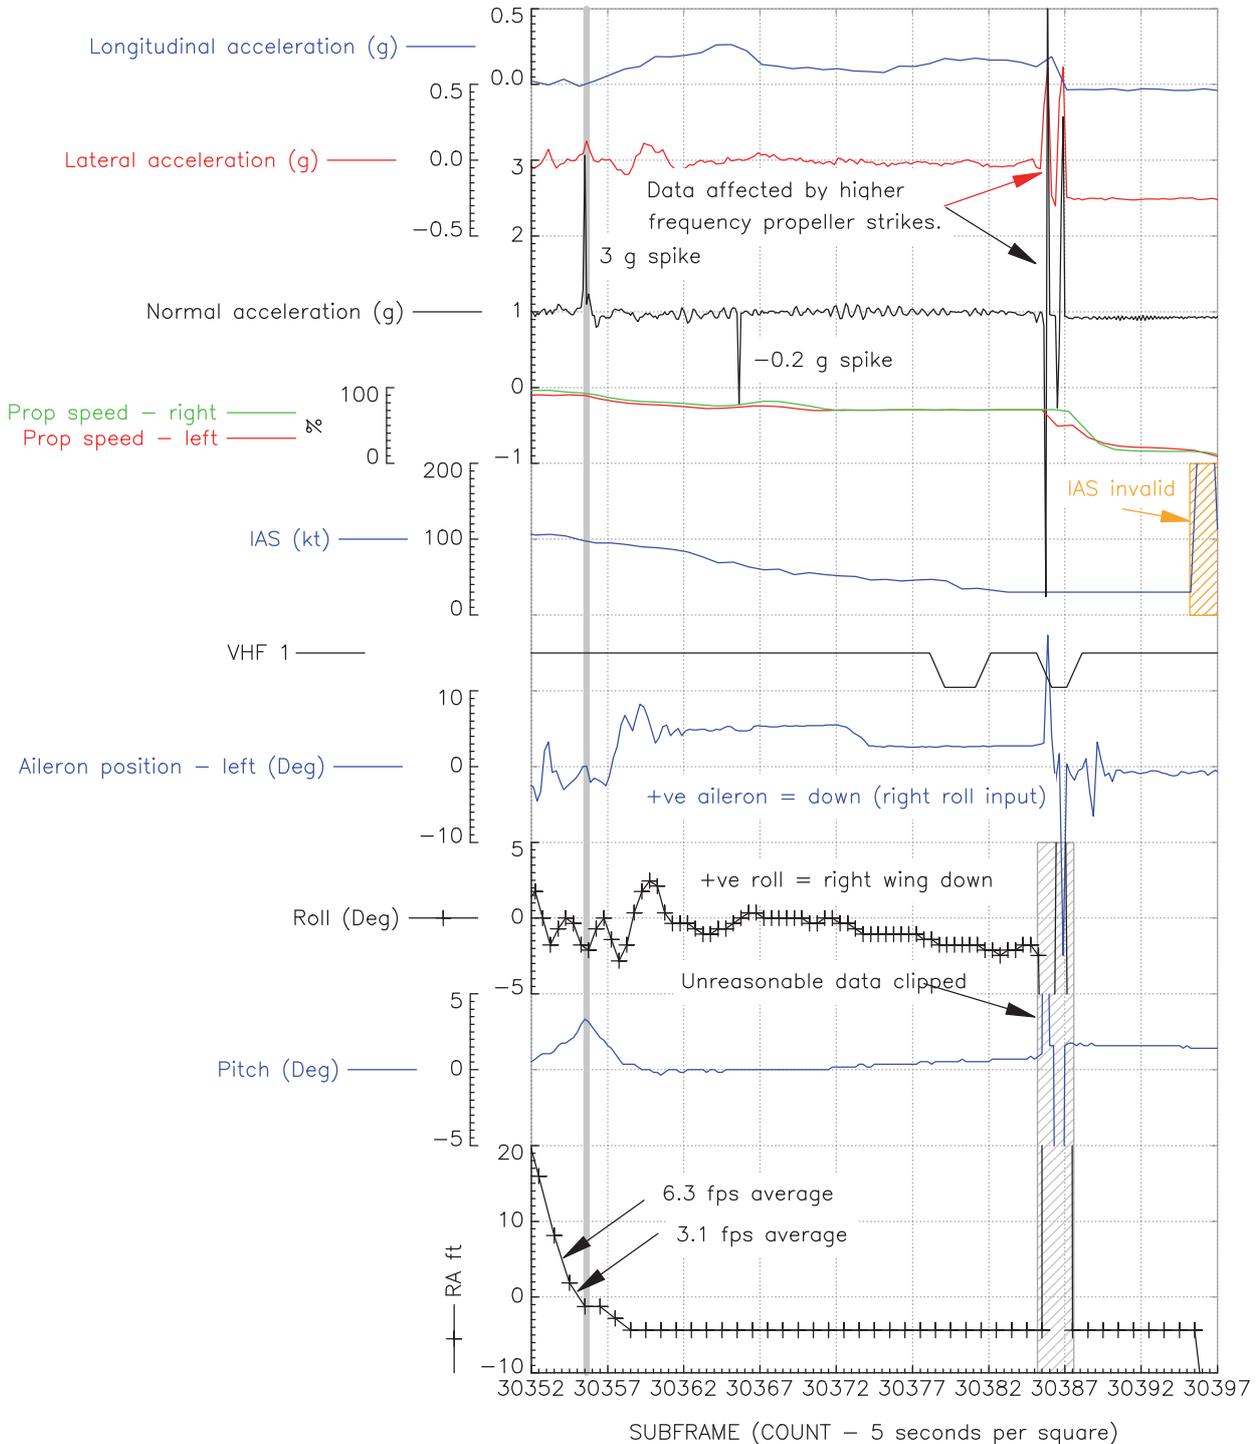
Figure 2
Pertinent FDR parameters

The FDR recorded a 3g normal acceleration spike on touchdown, significantly higher than would be expected during a landing. However, the recorded radio altitude profile indicated a descent rate averaging approximately 3.1 fps over the second just prior to touchdown which was only slightly higher than normal when compared to ten other flights recorded by the FDR. These calculated descent rate figures have limitations due to the low sample rate of once per second; the final height loss may have occurred within a shorter period than the one second between samples.

An isolated -0.2g spike in normal acceleration was recorded approximately 10 seconds after touchdown. No other parameter activity was associated with this spike. Many isolated spikes, that are also similar in value, are present throughout the FDR recording, in flight and on the ground. These are not considered real events. A similar comparison for the 3g spike recorded on landing showed that the other high value spikes were all associated with spikes in other parameters that were not evident during the landing and were likely to be associated with power interrupts. This indicates that the 3g normal acceleration spike is genuine.

Approximately 30 seconds after touchdown many of the parameters became briefly erratic. This is associated with the recorded dip in left propeller speed for a couple of seconds and is likely to be due to the high energy vibrations of the propeller blades striking the runway.

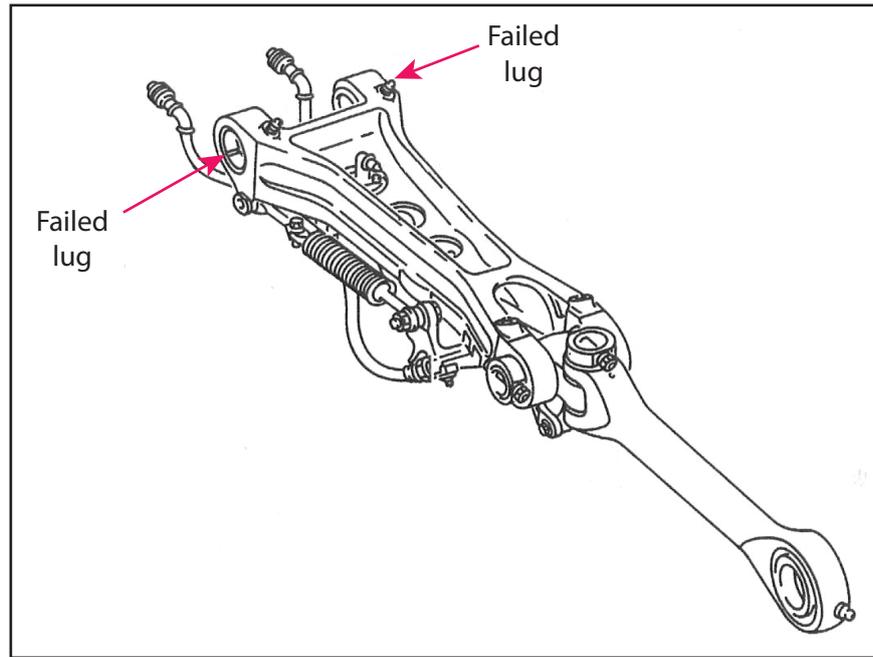
Figure 5

It was found that the side brace upper arm of the left main landing gear had suffered a structural failure. This had taken the form of a fracture of both lugs at their attachment to the through bolt in the fuselage-mounted pivot bracket (Figure 5). The failure

had rendered the side brace ineffective allowing the main leg to pivot outboard beyond its normal fully deployed position. This had resulted in non-design loading being transferred to the actuating cylinder and overload failure occurring in its attachment bracket to the fuselage structure. The unrestrained main trunnion had thus continued to translate outboard. Part of the lower fuselage had ultimately come into contact with the runway surface. The fractured lug recovered from the runway was found to be the forward of the two lugs of the side brace upper arm.
