Piper PA-22-150 Caribbean (Modified), G-APTP

AAIB Bulletin No: 5/2003	Ref: EW/G2003/03/15	Category: 1.3
Aircraft Type and Registration:	Piper PA-22-150 Caribbean (Modified), G-APTP	
No & Type of Engines:	1 Lycoming O-320-B2B piston engine	
Year of Manufacture:	1957	
Date & Time (UTC):	18 March 2003 at 1250 hrs	
Location:	Roughay Farm, Upham	
Type of Flight:	Private	
Persons on Board:	Crew - 1	Passengers - None
Injuries:	Crew - None	Passengers - N/A
Nature of Damage:	Aircraft destroyed	
Commander's Licence:	Private Pilot's Licence	
Commander's Age:	67 years	
Commander's Flying Experience:	1,300 hours (of which 200 were on type) Last 90 days - 0.50 hours Last 28 days - 0.10 hours	
Information Source:	Aircraft Accident Report Form submitted by the pilot and telephone enquiries by the AAIB.

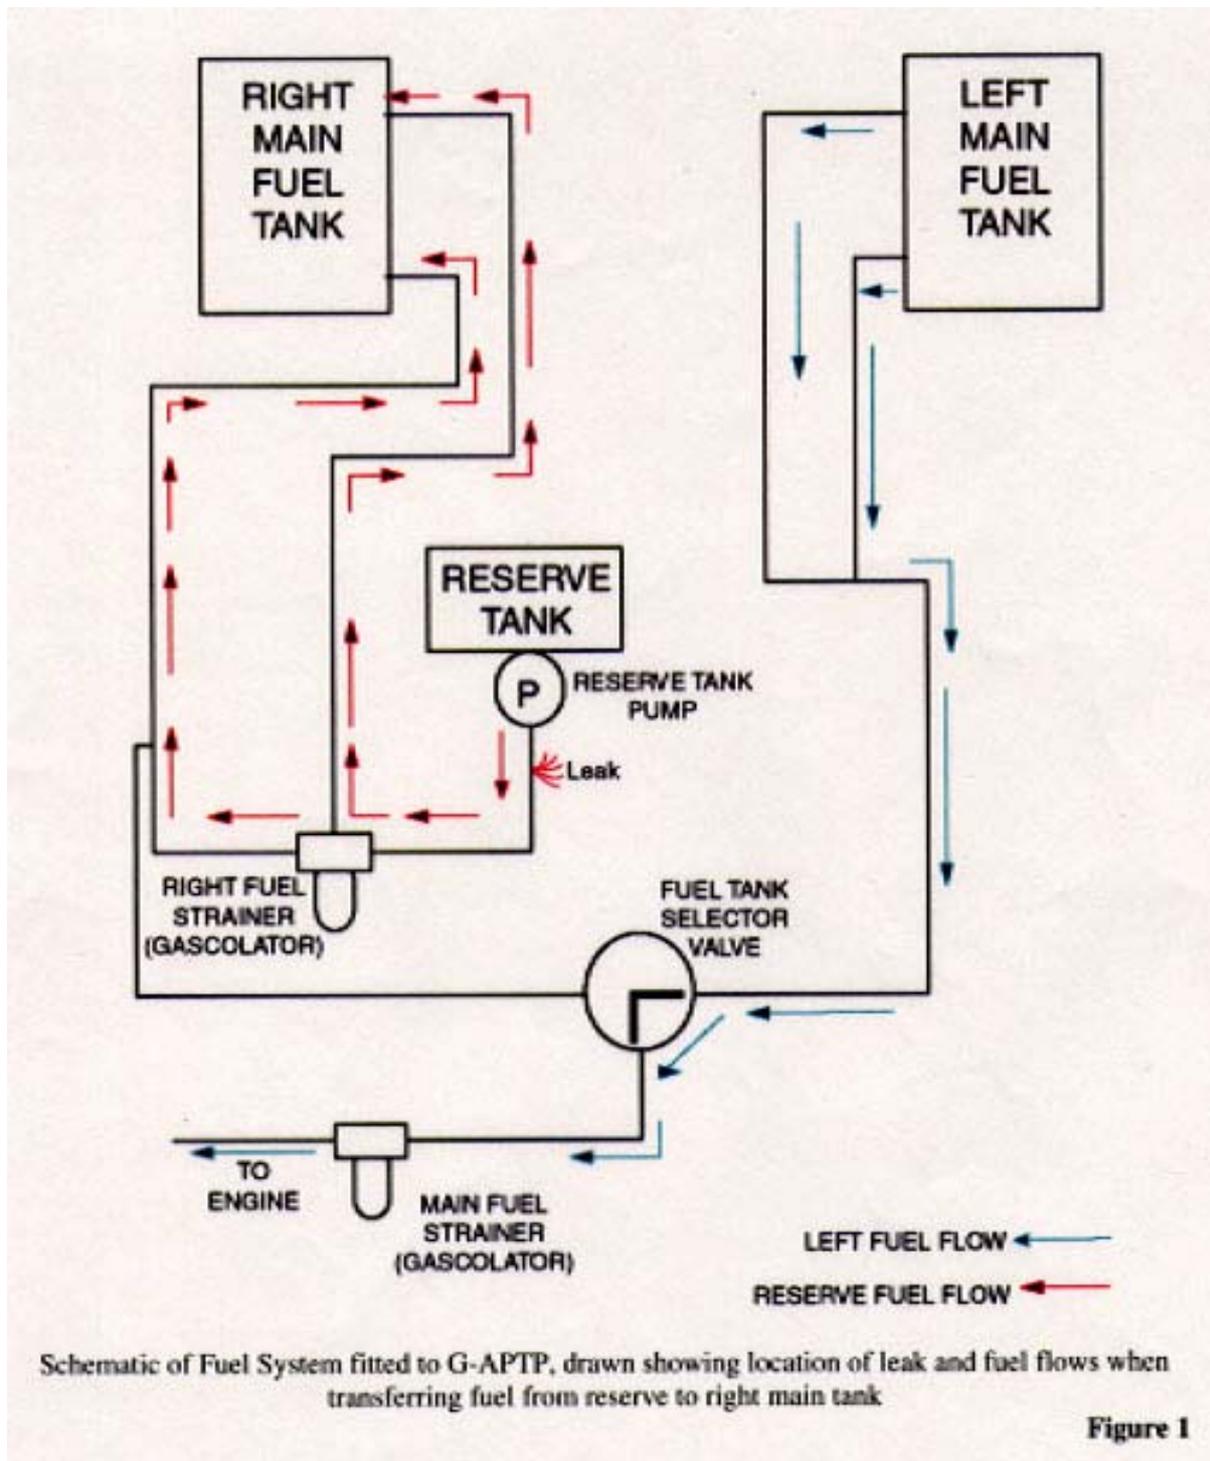
Fuel system description, Figure 1

G-APTP was fitted with an optional reserve fuel tank, which was installed at manufacture in 1957. This tank has a capacity of 8 US Gallons (37 Litres) and is situated under the rear seat in this model of aircraft. When the reserve fuel knob in the cockpit is pulled, an electrical fuel pump under the right hand seat pumps fuel from the reserve tank to the right main tank fuel strainer. This pressurised fuel then flows through the right main tank supply lines to replenish the right fuel tank; this process must be carried out with the fuel selector set for the engine to draw fuel from the left tank.
