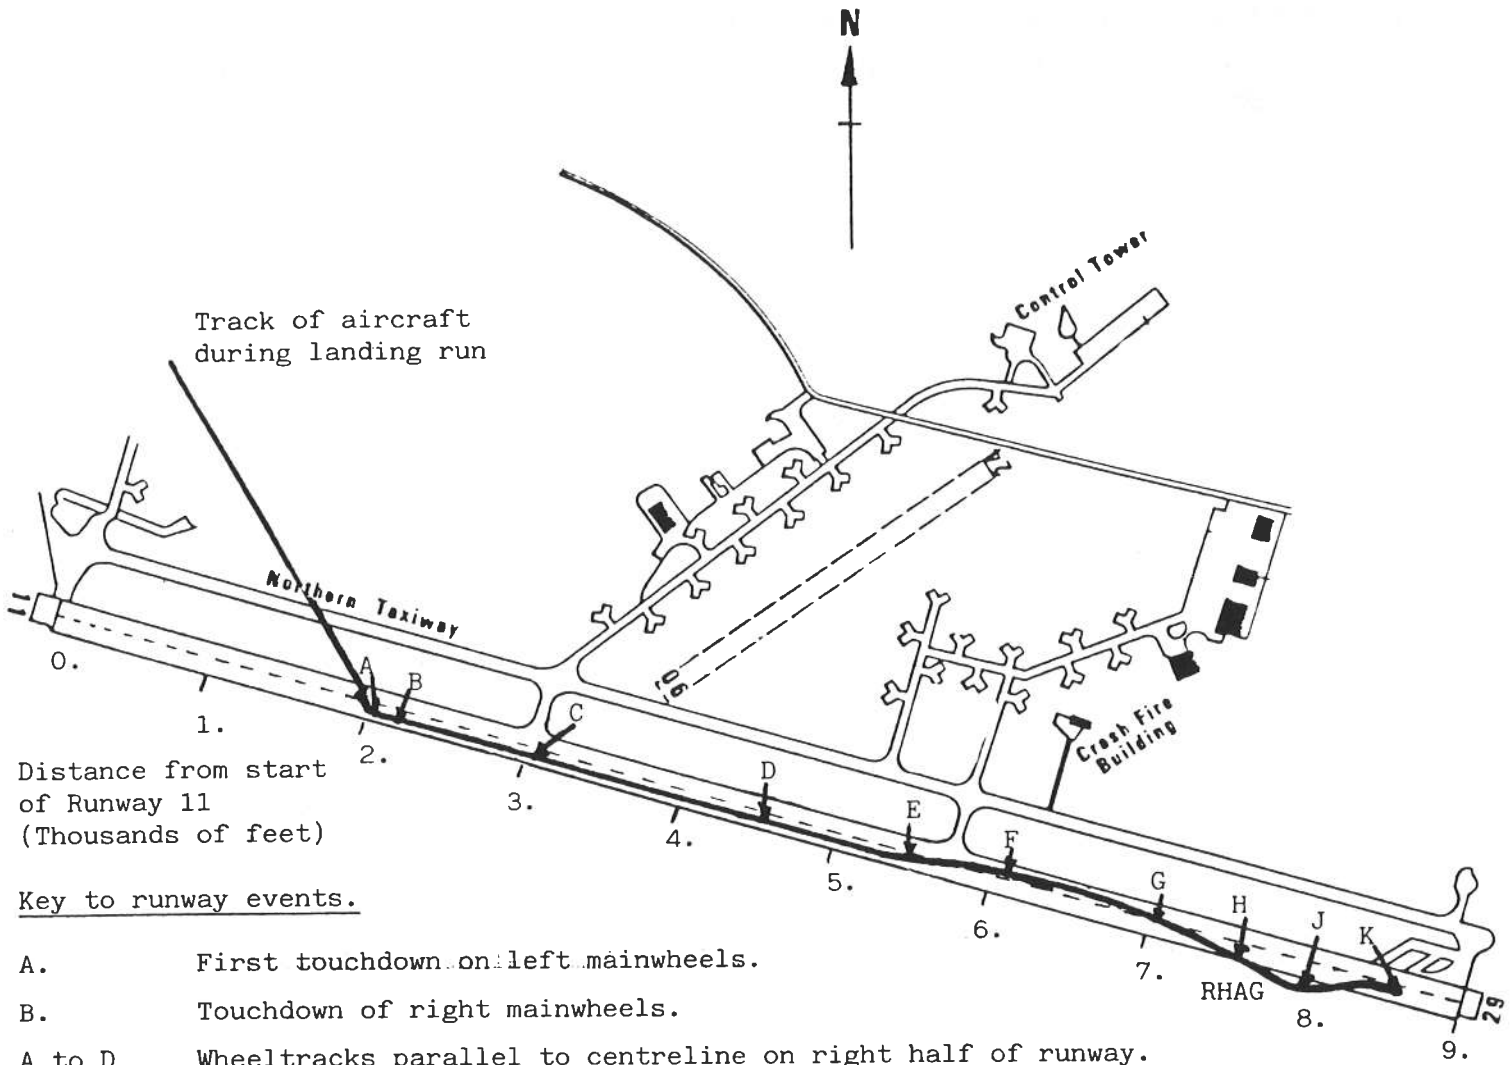
MANSTON - AERODROME LAYOUT

Examination of the tyre marks left by the aircraft on the runway showed that it had touched down first on the left mainwheels just over 2000 feet beyond the threshold, with the right main wheels touching down some 250 feet later. The main events of the landing roll are annotated on the runway plot at the end of this bulletin. Flight Data Recorder (FDR) information indicated that the aircraft touched down whilst yawed about 8° left of runway heading, which is consistent with the heavy but even definition of the wheel tracks during the early part of the ground roll. The striking of the starboard outer propeller on the runway indicates a roll angle of about 8° and the reduction of the main gear track separation from 31 feet (the nominal track of the aircraft) to 18½ feet suggests a yaw angle of about 50° to the left developed. (This was not apparent on the FDR trace.)
