# Kolb Twinstar MK3 (Modified), G-MYNY, 21 July 1996

## AAIB Bulletin No: 10/96 Ref: EW/G96/07/21 Category: 1.3

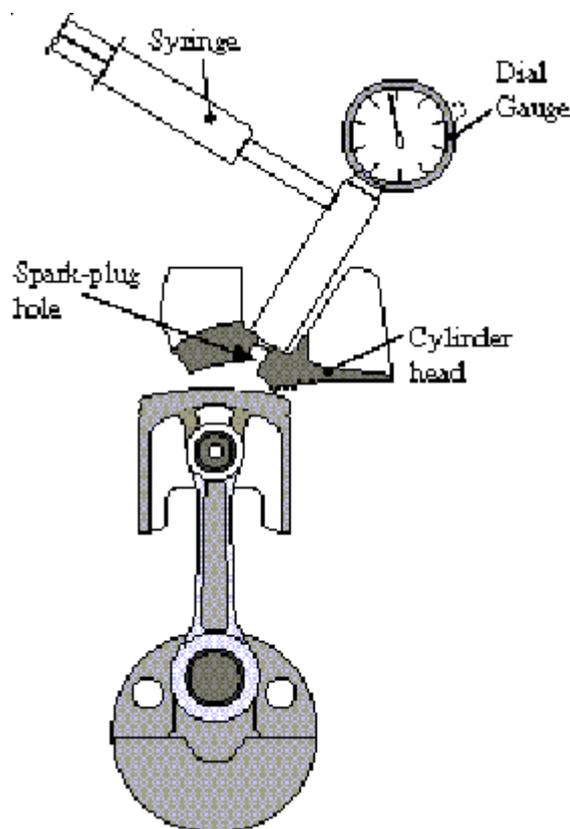
Figure 1 The Cyclone Conrod Bearing Clearance Testerfor Rotax Engines

Called the 'Cyclone Conrod Bearing Clearance Tester' the device is illustrated in Figure 1. Essentially it is a dial gauge mounted on an extension tube which screws into the spark-plug holes and bears on the piston crown at top dead centre. A syringe is used to suck/blow the piston up and down and the difference in gauge readings is converted into combined bearing clearance. It is recommended that this check be performed every 12.5 flight hours when the plugs should be removed for inspection in accordance with the Rotax service schedule. Maximum wear figures are given with the instrument but records should also be kept so that any trend can be detected in advance. It is understood that the Popular Flying Association agree that this device has been effective in preventing failures of this nature and published an article entitled 'KNOW YOUR BIG END WEAR' in the December 95/January 96 edition of their magazine *Popular Flying*.'
