AAIB Bulletin No: 11/95 **Ref: EW/C95/4/1** **Category: 1.1**

Aircraft Type and Registration: Boeing 747-200, PK-GSE
No & Type of Engines: 4 Pratt & Whitney JT9D-7Q turbofan engines
Year of Manufacture: 1982
Date & Time (UTC): 8 April 1995 at 1615 hrs
Location: London Gatwick Airport
Type of Flight: Public Transport
Persons on Board: Crew - 18 Passengers - 394
Injuries: Crew - None Passengers - None
Nature of Damage: Departure of outboard section of left inboard trailing edge fore flap, puncture to fuselage, damage to wing spoilers and mid flap
Commander's Licence: Airline Transport Pilot's Licence (Indonesian)
Commander's Age: 39 years
Commander's Flying Experience: 10,595 hours (of which 4,244 were on type)
Last 90 days - 169 hours
Last 28 days - 61 hours
Information Source: AAIB Field Investigation

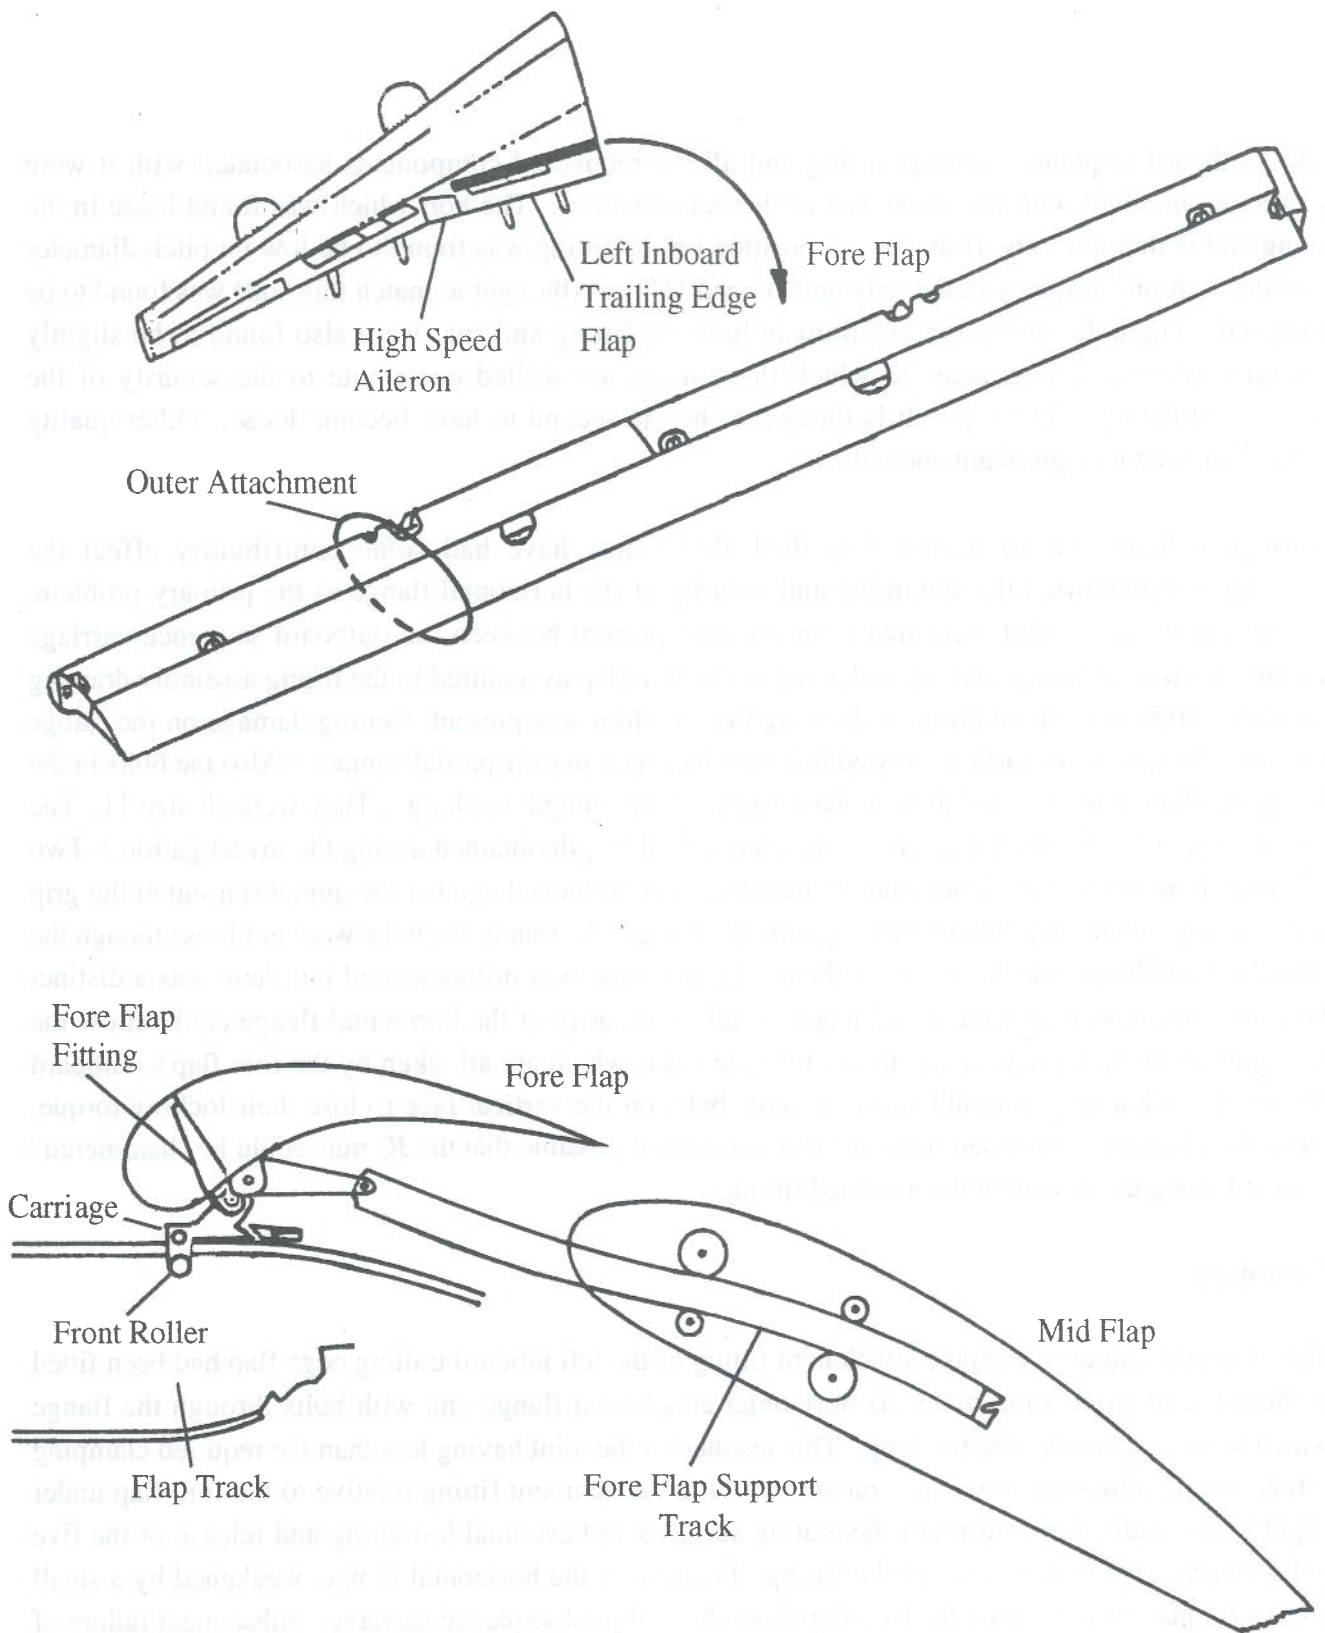
Fig. 1 - Trailing Edge Fore Flap Outer Support

A number of passengers in the rear cabin noticed small pieces of material coming away from the outboard end of the left inboard trailing edge flap (Fig. 1) and reported this to a cabin attendant. After the seat belt sign had been switched off the passengers' observations were relayed to the commander and, some time later, the flight engineer went into the cabin to inspect the area of the wing around the left inboard flap. At this stage the flap was fully retracted and there was no damage evident.

After the aircraft had landed it was found that the outboard half of the left inboard trailing edge fore flap was missing. It had failed rearwards and upwards and its outboard end had hit the side of the fuselage at station 1820, at and just below the window level. It had indented the structure, caused a number of penetrations through the skin and had partially dislodged one of the windows and the internal cabin panelling. Some damage had also been caused to the wing as the fore flap had detached. The mid flap had an indentation in its leading edge and some structural damage where the fore flap support tracks, which are contained within the mid flap (Fig. 1), had been bent and broken. The inboard spoilers, located above the flaps, had some impact damage and the closure rib adjacent to the flap outboard end, which provides support for the high speed aileron, had suffered some abrasion, indentation and cracking. The debris which had fallen from the aircraft on the approach was found in an open field 3.5 km from the touchdown point on Gatwick's 08R runway close to the extended centreline. This material was recovered and taken to the AAIB HQ at Farnborough.

The inboard flap assembly (fore flap, mid flap and aft flap) deploys rearwards along two flap tracks attached to the wing. The mid flap rides on a carriage on each track and each mid flap carriage is moved by a screw jack to deploy the whole flap system. The aft flap is attached to the mid flap and is not relevant to this inquiry. The fore flap rides on a pair of sequence carriages also on the main tracks whose movement relative to the mid flap carriages is controlled by stops and detents. The fore flap is also tied to the mid flap by three sets of attachment fittings linked to support tracks which move between rollers within the mid flap. This system allows the fore flap to adopt the correct spacing and angle relative to the mid flap as the flaps extend. The detached portion of fore flap contained the location of the outboard sequence carriage attachment fitting. The fitting (Part No 65B39025-13) was found still attached to its sequence carriage on the aircraft. The inboard fitting was found intact on the aircraft with the inboard portion of the fore flap. The two outboard rail attachment fittings and support track assemblies had been ruptured but the inboard set remained intact on the aircraft with the inboard section of fore flap.

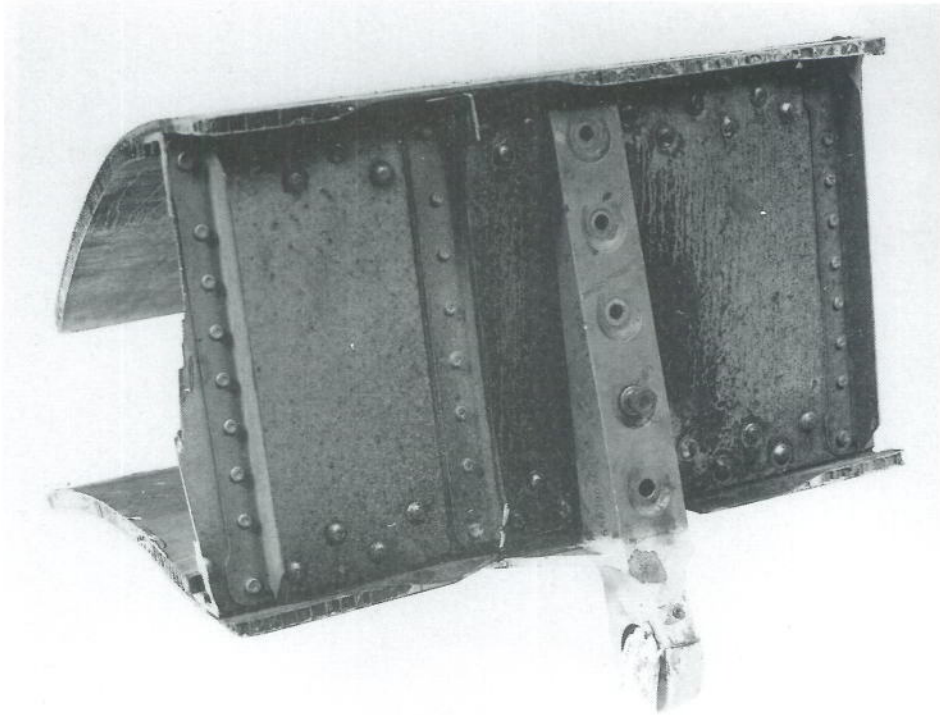
Fig. 2 - Fitting on fore flap spar (After fitting cleaned)

The fitting was found with 1 bolt present (bent and trapped in its hole) out of the vertical array of 5 bolts which attached the fitting to the front face of the fore flap spar (Figs. 2 & 3). The corresponding holes in the fore flap's spar were empty. The trapped bolt was slightly bent and had some thread damage at its tail end but was otherwise intact. Another bolt was found lying loose on one of the wing lower surface panels in front of the fore flap, near the point at which the fore flap failed. From the dimensions of this bolt and from a chemical analysis of contamination on its surface, which matched fretting product found on the fore flap fitting, this was identified as the top bolt from the fitting. This bolt was intact and undamaged. Three bolts were, therefore, missing. Five nuts and five washers of the correct sizes were found within the fore flap when it was opened up during the investigation.

The attachment fitting and its location on the fore flap were liberally covered in a greasy black deposit. A chemical analysis of this showed it to be a mixture of grease and fretting product. Both the face of the fitting and the spar surface showed loss of primer and metal which indicated that the surfaces had been held together but with insufficient clamping load to prevent movement. Examination showed that all the bolts had been in position at one time with the nuts fitted, that the bottom bolt had been the first to become loose and be lost, the top bolt the second and that the remaining three bolts had been loose but retained, resulting in damage to their holes in the fore flap spar.

The nuts used on this fitting were type BAC N10JC ('JC nuts'). They are formed from sheet steel with a hexagonal lip and the threaded bore is ovalised to provide the locking effect. New nuts and bolts were used during assembly after overhaul. Most carried some contact evidence that they had been loaded by a spanner or socket in the tightening direction. The bottom nut (identified because its size was 5/16" whereas the others were 1/4") had suffered some impact damage on the outside lip after it had been last tightened. The direction of this damage was in the untightening direction. A rivet adjacent to the nut appeared to have been reworked and the damage to the nut may have occurred during that process. The larger size of the bottom bolt was a modification which was intended to increase security of the fitting rather than static strength. The nuts were required to be torque loaded to the standard torques for their diameters (50-80 lb.in. for 1/4" and 100-150 lb.in. for 5/16") but it was noted that the agent's work instructions quoted only the value for the 1/4" nuts; previous modification standards of this fitting had used only 1/4" nuts and bolts. The bottom nut/bolt make the largest contribution to the stiffness of the fitting's vertical attachment as they attach directly to the front spar's lower chord; the other nuts/bolts are attached to the web which is more flexible. (A vertical crack was found in the doubling flange behind the web.) All the evidence pointed to the bottom nut/bolt being the first to become undone.

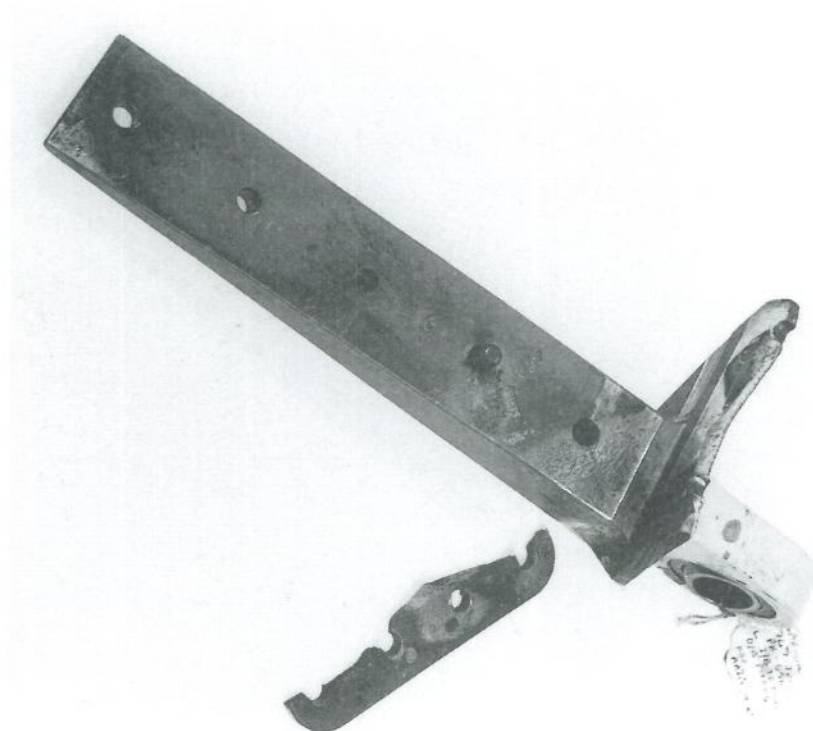
Fig. 3 - Fitting aft face and bottom flange (Showing fretting on both surfaces)

In addition to the location of the outboard sequence carriage fitting on to the front face of the fore flap spar the fitting has a flange which locates on the underside of the spar (Fig. 3). This lower flange had fractured but the four bolts which secured it were still intact and in place in the spar with the separated part of the flange. Most of the fracture was clearly overload with plastic deformation. There was one small area of fatigue at a bolt hole but this was considered to be secondary and due to the high bending loads suffered by the flange during the period after the front face bolts had become loose.

Though defects and anomalies described above may have had some contributory effect the investigation identified the shimming and security of the horizontal flange as the primary problem. There was evidence that there had been no shim present between the outboard sequence carriage fitting's horizontal flange and the underside of the fore flap as required in the fitting assembly drawing number 65B39011. In addition to showing that no shim was present, fretting damage on the flange face and the spar undersurface showed that they had been in only partial contact. Also the bolts in the horizontal flange were found to be at least 1 grip (shank) length too long. (They were all size 11. The specified size is 9 ± 1 and 9 was the estimated required length obtained during the investigation.) Two of them showed some evidence that the nuts had been tightened against the thread run-out at the grip reducing their clamping effectiveness against the flange. As found, the bolts were not loose though the retained half-flange was loose under them. Their torque was not measured but there was a distinct breakout torque as they were untightened. Lack of security of the horizontal flange could allow the fitting to move under load (particularly the side loads which are all taken by the fore flap's outboard fitting) in such a way as could cause the nuts/bolts on the vertical face to lose their locking torque. Once their locking torque had been lost it is considered possible that the JC nuts could be "hammered" outward along the thread by the loosened fitting.
