ACCIDENT

Aircraft Type and Registration:	Cirrus SR20, N470RD	
No & Type of Engines:	1 x Teledyne Continental IO-360-ES piston engine	
Year of Manufacture:	2006	
Date & Time (UTC):	10 August 2010 at 1435 hrs	
Location:	Countryside near Hornton, near Banbury, Oxfordshire	
Type of Flight:	Private	
Persons on Board:	Crew - 1	Passengers - 1
Injuries:	Crew - None	Passengers - None
Nature of Damage:	Aircraft damaged beyond economic repair	
Commander's Licence:	Private Pilot's Licence	
Commander's Age:	50 years	
Commander's Flying Experience:	180 hours (of which 109 were on type) Last 90 days - 10 hours Last 28 days - 4 hours	
Information Source:	AAIB Field Investigation

Synopsis

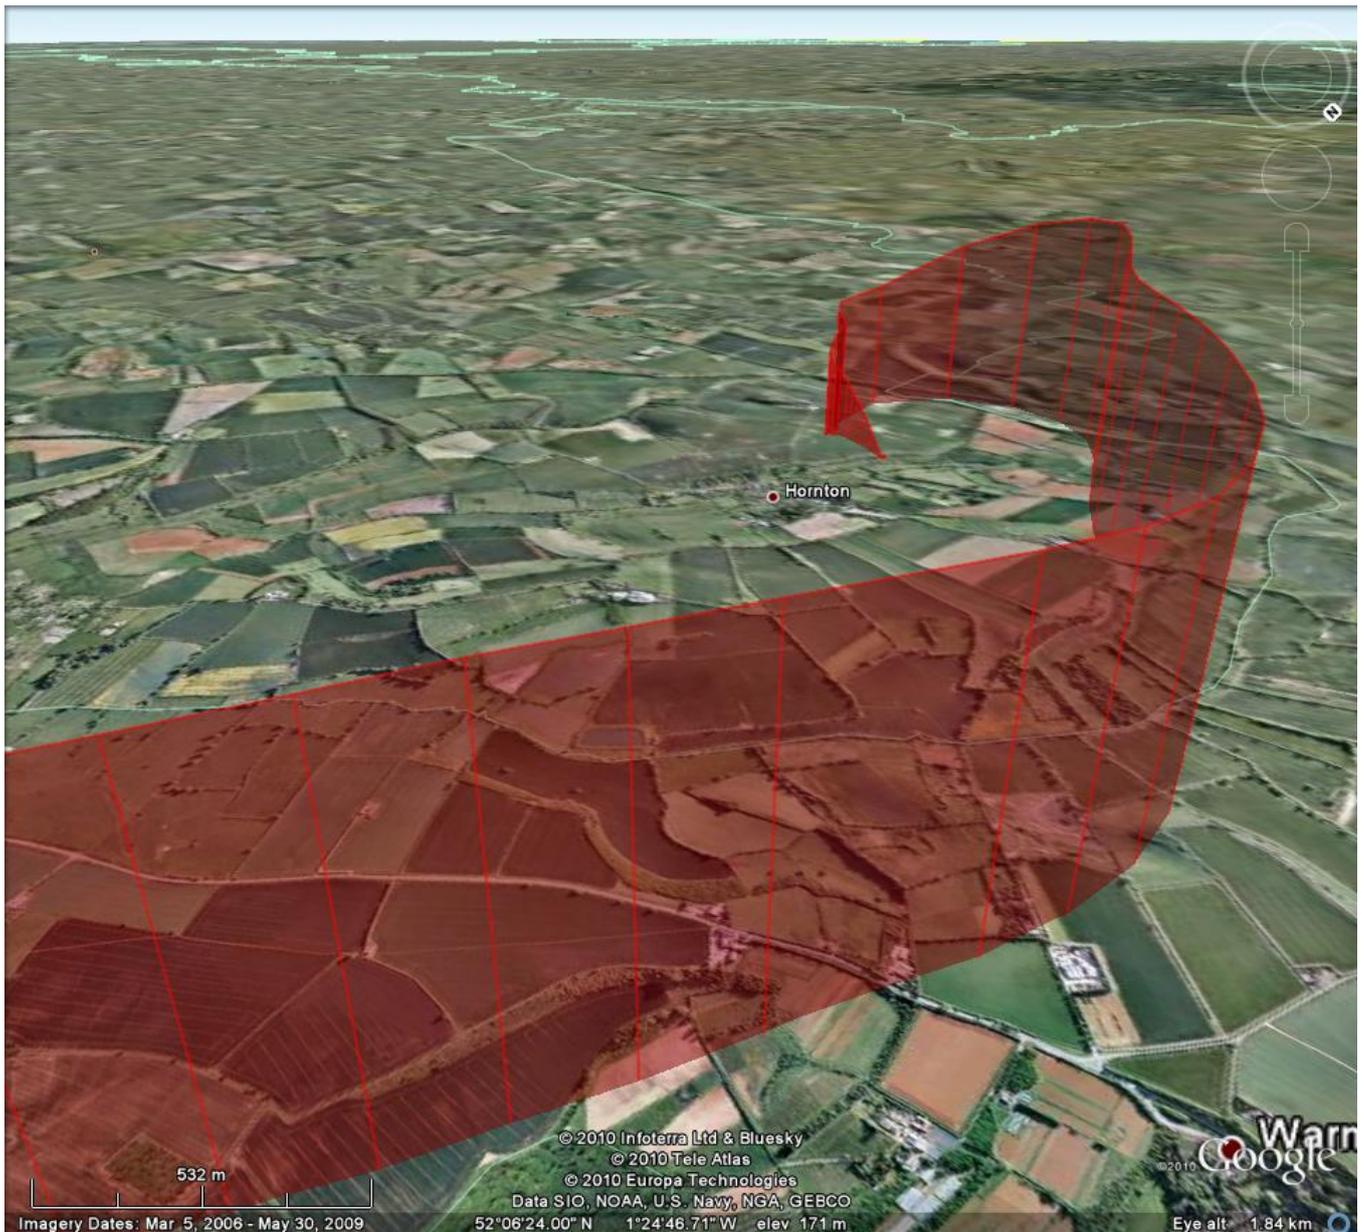
Figure 1

Recording began as the aircraft taxied at Turweston and ended with the aircraft on the ground following the accident. The later part of the accident track, based on the GPS positions and recorded pressure altitude, is presented in Figure 1. Selected recorded flight parameters are plotted in Figure 2 for the whole of the accident flight. The accelerations, which were recorded from accelerometers within the PFD, were converted to units of 'g' and corrected to the aircraft's centre of gravity position before being plotted. The altitude bug

3D view of the latter part of the aircraft's track
from GPS position and recorded pressure altitude

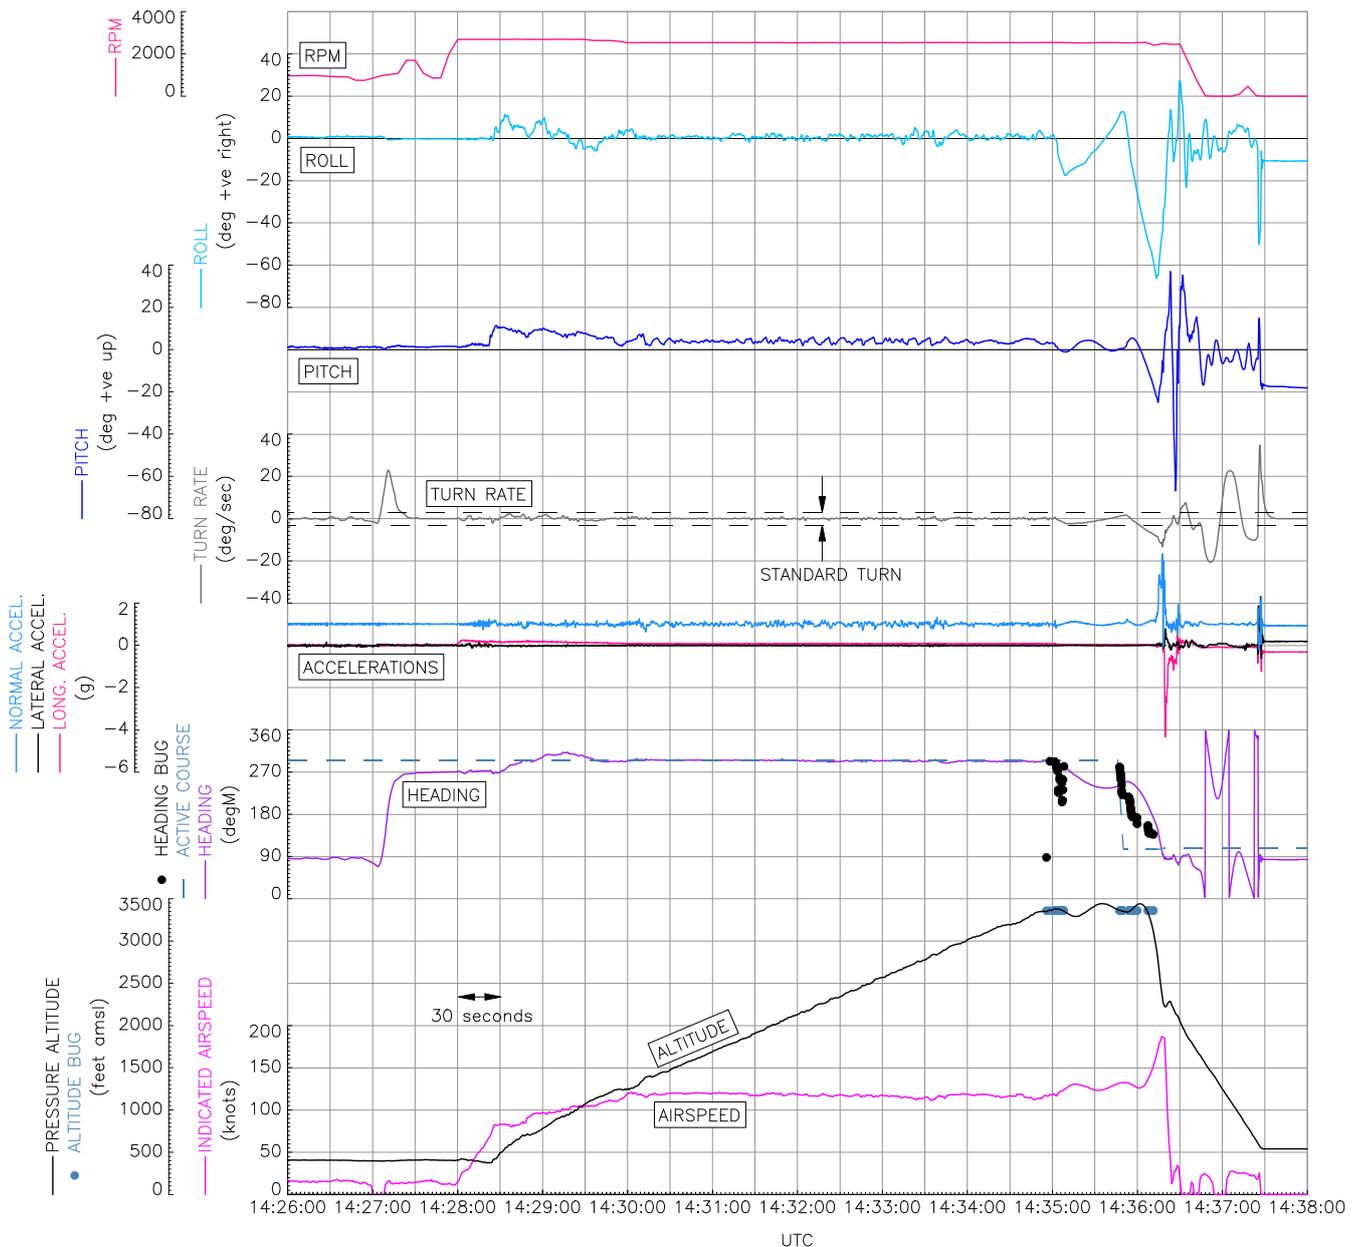
Figure 2 shows that between 1430:30 hrs and 1434:30 hrs, the aircraft was climbing at a constant 400 ft/min on a heading of 295°M. The recorded engine speed was 2,530 rpm and the indicated airspeed

120 kt, reducing to 115 kt. The aircraft then began to level off. 25 seconds later, at 1434:55 hrs, the aircraft reached 3,360 ft amsl and this altitude was selected on the altitude bug. During the next 75 seconds of flight the data is smoother than data recorded up to this point. The recorded data covering this portion of the flight is presented in more detail in Figure 3, which includes the

Salient recorded parameters from the PFD and MFD showing the whole flight

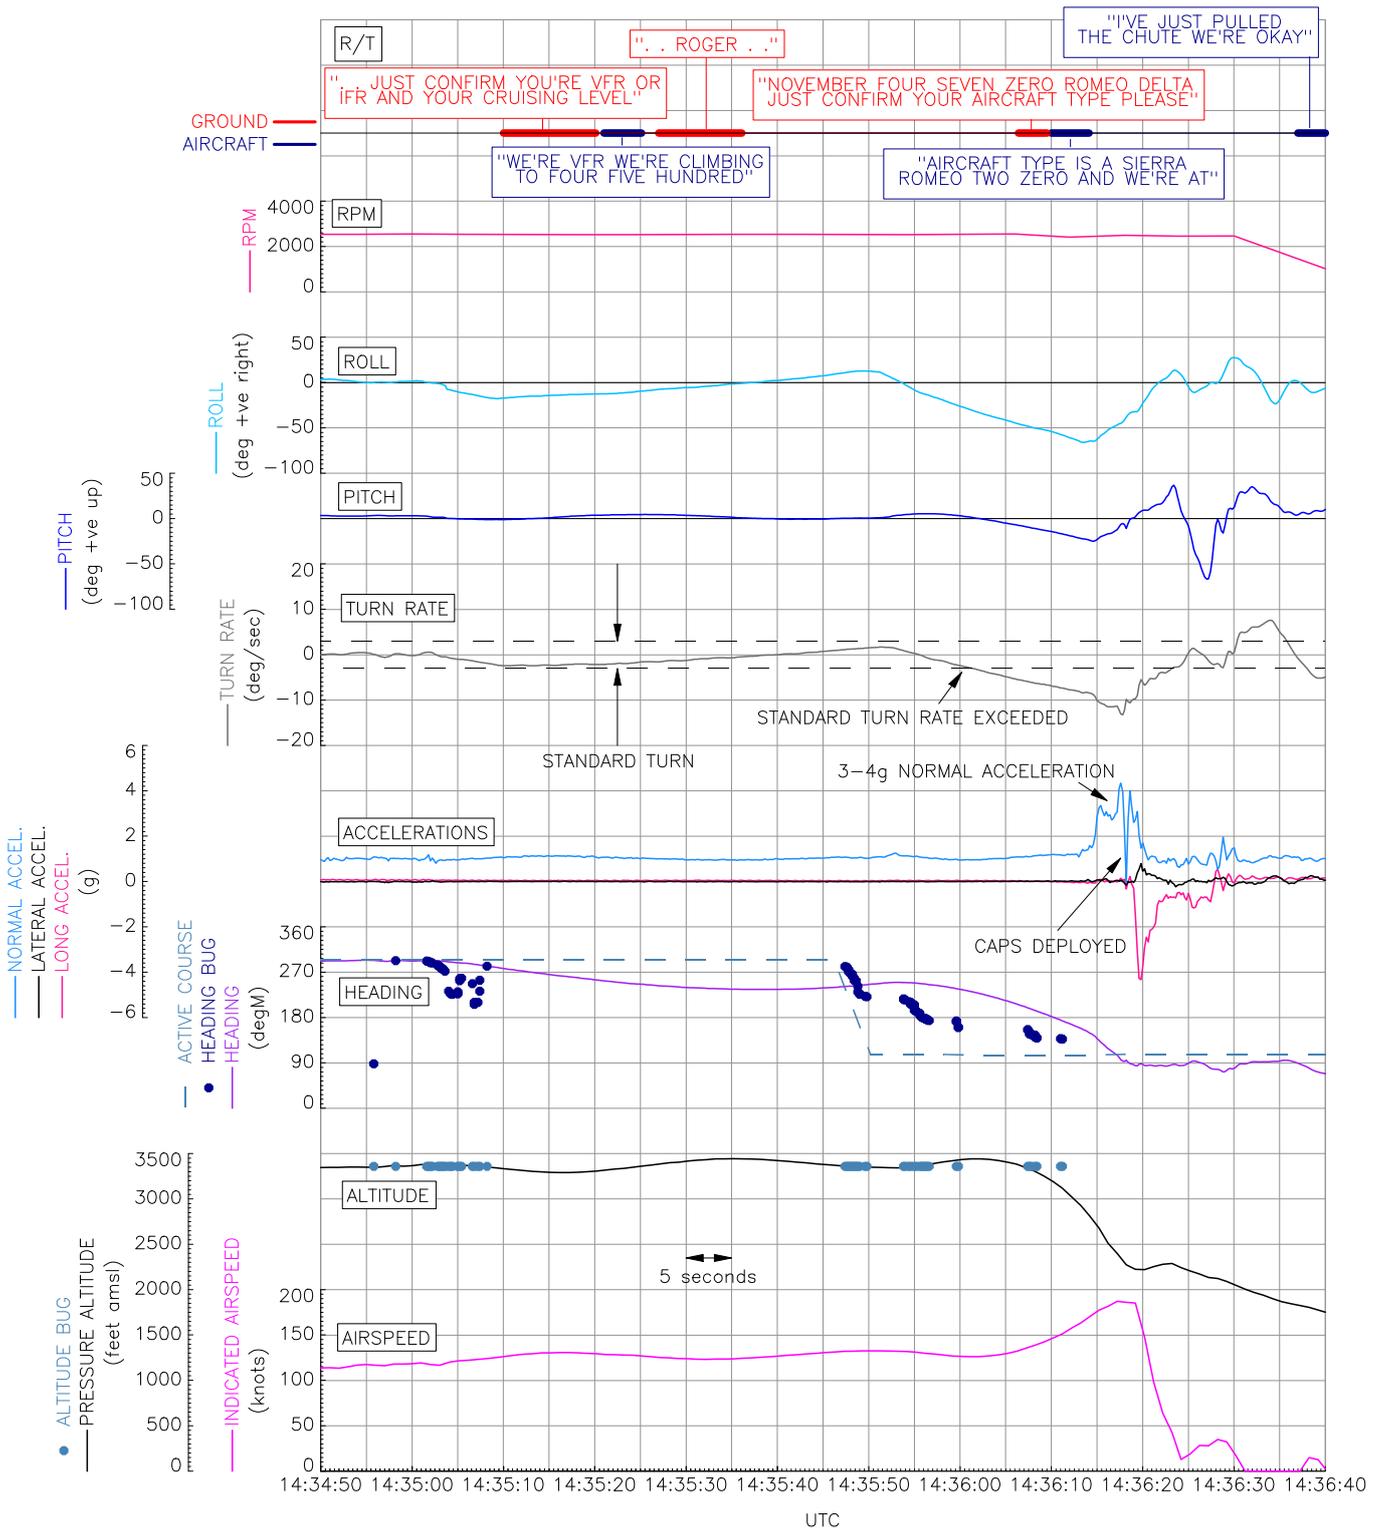
Figure 3
Salient recorded parameters from the PFD and MFD from top of climb to the CAPS deployment

Between times 1434:55 hrs and 1436:15 hrs, the aircraft’s flight path and attitude were not stable.

The altitude climbed gradually by about 50 ft while oscillating two and a half times through ± 75 ft, with corresponding oscillations in pitch ($\pm 3^\circ$) and airspeed (± 5 kt and increasing by 10 kt). The roll was less oscillatory (and also not in phase with the pitch oscillations), initially rolling to 18° left wing down then to 13° right wing down, and then to the left again.

A corresponding heading change can be seen as the aircraft initially turned to the left from 295°M through 50°, at less than the standard turn rate of 3°/sec. As the aircraft started to turn there were a number of changes to the heading bug over a period of seven seconds. On reaching 235°M in the left turn, the aircraft started a similarly gentle turn to the right through 15° during which the active course changed from 295°M to 197°M. The heading bug also changed in stages to 221°M. The aircraft then started another turn to the left, during which the turn rate exceeded the standard value and continued to increase. A similar divergence was recorded in the aircraft's attitude as it banked left and pitched down, with increasing airspeed and loss in altitude. Further heading bug changes were recorded, to a final value of 137°M.

At 1436:13 hrs, as the bank angle reached 66° left wing-down and the pitch 25° nose-down, there was a sharp rise in the normal acceleration from a nominal 1g to 3g, and then to 4g two seconds later, consistent with recovery from a developing spiral dive. A review of the recorded data made by the aircraft manufacturer confirmed that from 1436:17 hrs, the aircraft's flight profile and dynamics were consistent with the CAPS having been deployed. At the time of deployment (1436:17 hrs) the aircraft's altitude and airspeed were 2,400 ft amsl and 187 kt, respectively. The pitch attitude was 9° nose-down and aircraft was banked 45° to the left.
