**AIRCRAFT ACCIDENT REPORT 1/2006**

**Report on the accident to  
Fairey Britten Norman BN2A Mk III-2 Trislander  
registration G-BEVT  
at Guernsey Airport, Channel Islands  
on 23 July 2004**

**Air Accidents Investigation Branch**

**‘Examination of G-BEVT  
Trislander De-icing Boot Failure’**

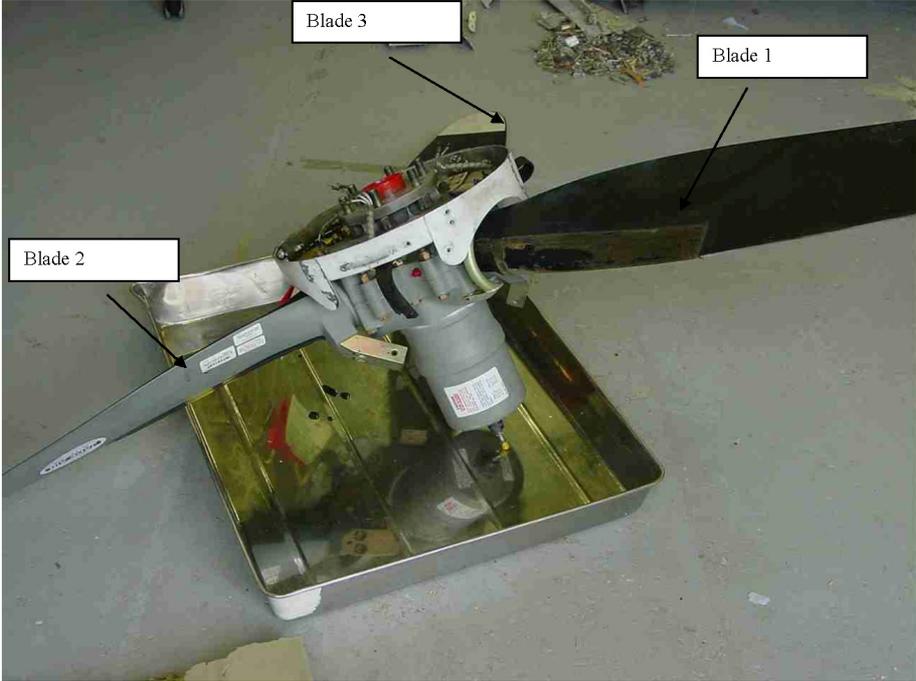
- 2.1 Figure 2 shows a photograph of the propeller identifying the three blades. Blade 1 had shed the de-icing boot and Blades 2 and 3 appeared well bonded. On arrival at QinetiQ each part of the propeller and the damaged de-icing boot was photographed and visually examined.

Figure 2: Photograph showing propeller from Trislander G-BEVT

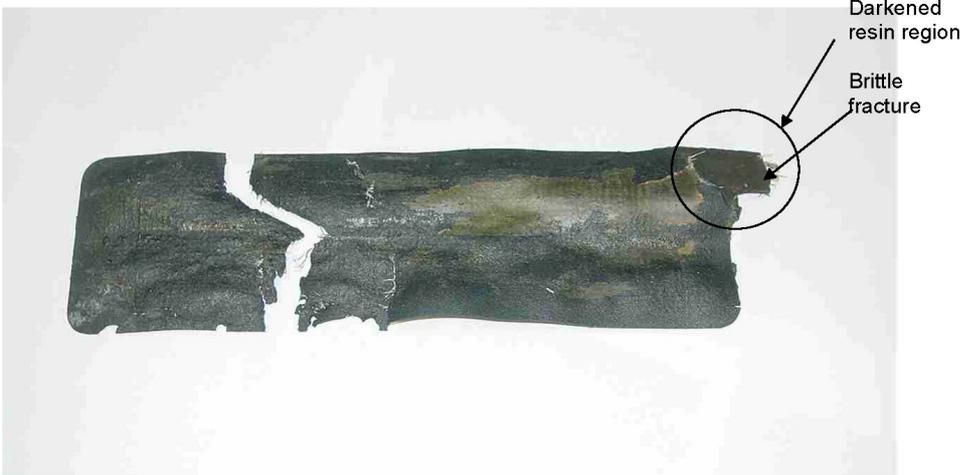
- 2.2 The failed de-icing boot was supplied in two parts, the separation into the two halves was believed to be a result of the impact with the window, see Figure 3. On the bonded surface of the boot there was a small patch of adhesive near the centre. The remainder of the surface showed no residual adhesive. At the root end of the boot the resin appeared much darker (marked in Figure 3). The boot strap had fractured at the root of the de-icing boot, this failure of the rubber appeared brittle, see Figure 4. Examination of the surface of Blade 1 showed the adhesive to be well bonded in most regions with the exception of the root end as shown in Figure 5.

Figure 3: Photograph showing failed de-icing boot from Blade 1

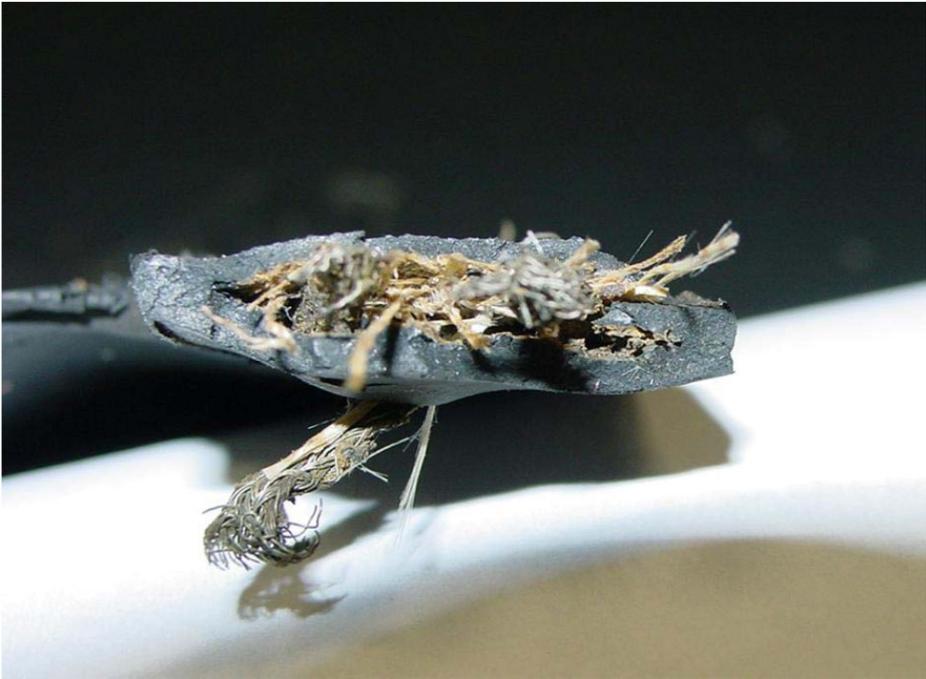
Figure 4: Rubber failure at the root end of boot from Blade 1

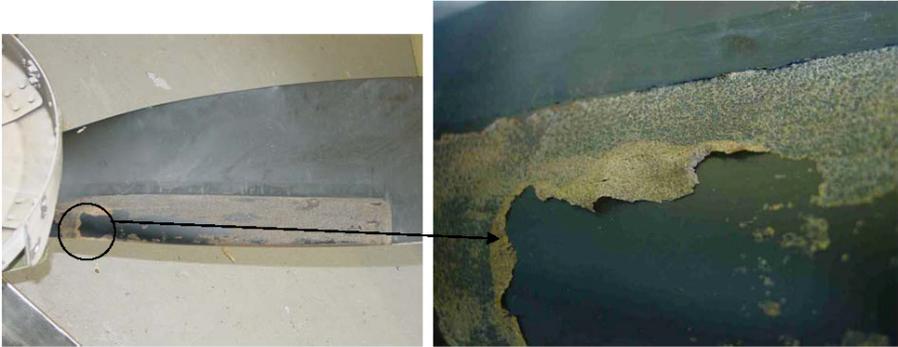
Figure 5: Bonding area of Blade 1, showing disbonded adhesive

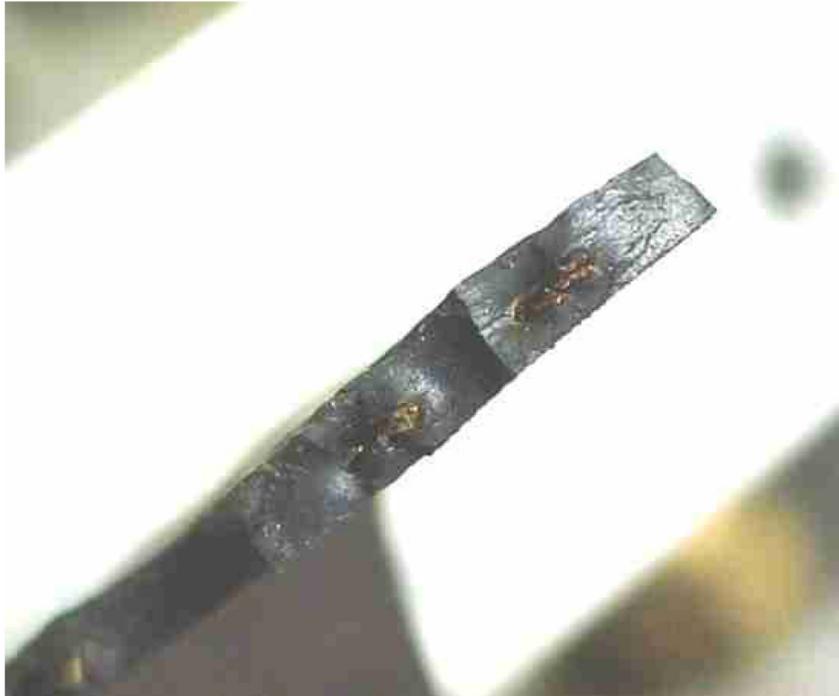
- 2.3 Near the electrical termination, a second fracture in the strap was found (Figure 6). In this case the fracture appeared to be ductile. It was apparent, however, that a large section of the strap was missing between the two fractures when compared to the strap on the de-icing boot of blade 2 (Figure 7).

*Figure 6: Second fracture in strap, near electrical termination*

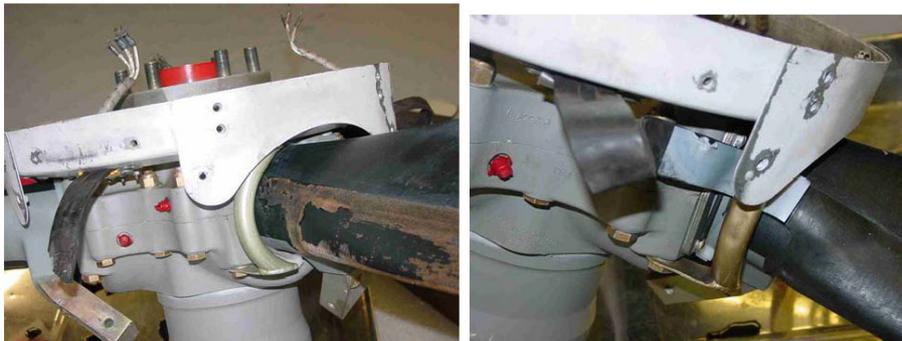
*Figure 7: Remains of strap attached to hub from Blade 1 de-icer boot (left-hand image) and equivalent strap on Blade 2 (right hand image)*

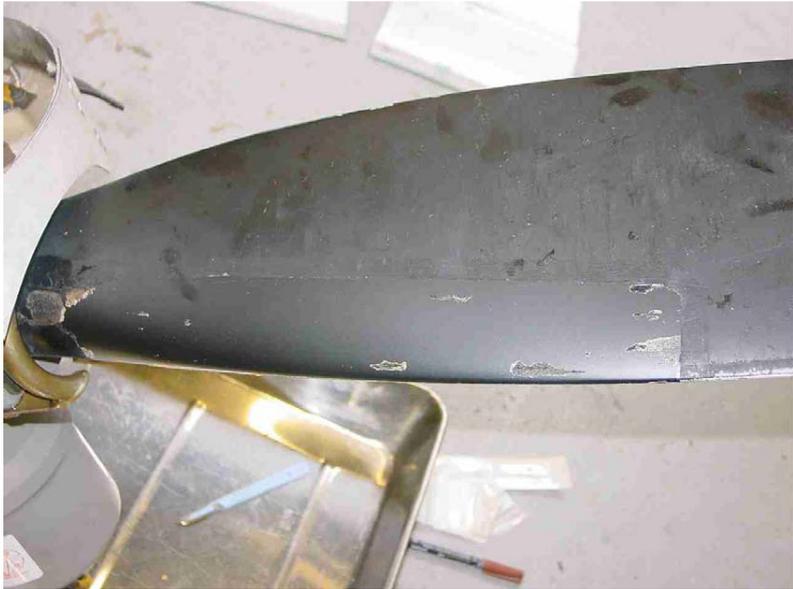
- 2.4 The de-icing boot from Blade 2 was removed for comparison with the failed boot. The boot strap was cut near the electrical termination and the tie wrap around the strap was removed, the de-icing boot was then peeled-off from the root end. The boot was removed from the blade relatively easily indicating that, even though this boot was well bonded, the peel strength of the adhesive used was low, however, this may have been affected by the thinness of the adhesive layer applied. Figures 8 and 9 show the surface of blade 2 after the removal of the boot and Figure 10 shows an image of the boot surface. Although, the adhesive appeared to have failed in a similar manner to the boot on Blade 1, i.e. mostly adhesive failure, in this case, the failure generally occurred at the adhesive-blade interface rather than the adhesive-rubber interface, as observed on Blade 1.

Figure 8: Aft surface of Blade 2 after removal of de-icer boot

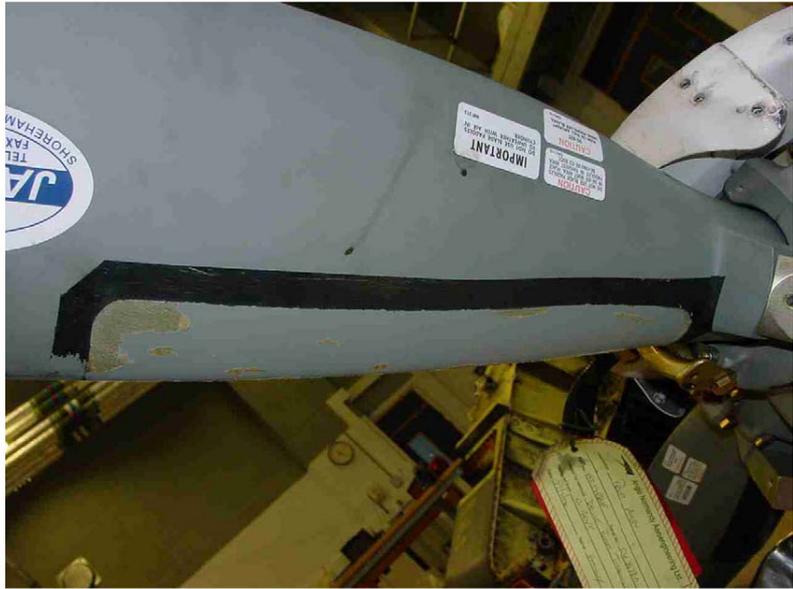
Figure 9: Forward surface of Blade 2 after removal of de-icer boot

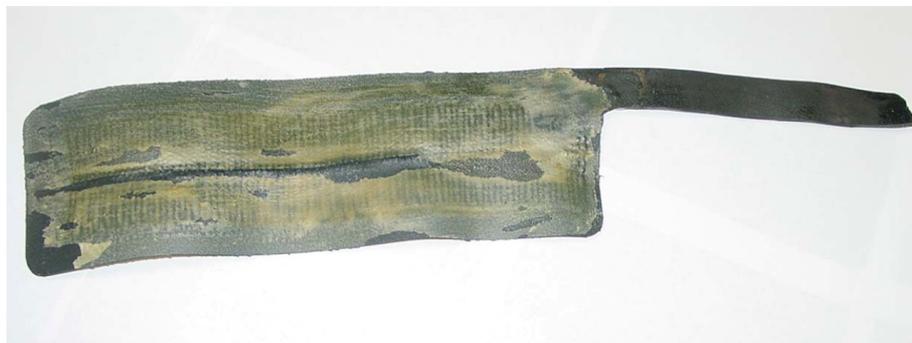
Figure 10: De-icer boot removed from Blade 2

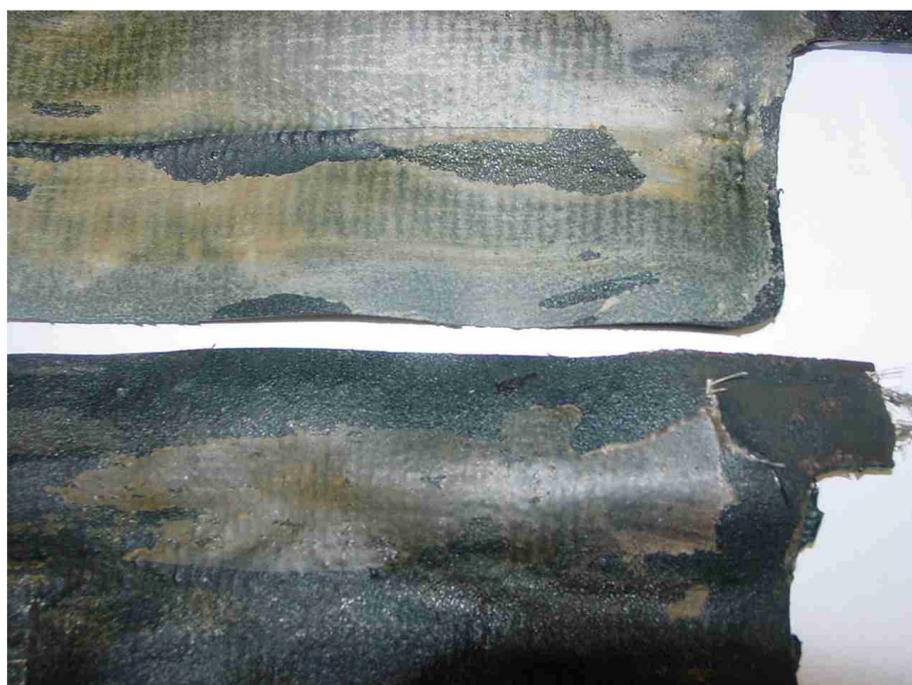
- 2.5 There was also a notable colour difference between the adhesive on the surfaces of the de-icing boots from Blade 1 and Blade 2. The adhesive on Blade 2 was a light yellow colour whereas the adhesive on Blade 1 was light brown, see Figure 11. Two weeks after the removal of the de-icing boot from Blade 2, the de-icing boot from Blade 3 was removed and it was observed that the adhesive from Blade 2 had significantly darkened during this period (Figure 12). This darkening has been noted by other users of the adhesive at

Figure 11: Comparison of adhesive colouration on de-icer boots from Blades 1 (bottom) and 2 (top)

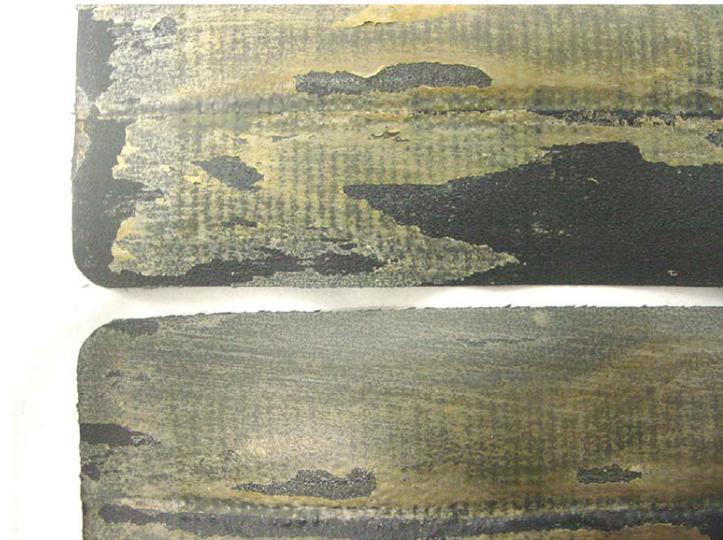
QinetiQ and appears to be a natural consequence of the exposure of this adhesive to environmental conditions.

Figure 12: Comparison of colouration of de-icer boots removed from Blades 3 (top) and 2 (bottom), showing discolouration of the former with time

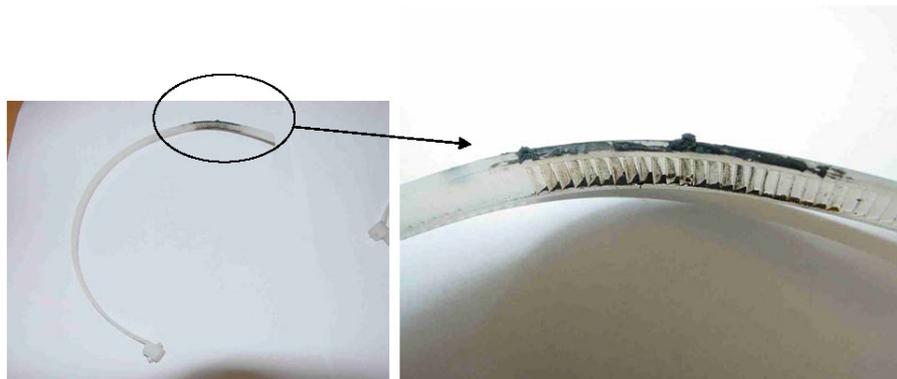
- 2.6 Figures 13 and 14 show the tie wraps from the failed and good de-icing boots. It was observed that the tie wraps from the undamaged boots showed no evidence of marking. On the tie wrap from the failed de-icing boot there was a build up of residue on the root edge (near electrical termination) suggesting that the boot strap had been pulled through.

Figure 13: Tie wrap from failed de-icer strap showing residue on root edge.

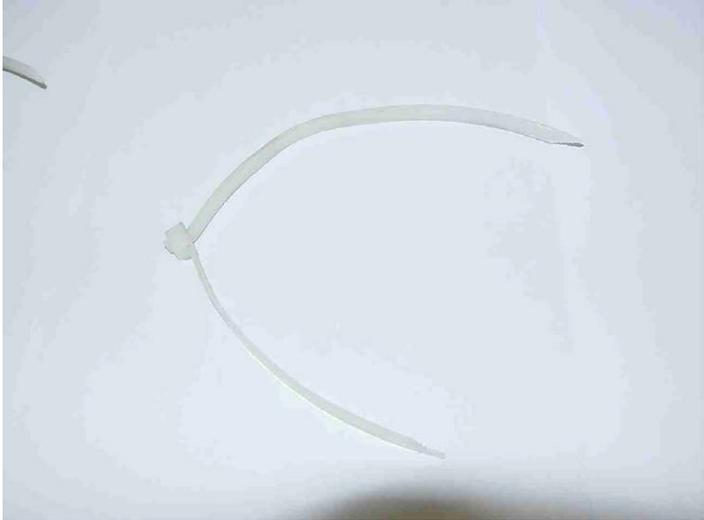
Figure 14: Tie wrap from good de-icer boot (Blade 2)

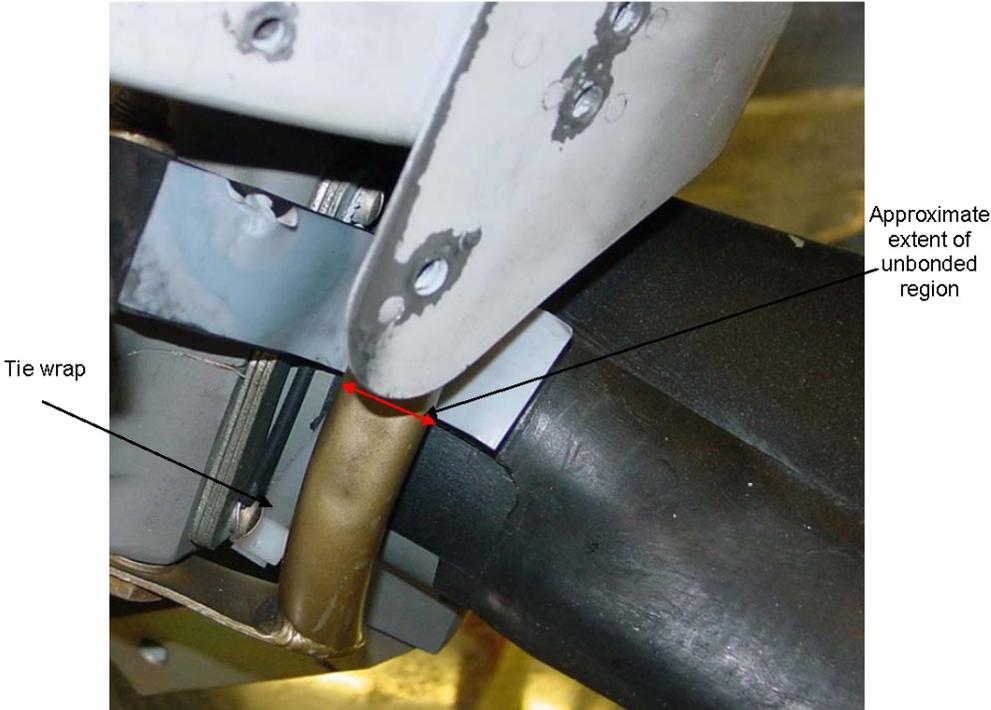
- 2.7 The position of the tie wraps on Blades 2 and 3 was significantly further from the root end of the boot than shown in the manufacturer's example images (Figure 1). The tie wrap is applied over the bonded region in the manufacturer's example but on Blades 2 and 3 the tie wrap was applied over the strap beyond the bonded region. This resulted in a region of unbonded strap, approximately 5-8 mm long between the bonded root of the boot and the tie wrap, see Figure 15. The position of the tie wrap with respect to the bonded region on the failed de-icing boot is unknown as the piece of strap that would have been beneath the tie wrap is missing.

Figure 15: Photograph showing the location of the tie wrap with respect to end of bonded region on blade 3

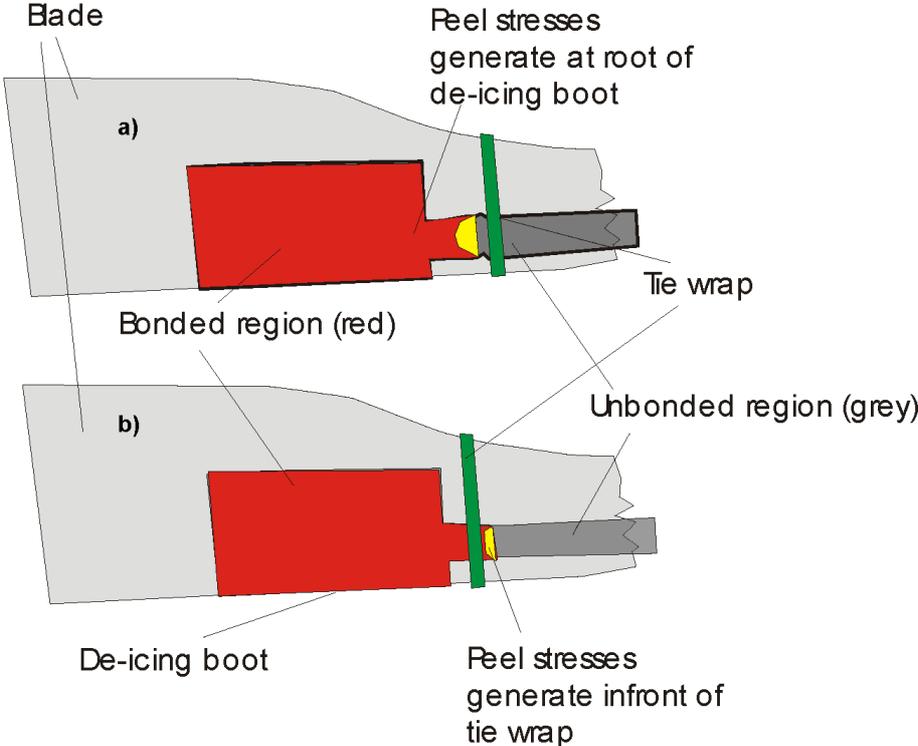
Figure 16: Schematic showing location of tie wraps and bonding on a) blade 2 and 3 from Trislander propeller examined and b) manufacturer's example

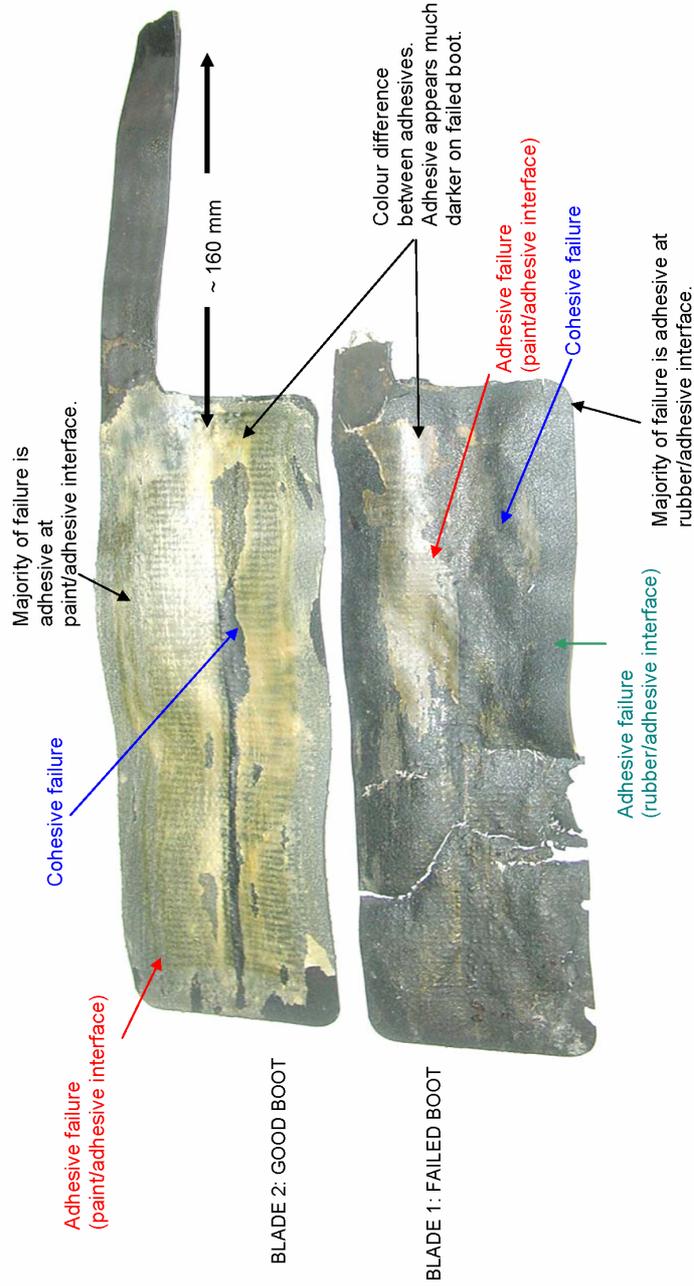
- 2.9 Figure 17 shows a summary of the bonded fracture surfaces from boots 1 and 2.
- 3 NDE**
- 3.1 Before the de-icing boots were detached from Blades 2 and 3, they were examined using the ANDSCAN non-destructive evaluation (NDE) technique. This technique utilises high frequency ultrasonic scanning with water as the contact medium. Changes in material properties, such as the presence of voids in the adhesive bond, result in a change in the bulk attenuation from which a map of damaged areas can be obtained. A number of different ultrasonic probes were tried with the ANDSCAN. However, the material was found to be highly attenuative and a scan of the whole bonded area was not possible. A 5MHz single crystal probe worked relatively well on the thin section of the boot. In these areas of the de-icing boot the bond appeared to be good, however NDE was not able to detect changes in the adhesive where the rubber thickness increased near the root region or at the leading edge where a tight radius of curvature existed.

Figure 17: Failure across bonded surfaces of good (top) and failed (bottom) de-icer boots
