AIRCRAFT GENERAL LAYOUT

POWERPLANT AND MAIN GEARBOX LAYOUT

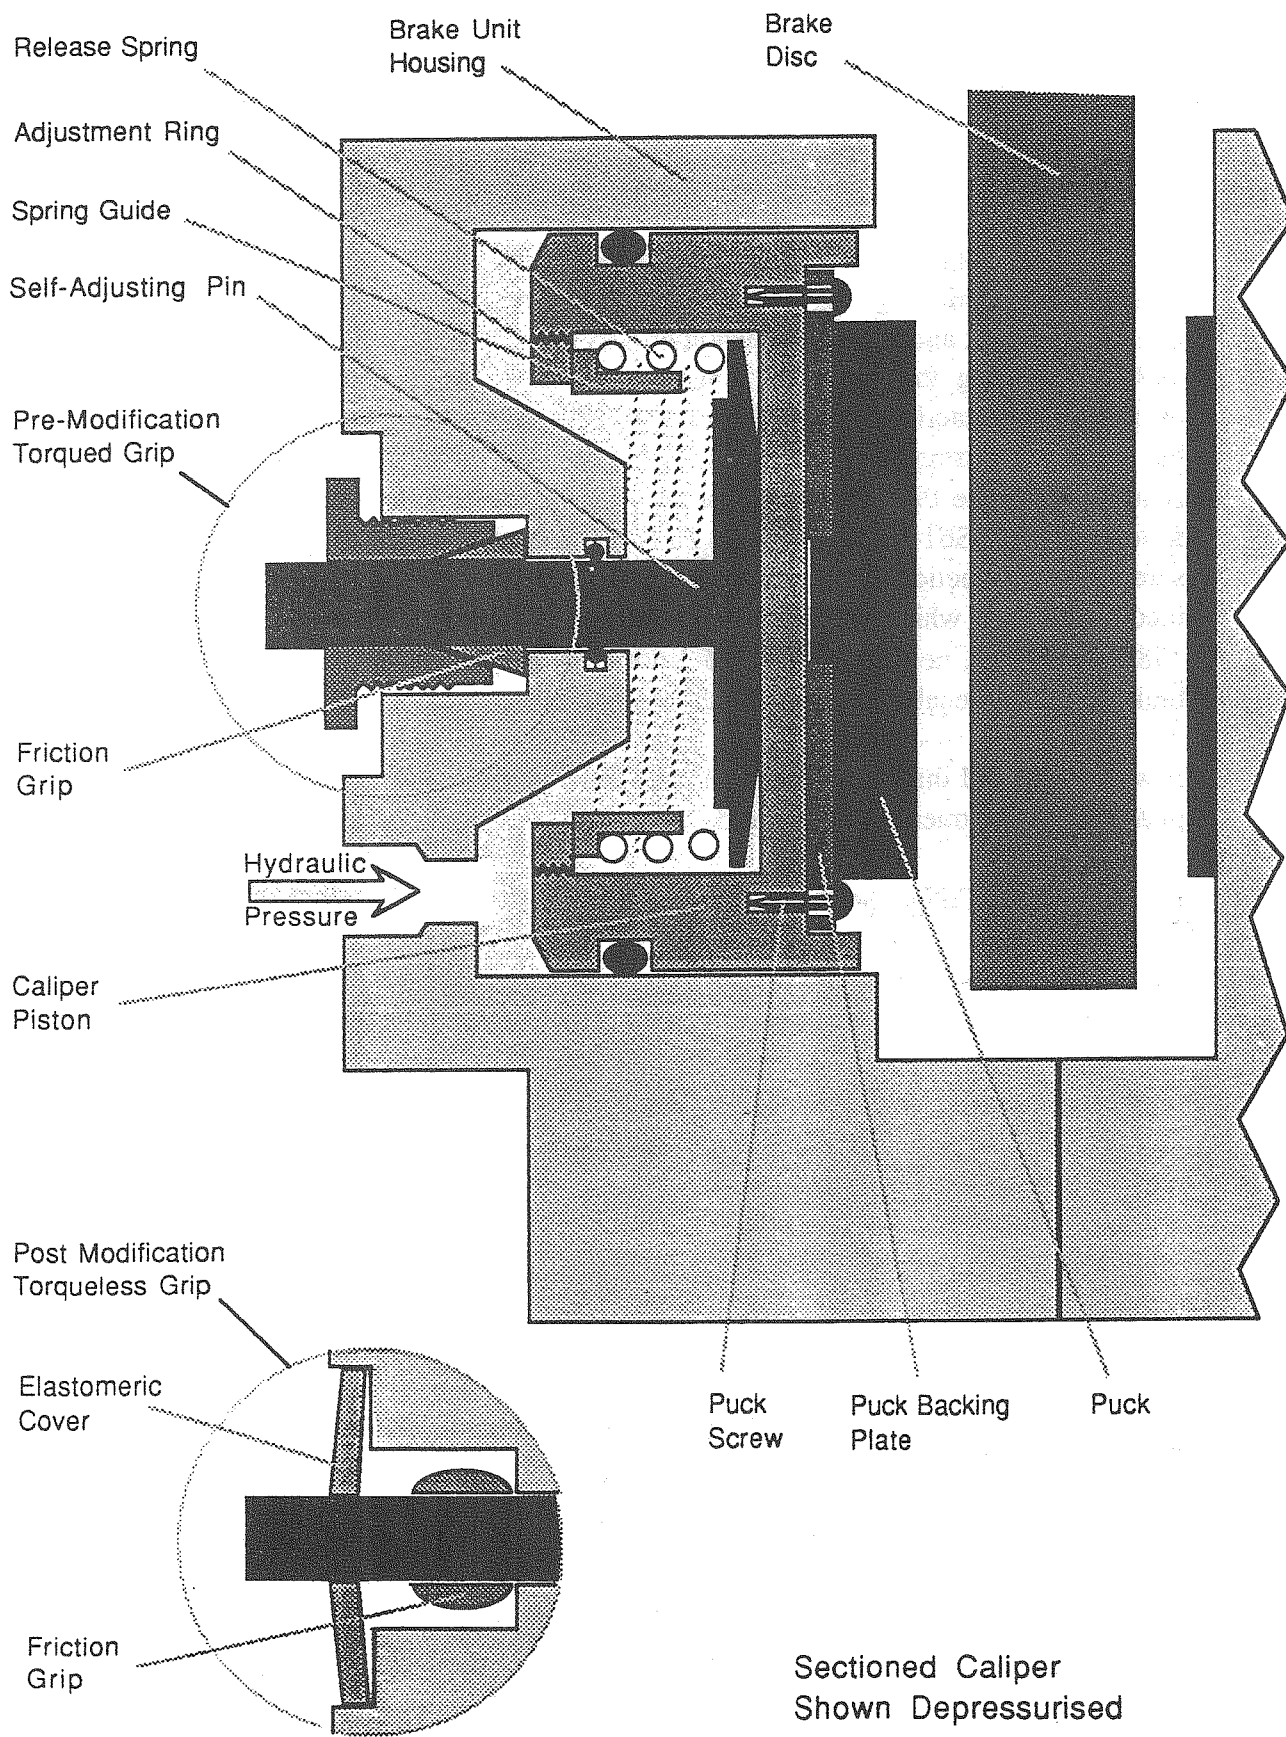
Sectioned Caliper
Shown Depressurised

A) Loose puck screws

Puck screws specified for the original standard of the brake, PN 944034, were type NK 526-632-5, 7.8mm long. Goodyear Service Bulletin (SB) S61-32-2, Rev 0, issue date 20 September 1985, and Sikorsky Customer Service Notice (CSN) S35-5, issue date 22 June 1986, modifying the brake to asbestos-free puck standard (PN 9440345-1), and to torqueless grip standard (PN 9440345-2) specified 9mm long NAS 1190-06P6 type screws but without requiring the screw holes in the pistons to be deepened. Rev 1 of SB S61-32-3, issue date 30 June 1986, corrected the error by specifying 7.8mm long -5 screws. This was followed by SB S61-32-2, issue date 28 November 1986, which required 9mm long -06P6 screws in conjunction with deepening of piston screw holes and a change in piston PN, incorporation of which was advised by Sikorsky CSN S35-5, Rev A, issue date 2 March 1987. However, neither SB S61-32-3 nor CSN S35-5, Rev A, required a change to the brake unit PN to enable units on which they had been incorporated to be identified.

It was also noted that an anti-corrosion compound was applied between the puck and the piston on puck fitment, which would have had the effect of masking any puck looseness.

B) Caliper bolt/nut torque

No firm cause could be found for the looseness in the bolts and nuts holding the two halves of the caliper together, which was found in some cases, but differences were noted in the assembly torques specified between the Sikorsky Maintenance Manual and the Goodyear Overhaul Manual. The former did not specify a torque value in the section (Chapter 65-50-2, Page 207, Step 19) covering reassembly, and the standard values of Chapter 20 thus applied, *i.e.* an assembly torque, unlubricated, of 325 in.lb for the bolt and 275 in.lb for the nut. However, the Goodyear Manual 9440345 (Page 703/4, Para K) specified a lubricated torque value of 160 - 190 in.lb.

C) Insufficient puck - disc clearance

Cases of insufficient puck clearance from the disc appeared to have resulted from a design feature of the torqueless grip modification, whereby the grip for the self-adjusting pin was not restrained from moving outwards (away from the disc) in its bore in the caliper body. This feature was unlike its predecessor, the torqued grip, which was restrained in both directions. If a piston were pushed into its cylinder during brake removal or refitment, or in the course of puck replacement, the torqueless grip would be moved outwards away from its inner stop. In this condition, the internal gap between the spring guide and the pin head, on which the puck back-off function with the brake released depends, would be lost following initial brake application. It was found that in this condition the puck would ratchet towards the disc during initial brake applications, finishing up in contact with the disc when the brake was released. Such an effect should have been detected by tests required after brake installation.
