**INCIDENT**

<b>Aircraft Type and Registration:</b>	Pegasus Quantum 15-912, G-BZMI	
<b>No &amp; Type of Engines:</b>	1 Rotax 912 piston engine	
<b>Year of Manufacture:</b>	2000	
<b>Date &amp; Time (UTC):</b>	13 September 2008 at 1820 hrs	
<b>Location:</b>	7 miles East of Sandy, Bedfordshire	
<b>Type of Flight:</b>	Training	
<b>Persons on Board:</b>	Crew - 2	Passengers - None
<b>Injuries:</b>	Crew - None	Passengers - N/A
<b>Nature of Damage:</b>	Front strut upper supporting bracket failed and monopole bent	
<b>Commander's Licence:</b>	Private Pilot's Licence	
<b>Commander's Age:</b>	54 years	
<b>Commander's Flying Experience:</b>	1,300 hours (of which 1,250 were on type) Last 90 days - 58 hours Last 28 days - 21 hours	
<b>Information Source:</b>	Aircraft Accident Report Form submitted by the pilot and AAIB inquiries

**Synopsis**

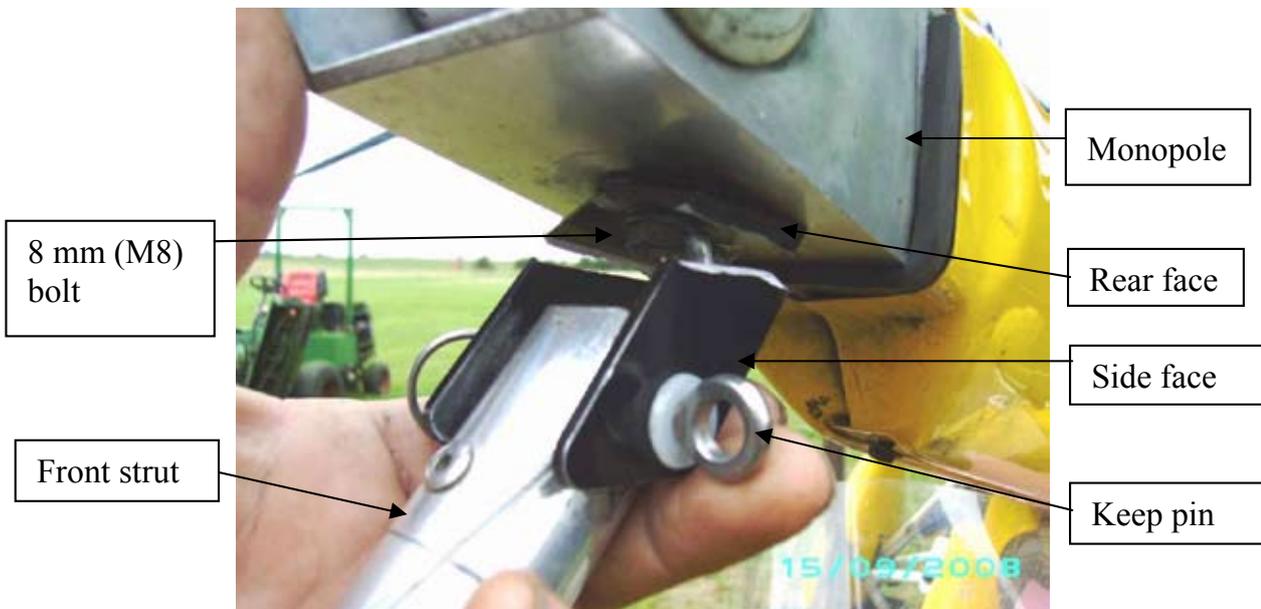
On the incident aircraft both side faces of the bracket had failed where they join the rear face (Figure 1). The rear face of the bracket had also failed across the M8 securing bolt hole. The distortion of the bracket and the direction of failure of the side faces indicated that the bracket had been orientated upside down and had been pulled away from the monopole. There was also a dent in the rear face of the monopole adjacent to the overcentre locking catch and the monopole had bent

rearwards, about this point, by approximately 2°. The securing holes in the front strut and over-sleeve were all slightly elongated.

**Figure 1**  
Failed front strut bracket on G-BZMI

The evidence indicates that the incident occurred as a result of the aircraft being flown with the bracket orientated upside down. Calculations and tests by

the aircraft manufacturer have shown that a correctly orientated bracket can sustain a load 2.25 times greater than a bracket that has been fitted upside down. When fitting the front strut it is likely that an additional tensile load was introduced into the incorrectly orientated bracket. It is probable that this additional tensile load, when combined with the flight loads, caused the bracket to fail in flight.

Immediately following this incident, the BMAA advised their inspectors and members owning Quantum aircraft of the consequences of flying with the front strut upper bracket orientated upside down. The aircraft manufacturer is considering introducing a modification to prevent the aircraft from being rigged with the bracket incorrectly orientated.

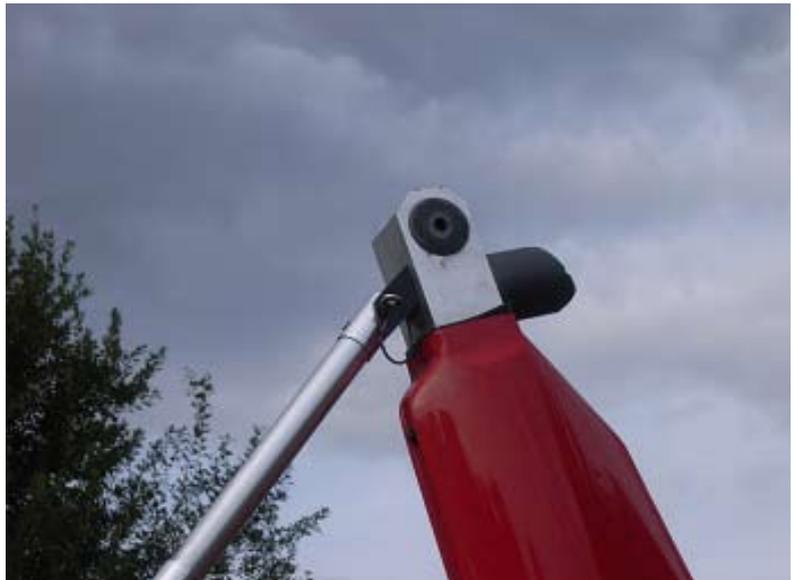
**Figure 2**

When the microlight is correctly rigged the front strut is aligned with the upper bracket (Figure 2).

Correct orientation of bracket
