**ACCIDENT**

<b>Aircraft Type and Registration:</b>	Piper PA-22-150 Caribbean, G-ARHN	
<b>No &amp; Type of Engines:</b>	1 Lycoming O-320-B2B piston engine	
<b>Year of Manufacture:</b>	1960	
<b>Date &amp; Time (UTC):</b>	9 September 2010 at 1310 hrs	
<b>Location:</b>	Woodlands, Hampshire	
<b>Type of Flight:</b>	Private	
<b>Persons on Board:</b>	Crew - 1	Passengers - 1
<b>Injuries:</b>	Crew - 1 (Serious)	Passengers - 1 (Serious)
<b>Nature of Damage:</b>	Aircraft extensively damaged, third party damage to buildings and garden	
<b>Commander's Licence:</b>	Private Pilot's Licence	
<b>Commander's Age:</b>	74 years	
<b>Commander's Flying Experience:</b>	340 hours (of which 20 were on type) Last 90 days - 18 hours Last 28 days - 4 hours	
<b>Information Source:</b>	AAIB Field Investigation

**Synopsis**

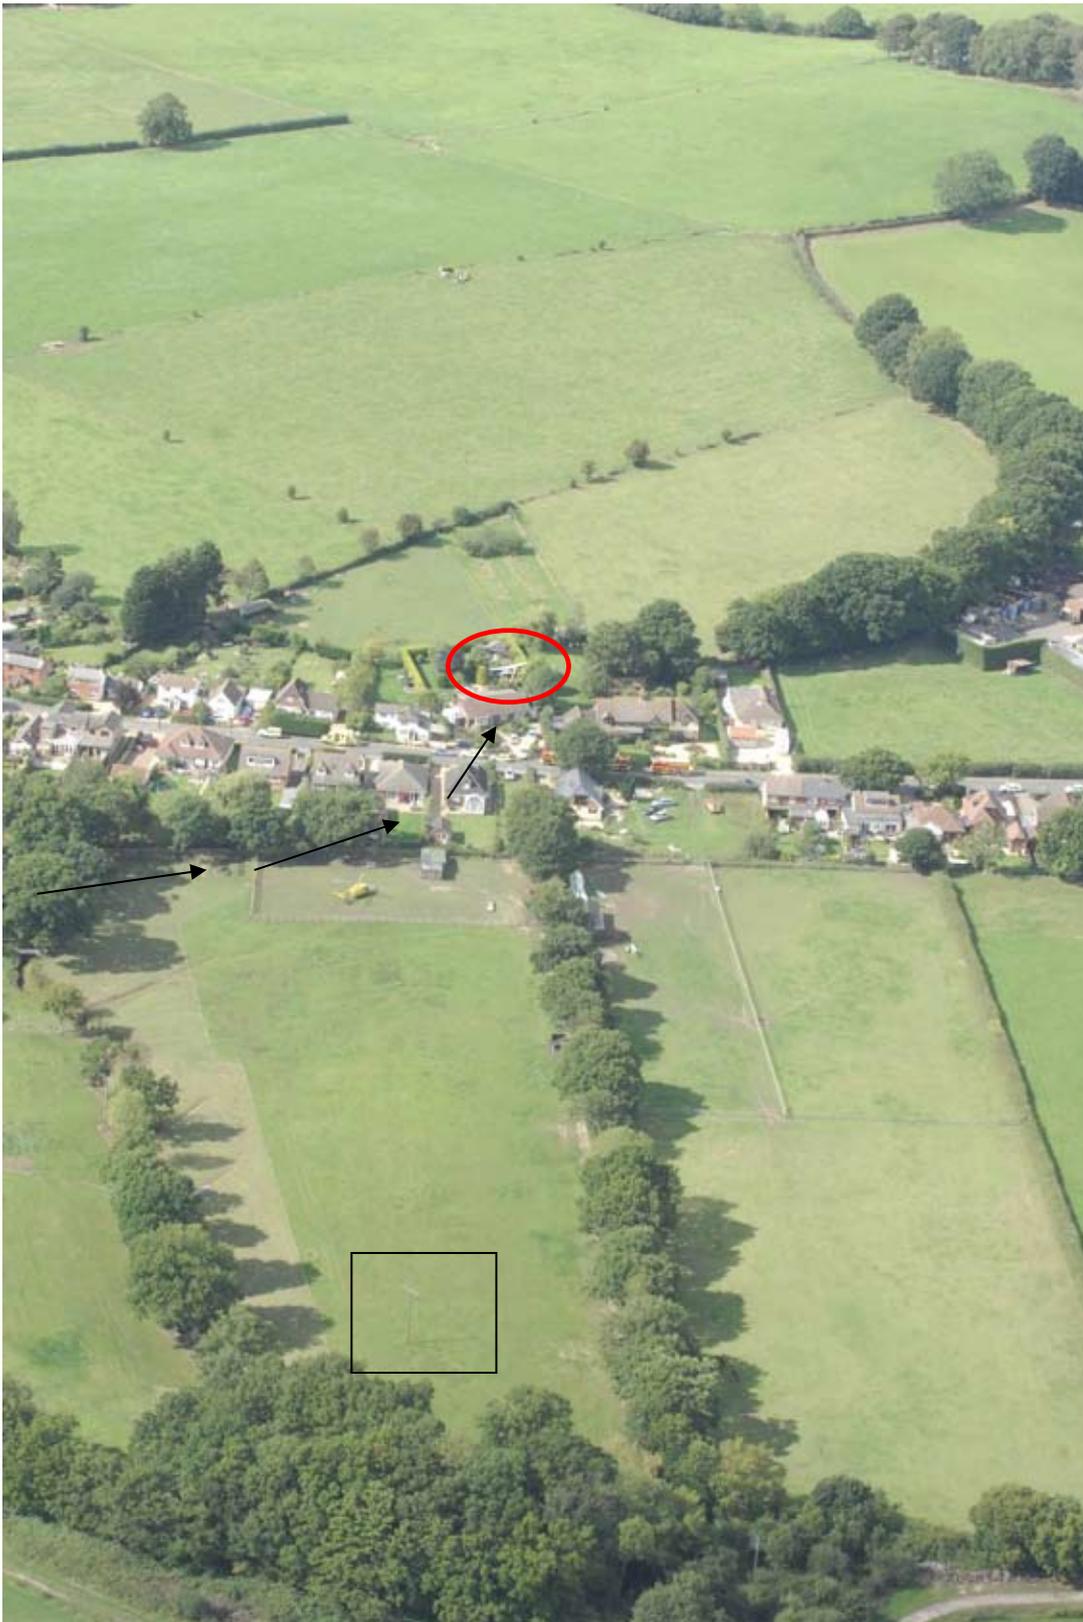
**Figure 1**

One witness described the aircraft as passing over them in a curving flight path. (Figure 1)

G-ARHN circled, witness ground track arrowed, note wires crossing field in foreground, pylon boxed.
