**ACCIDENT**

<b>Aircraft Type and Registration:</b>	Piper PA-34-200T Seneca II, G-BNEN	
<b>No &amp; Type of Engines:</b>	2 Teledyne Continental TSIO-360-EB piston engines	
<b>Category:</b>	1.3	
<b>Year of Manufacture:</b>	1980	
<b>Date &amp; Time (UTC):</b>	22 February 2003 at 1230 hrs	
<b>Location:</b>	White Waltham Airfield, Berkshire	
<b>Type of Flight:</b>	Public Transport (Passenger)	
<b>Persons on Board:</b>	Crew - 1	Passengers - 1
<b>Injuries:</b>	Crew - None	Passengers - None
<b>Nature of Damage:</b>	Nose landing gear collapsed, damage to underside of nose, nose gear doors and engine cowlings, all propeller blades bent and engines shock loaded	
<b>Commander's Licence:</b>	Commercial Pilot's Licence	
<b>Commander's Age:</b>	36 years	
<b>Commander's Flying Experience:</b>	1,300 hours (of which 800 were on type) Last 90 days - 125 hours Last 28 days - 40 hours	
<b>Information Source:</b>	AAIB Field Investigation

**Synopsis**

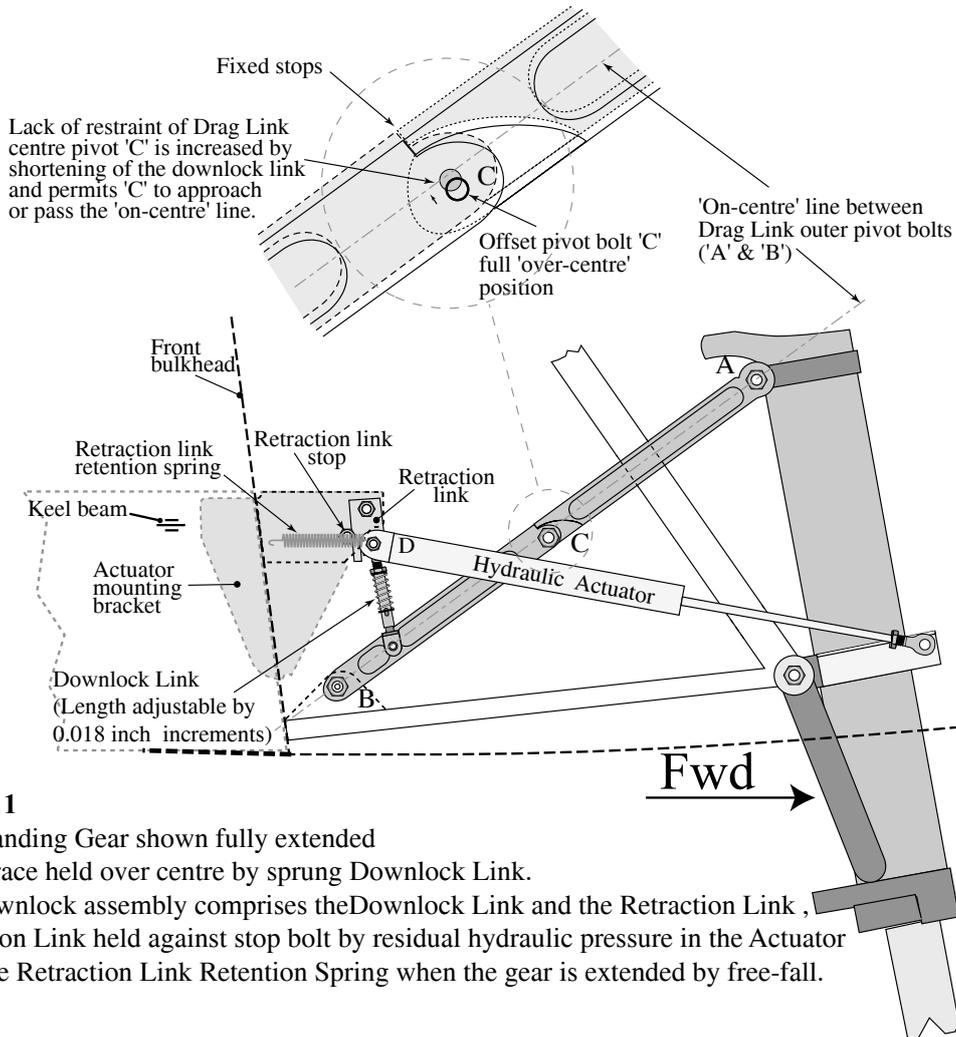
Inspection of the drag link after its removal from the aircraft showed that there was considerable wear in the upper and centre pivot joints ('A' & 'C' on Figure 1, next page) but the lower joint ('B' on Figure 1) of the lower link exhibited very little wear. Before dismantling the assembly, the 'over-centre' dimension of the drag link assembly was measured to be 0.310 inch which was greater than the specified minimum.

The upper joint, attaching the link to the landing gear leg, was the most severely worn. Measurement of the individual components showed that the bolt itself was unworn and dimensionally correct. The steel sleeve (Part No 9061-29) which runs in the upper link bush was found to have no significant wear on its outer surface. However, the bore of this sleeve, for which wear limits are given in the Aircraft Maintenance Manual (AMM), had been worn bell-mouthed at both ends. Although at its mid-point the bush bore was measured as 0.001 inch smaller than the lower limit given, resulting in a bolt clearance of only 0.003 inch on the measured bolt diameter, at the ends the clearance was 0.006 to 0.007 inch; the greatest wear being 0.001 inch above the maximum limit. The inside diameter of the bronze bush at the upper end of the upper drag link, within which the steel sleeve worked was also measured and also found to be bell-mouthed. There were no established wear limits for this bronze bush at the time of this accident. In the bore of this bush it was found that the wear was oval and more severe along the axis of the link. Similarly to the steel sleeve, the bore of the bronze bush also was very little worn near the middle of the bush and most worn on the left side which had been adjacent to the landing

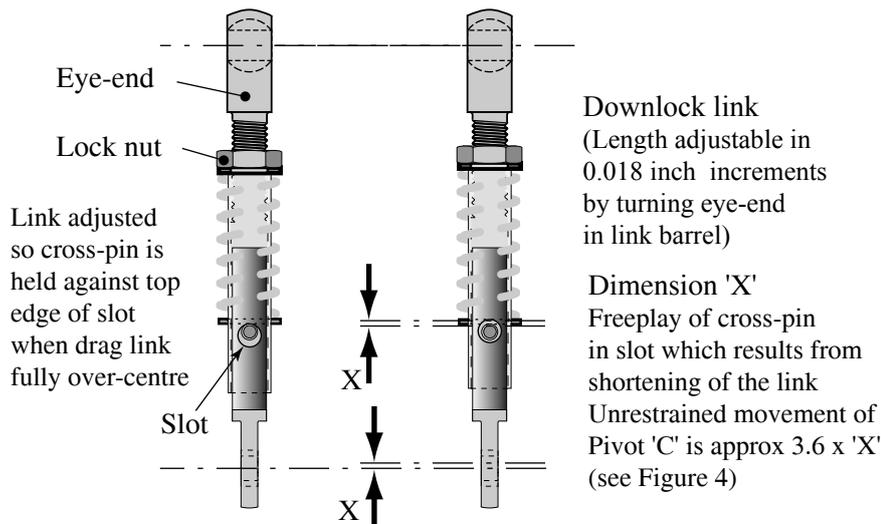
**Figure 3**

At the 50 hour check the fault in the emergency lowering of the nose landing gear was confirmed. It appeared that the downlock link was slightly too long to allow the retraction spring to pull the retraction link onto the downlock stop (see Figures 1 & 3). After lubrication of the downlock mechanism, the link was shortened by a small amount

The instructions for rigging the downlock link state that after having set its length, initially, to hold the drag link at its maximum 'overcentre' position, the final step calls for it to be shortened by one half-turn of the eye end (0.018 inch). Consideration of the geometry of the lock and link mechanism indicates that every half-turn shortening adjustment of the length of the downlock link permits about 0.065 inch of unrestrained movement of the centre joint of the drag link towards the 'on centre' position by allowing movement of the pin in the downlock link slot (Dimension 'X'). Since it is only possible to

adjust the link length by increments of half a turn, it is possible for the unrestrained movement to approach twice this value and for the lock to be correctly rigged in accordance with the setting-up procedure in the AMM. Any subsequent shortening (necessarily by half-turn steps) would relax the restrained 'overcentre' state of the drag link a further 0.065 inch.

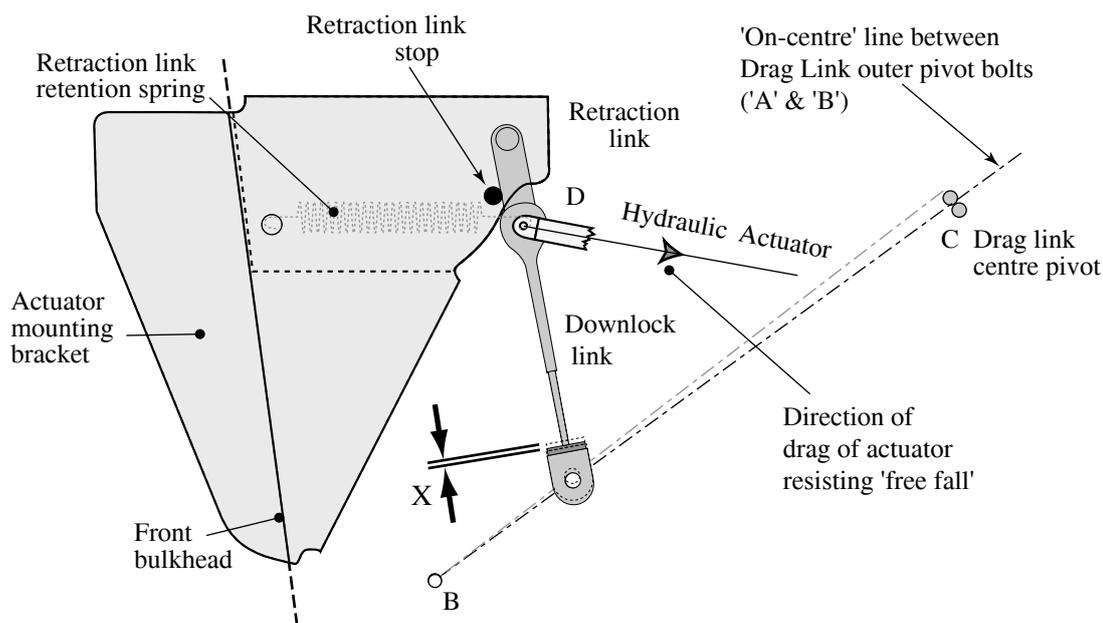
**Figure 4**

Whilst there is no doubt that shortening the downlock link would have made it easier for the retraction spring to draw the downlock linkage into the position required to hold the retraction link against its stop, it would reduce the distance by which the drag link was forced 'overcentre'. This solution to the problem of the failure of the gear to 'free-fall' into the locked position is not proposed in the AMM. Moreover, neither the normal adjustment instructions nor the 'Troubleshooting' table in the AMM appear to give any guidance on what to do in this eventuality.

Schematic diagram of locking linkage showing effect of free play in Downlock Link on restraint at pivot 'C'
