**ACCIDENT**

<b>Aircraft Type and Registration:</b>	British Aerospace Jetstream 41, G-MAJD	
<b>No &amp; Type of Engines:</b>	2	Garrett Airesearch TPE 331-14GR-807H turboprop engines
<b>Year of Manufacture:</b>	1992	
<b>Date &amp; Time (UTC):</b>	4 February 2011 at 1921 hrs	
<b>Location:</b>	Leeds/Bradford Airport	
<b>Type of Flight:</b>	Commercial Air Transport (passenger)	
<b>Persons on Board:</b>	Crew - 3	Passengers - 5
<b>Injuries:</b>	Crew - None	Passengers - None
<b>Nature of Damage:</b>	Left main landing gear outboard trunnion pin fractured	
<b>Commander's Licence:</b>	Airline Transport Pilot's Licence	
<b>Commander's Age:</b>	48 years	
<b>Commander's Flying Experience:</b>	5,237 hours (of which 3,530 were on type) Last 90 days - 121 hours Last 28 days - 46 hours	
<b>Information Source:</b>	AAIB Field Investigation

**Synopsis**

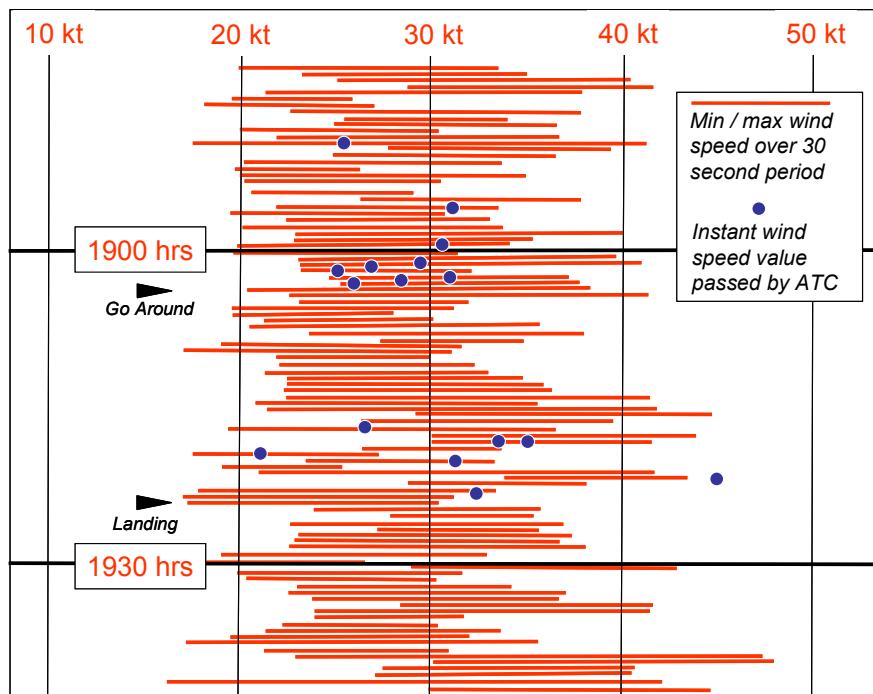
**Figure 1**

In the time period covering the two approaches, the wind direction averaged between 240° and 250° with occasional greater variations between 210° and 270°. The variations became more frequent during the second approach, with a single variation up to 277° recorded at about the time of landing.

Anemometer data, with blue dots indicating time and value of ATC reported wind strength

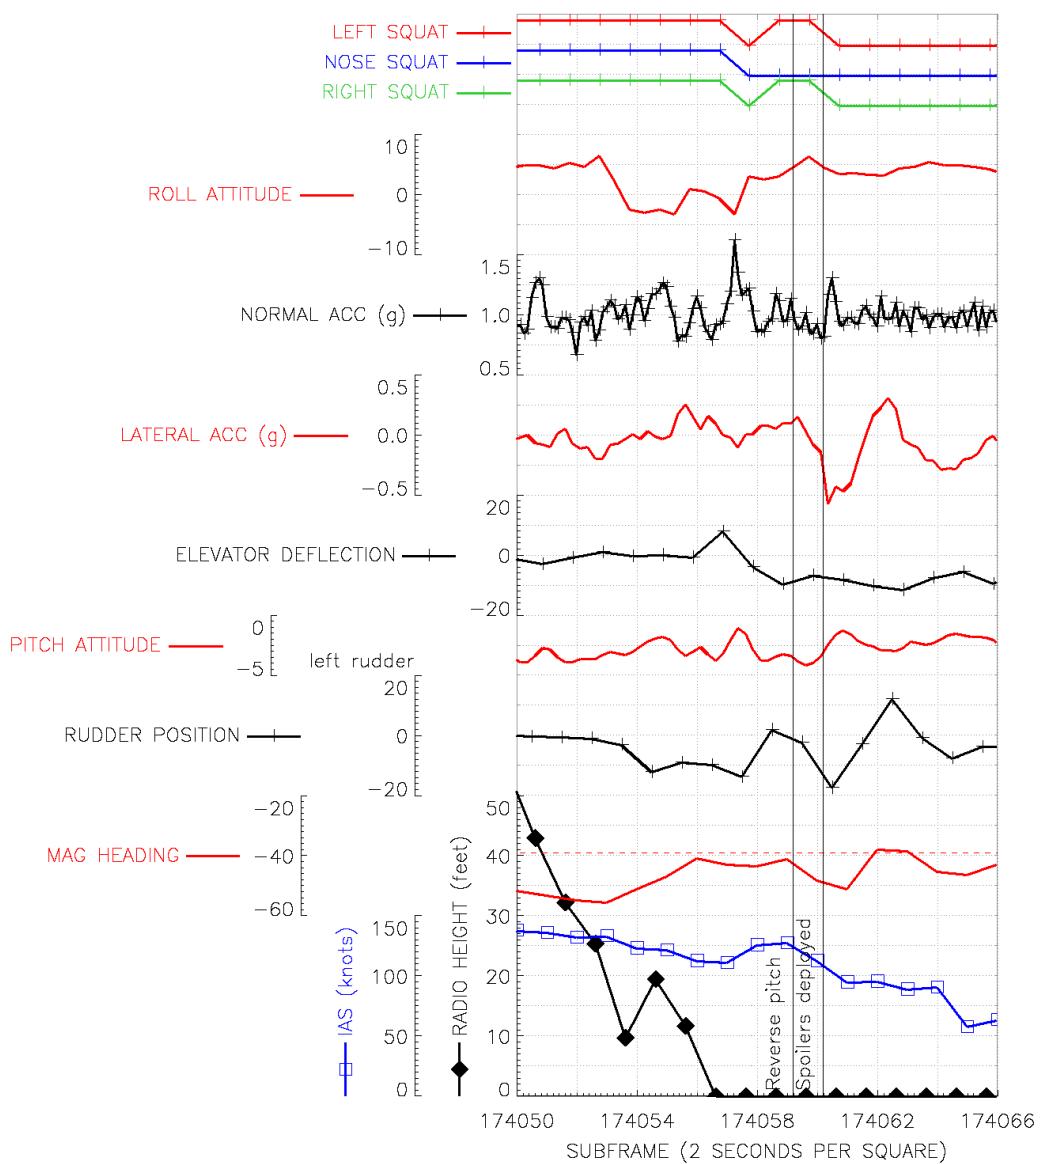
**Figure 2**  
Pertinent FDR data

On the second approach, the drift angle just prior to landing was approximately 15°. This equated to a crosswind component of approximately 34 kt. Figure 2 shows the pertinent parameters on the final landing.

The data registered a small elevator deflection with a small change in pitch attitude but no significant flare. The required recording accuracy of the pitch parameter is only  $\pm 2^\circ$ , however the data showed that the pitch was generally more nose-down than any of the other 46 landings recorded.

Just prior to touch down, the drift was reduced to near zero. All three gear parameters registered as on the ground within the same one second sample period,

associated with a peak recorded normal acceleration of 1.6 g and the aircraft slightly rolled to the left. The subsequent two samples, one second apart, showed that the main gears were no longer sufficiently compressed to register as on the ground, with the nose gear still showing on the ground. The aircraft yawed right before being brought back rapidly left in the same timeframe as the main gear recompressing. This was coincident with the peak recorded lateral acceleration of 0.6 g and a normal acceleration spike of 1.3 g.

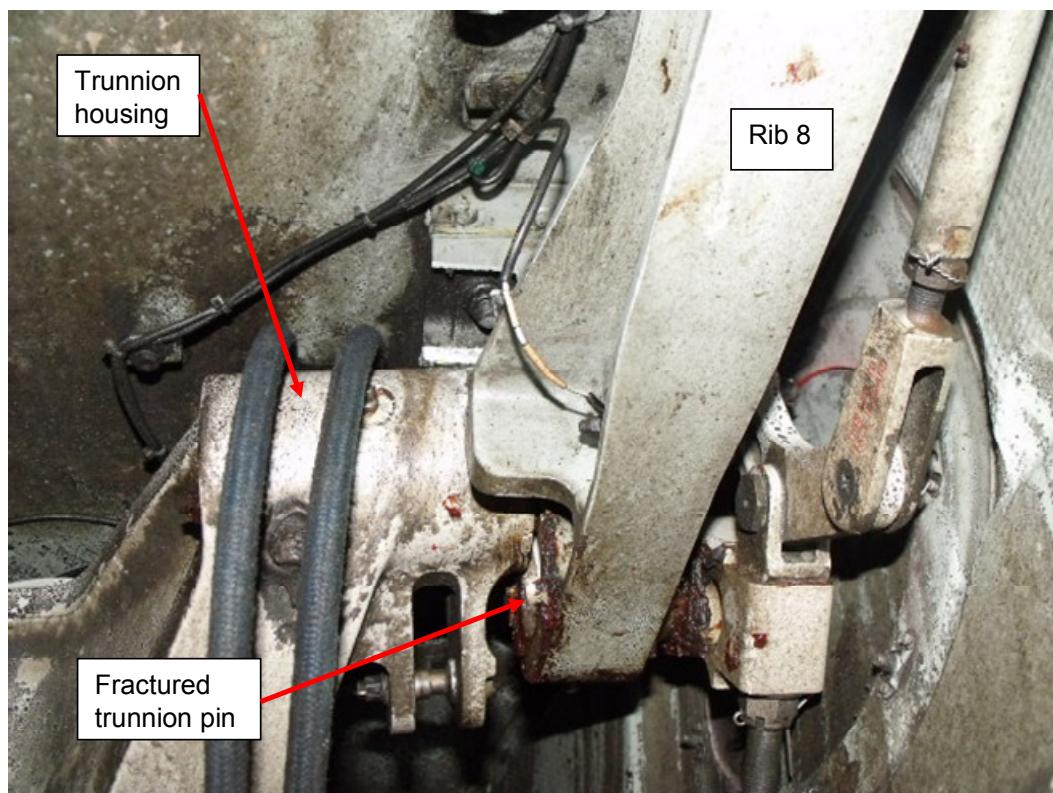
**Figure 3**

The AAIB examination of G-MAJD took place on the night of the accident. The aircraft was parked on the apron and was supported on jacks. It could clearly be seen that the left Main Landing Gear (MLG) was leaning outwards and, when looking into the left MLG bay, it was found that the outboard trunnion pin had broken. The trunnion pin is a fusible link and is designed to fail at a descent rate at touch down of approximately 10 ft/s. The trunnion housing was resting against the outboard rib (Rib 8), which had been damaged but was supporting the MLG leg albeit at a splayed angle (Figure 3). Also apparent was that the MLG doors were open, because the trunnion pin, which is attached to a bellcrank, is part of the door actuating mechanism; with the pin failed, the doors were able to drop down under gravity.

Photograph of left MLG showing fractured trunnion pin and trunnion housing forced up against Rib 8

The fractured pin and the broken Rib 8 were removed and submitted to a metallurgical laboratory to ascertain whether there had been any material defects contributing to the failure and also for information concerning directionality of the fracture ie vertical or lateral loading being involved in the failure. The report from the laboratory showed that the pin had no pre-existing material defects and had failed primarily in overload shear. Starting at the lower surface, a crack propagated rapidly around the pin until full rupture finally occurred with the remaining material bending and fracturing in tension.

After pin failure, the whole MLG leg assembly moved upward, breaking two stiffening webs on Rib 8 before the trunnion housing became wedged against the rib, preventing further upward movement of the outboard trunnion but leaving the whole MLG leg to splay outwards.

The landing had been carried out in strong and gusty crosswind conditions. There were no signs of any pre-existing material defects and that significant lateral loads contributing to the failure. Consideration of the MLG geometry and the direction of the fracture led to the conclusion that the trunnion pin had failed in overload due to purely upward loading on the outboard wheel.
