INCIDENT

Aircraft Type and Registration:	Mystere Falcon 50, G-KPTN	
No & Type of Engines:	3 Allied Signal TFE731-40-1C turbofan engines	
Year of Manufacture:	2004	
Date & Time (UTC):	21 January 2010 at 1617 hrs	
Location:	Approximately 4 nm south-west of London City Airport	
Type of Flight:	Private	
Persons on Board:	Crew - 2	Passengers - None
Injuries:	Crew - None	Passengers - N/A
Nature of Damage:	None	
Commander's Licence:	Airline Transport Pilot's Licence	
Commander's Age:	61 years	
Commander's Flying Experience:	12,000 hours (of which 7,000 were on type) Last 90 days - 23 hours Last 28 days - 12 hours	
Information Source:	Aircraft Accident Report Form submitted by the pilot and subsequent enquiries made by the AAIB

Synopsis

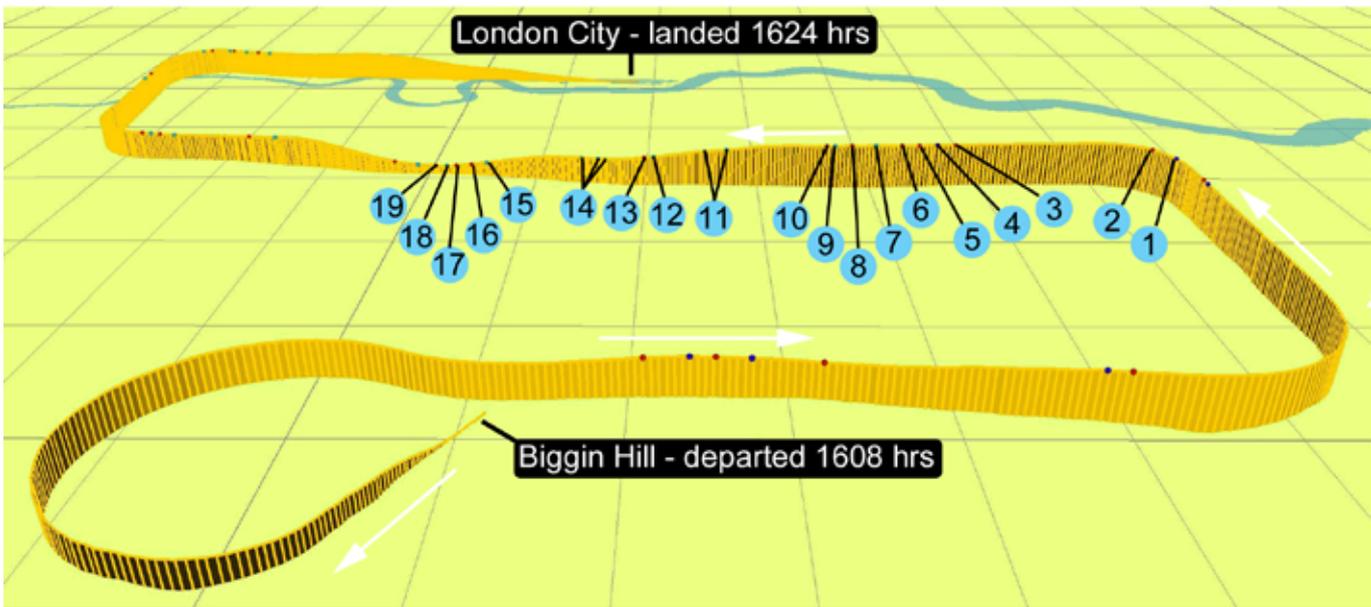
Figure 1

- 1 TR: "...CONTACT CITY RADAR ONE TWO EIGHT DECIMAL ZERO TWO FIVE" Correctly read back frequency
- 2 AC: "...ONE TWO EIGHT ZERO TWO FIVE..."
- 3 AC: "ER SAY AGAIN THE THE TOWER CITY FREQUENCY PLEASE..."

- 4 TR: "...CITY RADAR ONE TWO EIGHT DECIMAL ZERO TWO FIVE" Did not tune the read back frequency. Expected City Tower frequency
- 5 AC: "ZERO TWO FIVE SORRY SIR"

- 6 AC: "CITY GOOD AFTERNOON..."
- 7 CR: "...DESCEND NOW ALTITUDE TWO THOUSAND FEET TURN RIGHT FIVE DEGREES REPORT THAT HEADING"
- 8 AC: "TO THE RIGHT FIVE DEGREES ER TWO SEVEN FIVE CONFIRM DESCENT TWO THOUSAND"

- 9 CR: "THAT IS CORRECT ..."
- 10 AC: "DESCENDING TWO THOUSAND..." Correctly read back the last cleared altitude of 2,000 ft
- 11 City Radar gave another aircraft a heading change to establish on the localizer and instructions to descend with the glidepath when established. This was acknowledged by that aircraft.

- 12 CR: "...TURN RIGHT HEADING TWO EIGHT ZERO DEGREES"
- 13 AC: "TWO EIGHT ZERO..."
- 14 The other aircraft reported established on the glideslope. The aircraft was instructed to descend with the glideslope and contact City Tower.

- 15 CR: "...CLIMB CLIMB ALTITUDE TWO THOUSAND FEET INDICATING ONE THOUSAND ONE HUNDRED"
- 16 AC: "COPY CLIMBING..." Approach / landing terminology
- 17 AC: "...WE GO AROUND. CONFIRM"

- 18 CR: "...CLIMB TWO THOUSAND FEET NOW"
- 19 AC: "CLIMBING NOW TWO THOUSAND FEET..."

Overview of the flight

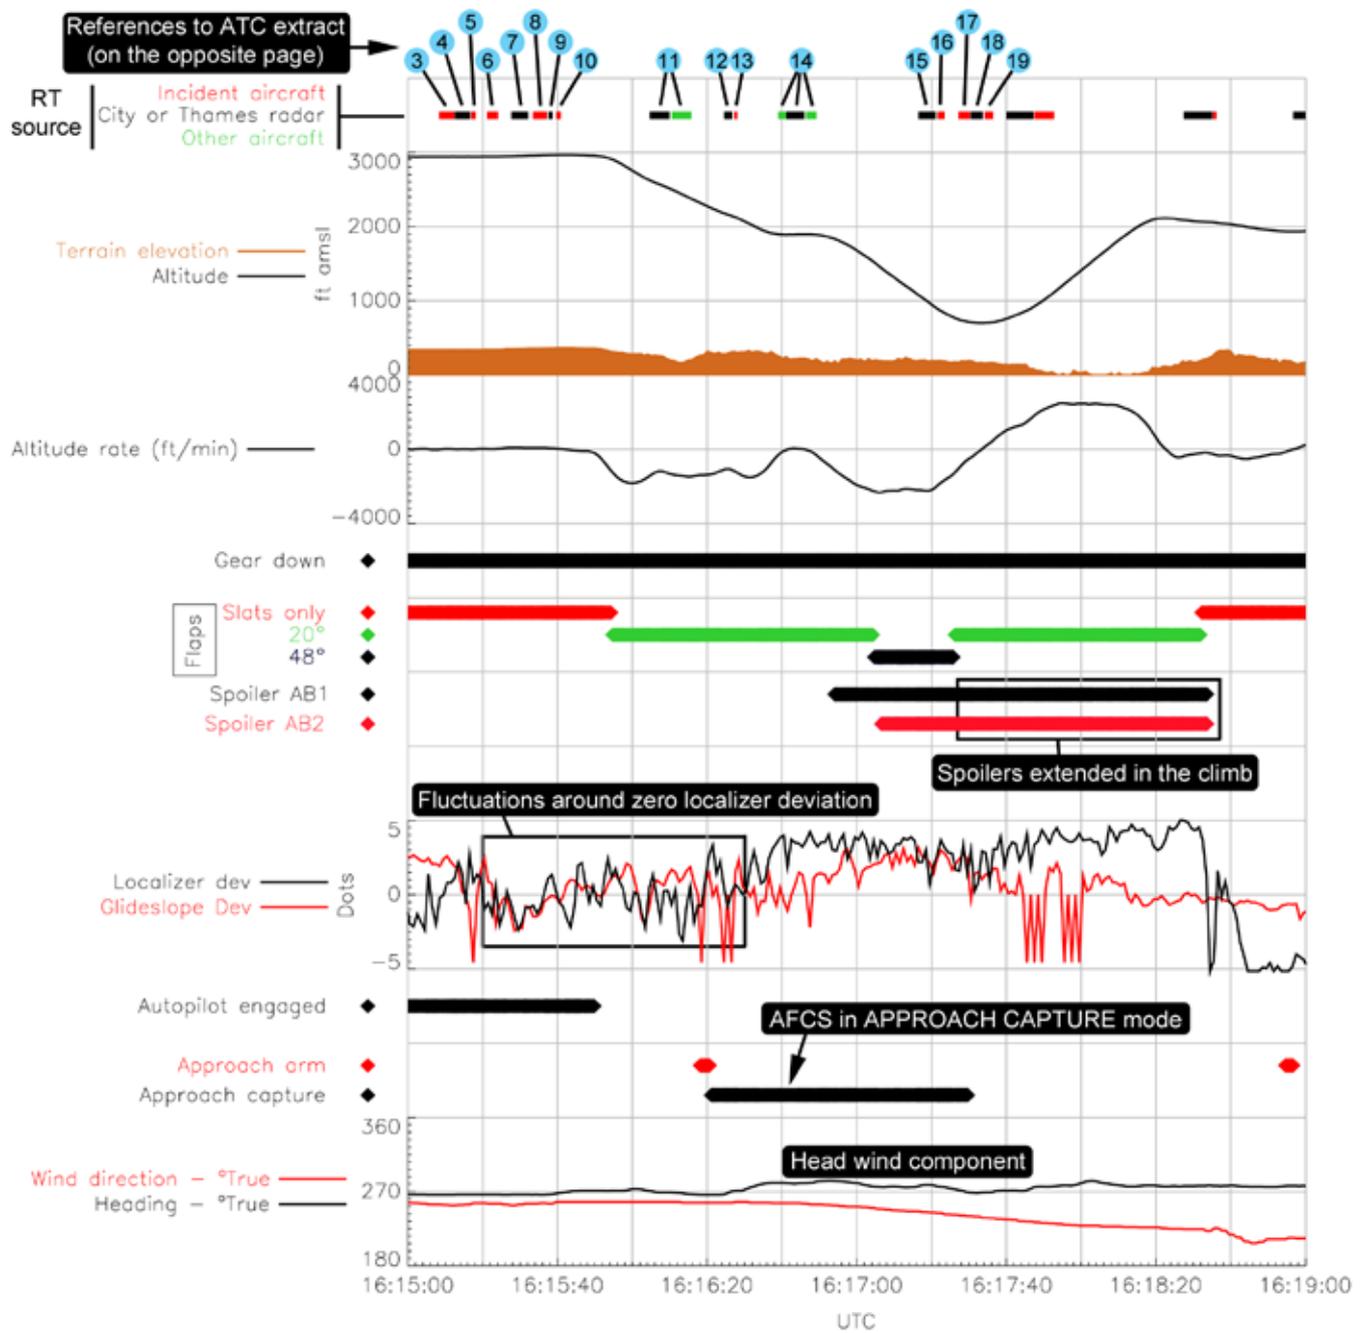
The spoilers and full flap were both deployed. A steady descent rate of approximately 2,200 ft/min was established until, on passing 1,100 ft amsl (approximately 900 ft agl), ATC instructed the aircraft to climb. The descent rate was reduced quickly, the aircraft descending approximately 250 ft before achieving a climb. The aircraft was now approximately 4 nm south-west of the runway on a downwind leg.

During the climb back to the cleared altitude Flap 20 was reset but the spoilers and landing gear remained deployed, contrary to the published go-around procedure. The aircraft regained the cleared altitude and landed on Runway 09 without further incident at 1624 hrs.

Figure 2
Descent below cleared altitude
