No: 9/90

Ref: EW/C1166

**Aircraft Type and Registration:** Lockheed L-1011-385-1 Tristar, N31019

**Nature of Damage:** Damage to bleed air ducting, insulation and cabin furnishings

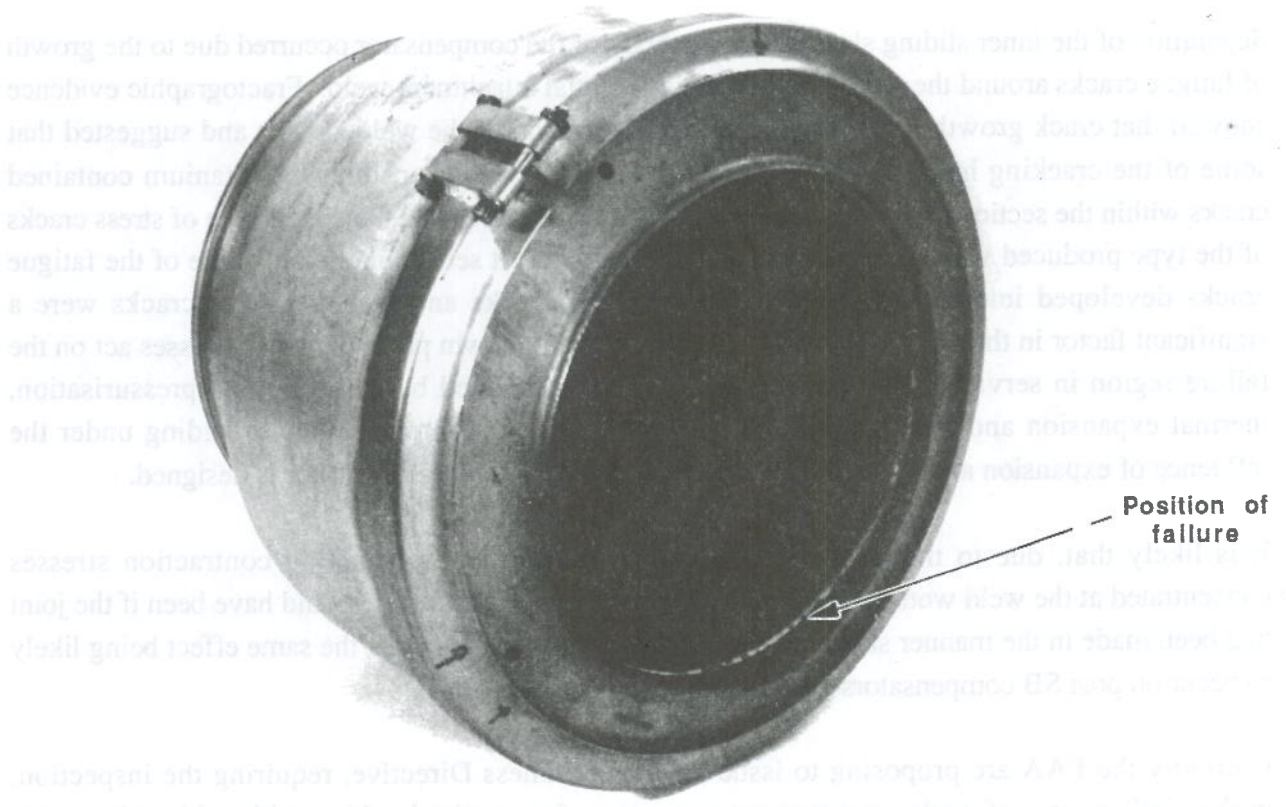
**Fig 1** **Compensator body**

The two sections of the failed compensator were taken to the Materials Dept of the Royal Aerospace Establishment at Farnborough where a detailed examination of the fracture surfaces was carried out. The compensator body is shown in Fig 1 with the position of the circumferential fracture arrowed. The barrel assembly, Fig 2, of which the flange was an integral part, extended into the body and acted as the inner part of a sliding seal and, before failing, had been attached to the body by the circumferential TIG (Tungsten Inert Gas) weld at the position arrowed. A length of this weld and the associated fracture are shown in detail in Fig 3, while Fig 4 illustrates the position on the body where radial tearing was evident and where it is considered that final fracture took place. This corresponds to a step in the fracture path arrowed in Fig 3. There were two other circumferential resistance welds in the vicinity of the failure, as can be seen in Fig 3, and it was evident that the local construction was quite complex.

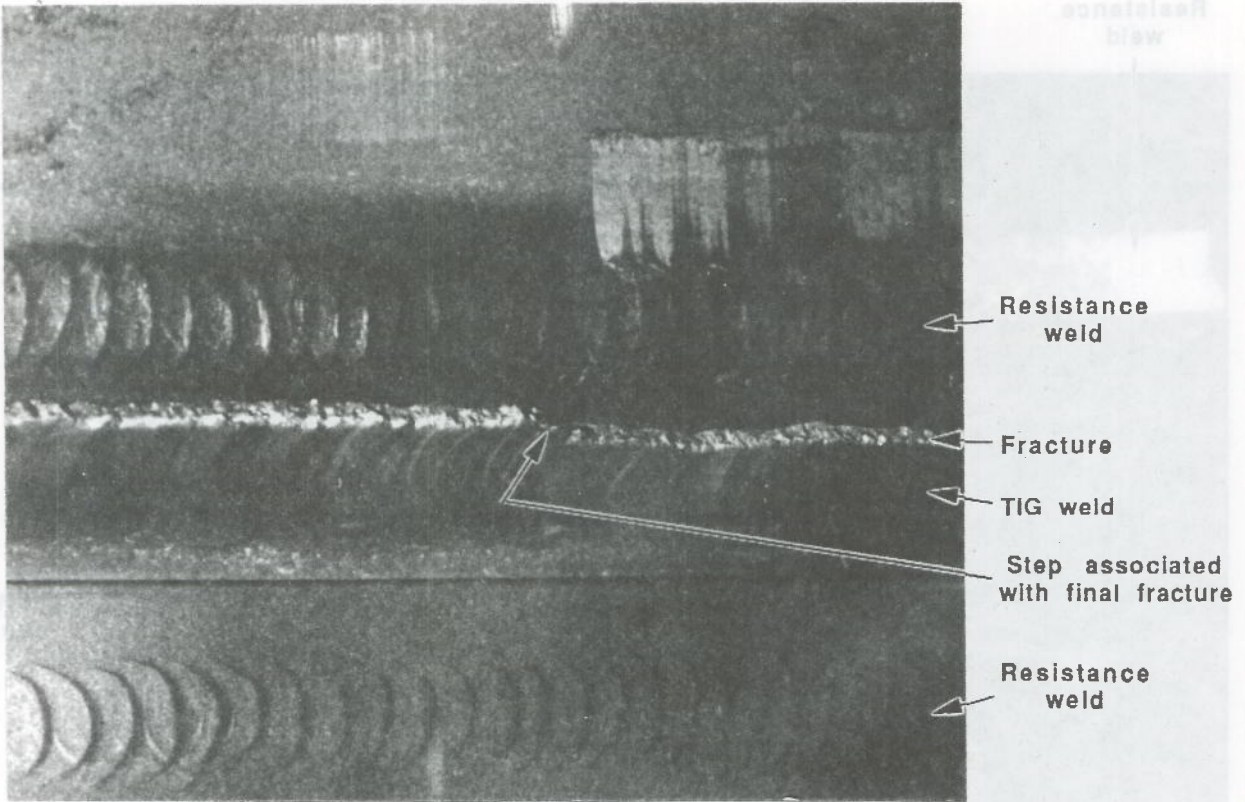
The fracture, when viewed at low magnification, was very faceted along the whole of its length and appeared to contain a lot of cleavage-type rupture, with little evidence of ductility. Apart from the short length over which final failure occurred there was no distortion of the fracture around the inner sliding member and no other evidence that overstressing had been involved in the separation.

**Fig 3** Detail of fracture associated with circumferential weld around inner sleeve

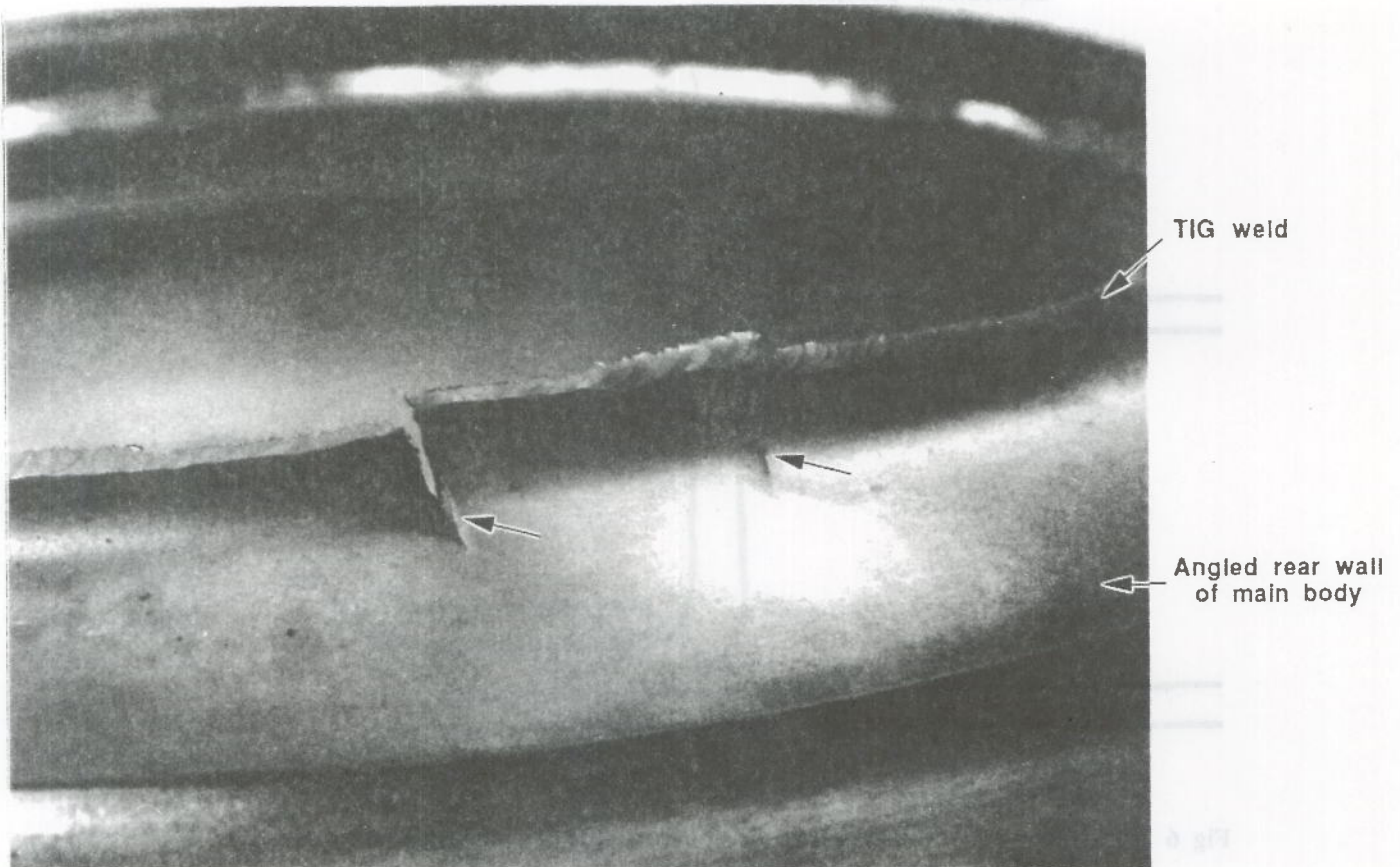
**Fig 4** Radial tearing associated with final fracture

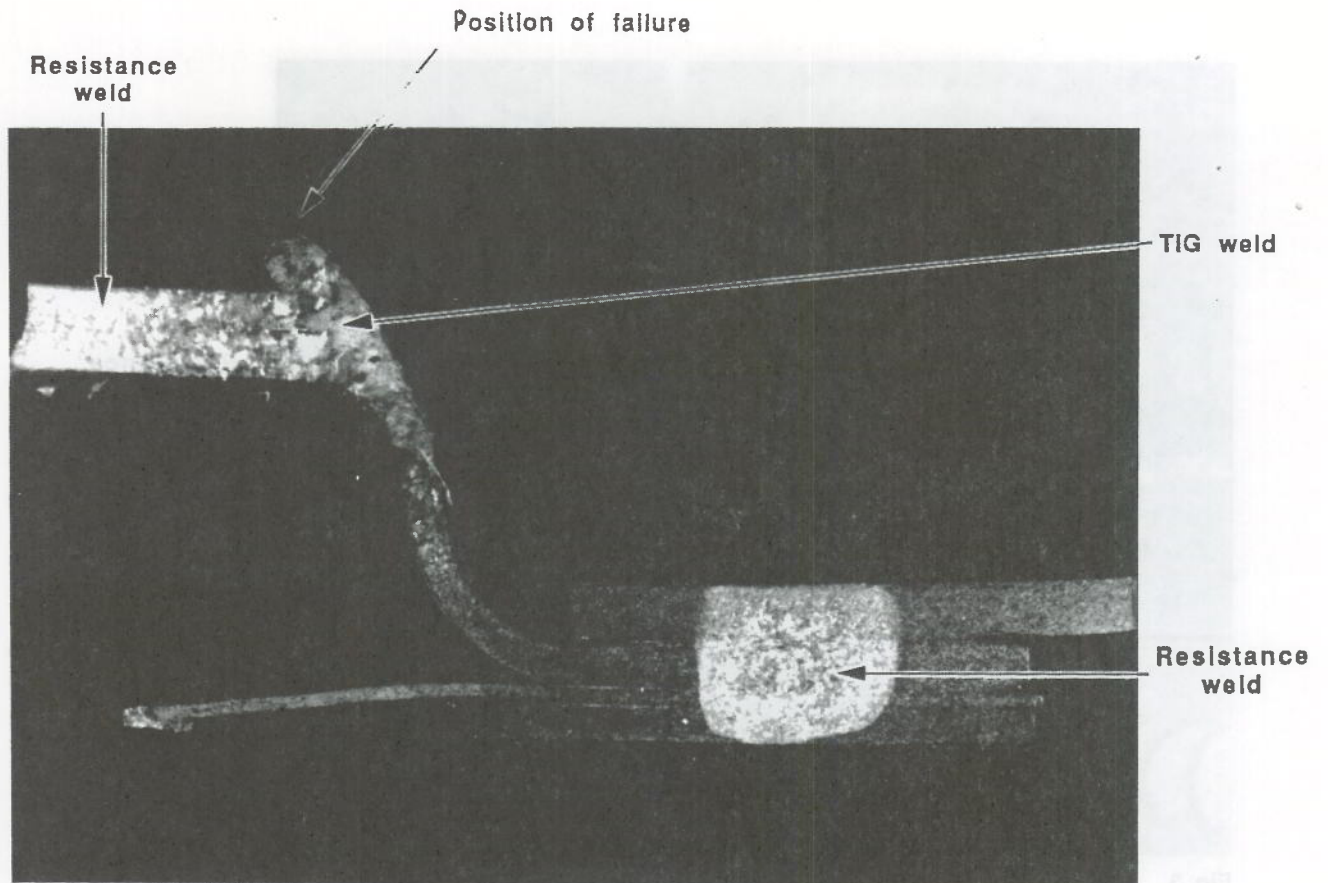
A section, parallel to the longitudinal axis of the duct, was cut through the fracture and the adjacent welds and is shown in Fig 5, to illustrate the mode of construction in that region. The original thickness of the sheet that fractured at the weld, arrowed A, was obtained from this section and found to be 0.75 mm, although clearly it had been thickened by TIG welding at the position of failure.

Comparison of the section shown in Fig 5 with a detail of the local construction taken from Welding Procedure Drawing No 250 (part of the SB) for the compensator, Fig 6, indicated that the configuration of the particular joint of the compensator that had failed was not in accordance with the design shown in the SB or assembly drawing. These drawings showed that the failed part of the assembly should have been bent from a slope of  $60^\circ$  to run parallel to the longitudinal axis adjacent to the weld. However, in the section, it is evident that it actually met the attachment at  $60^\circ$ .

It is likely that, due to the configuration of the failed joint, the cooling contraction stresses concentrated at the weld would have been significantly higher than they would have been if the joint had been made in the manner shown in the welding procedure drawing, the same effect being likely to occur on post SB compensators of the same joint configuration

Fig 5 Longitudinal section through structure in region of fracture A X6

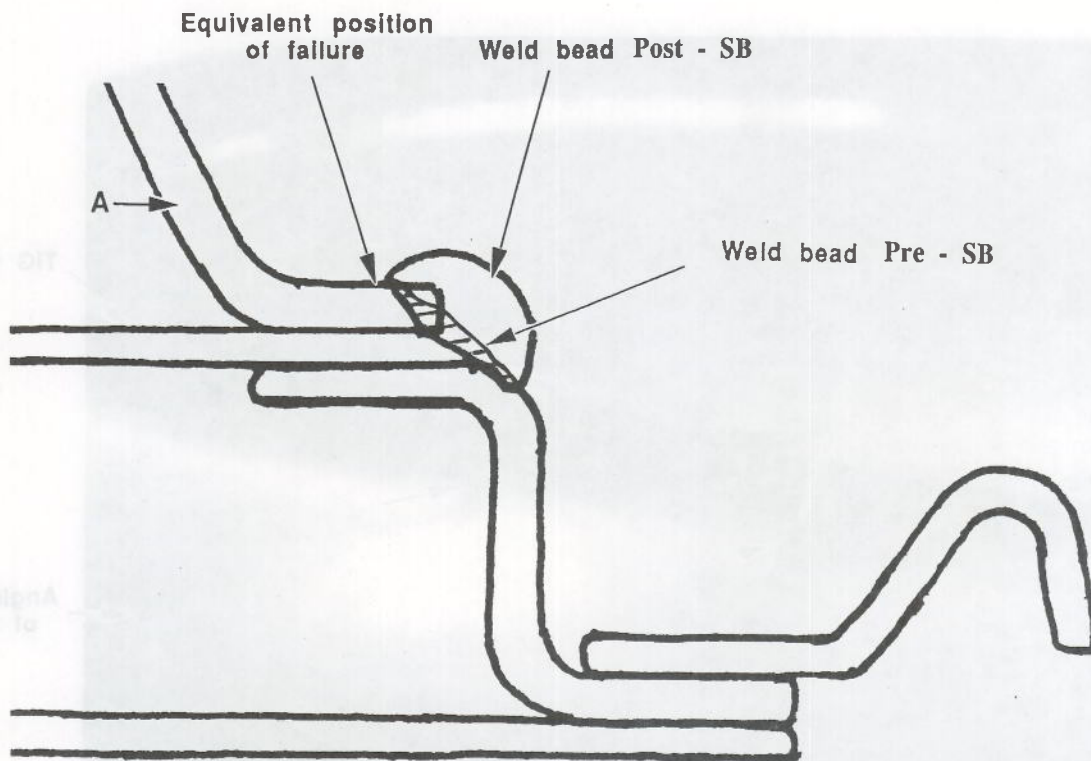
Fig 6 Detail from welding procedure drawing

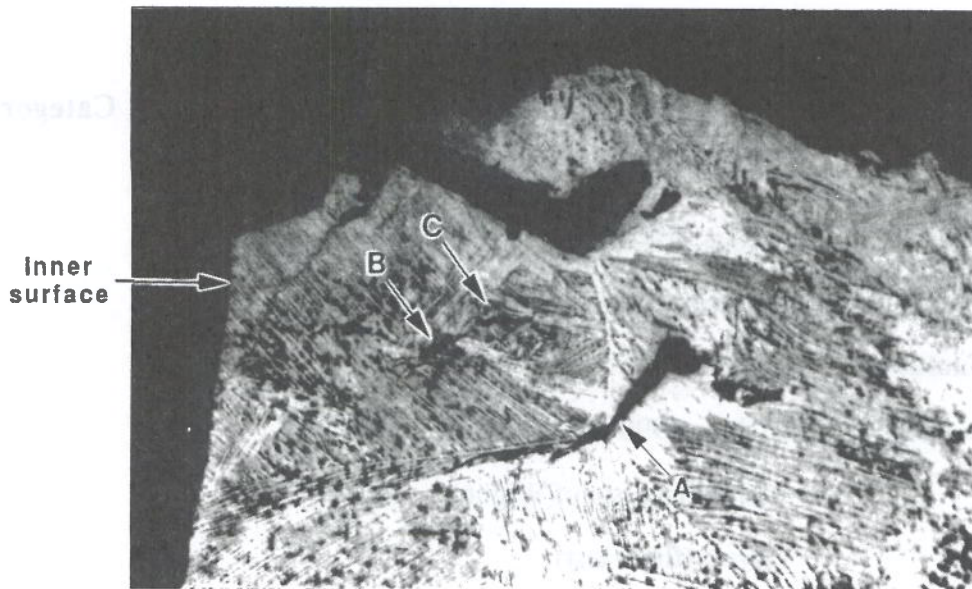
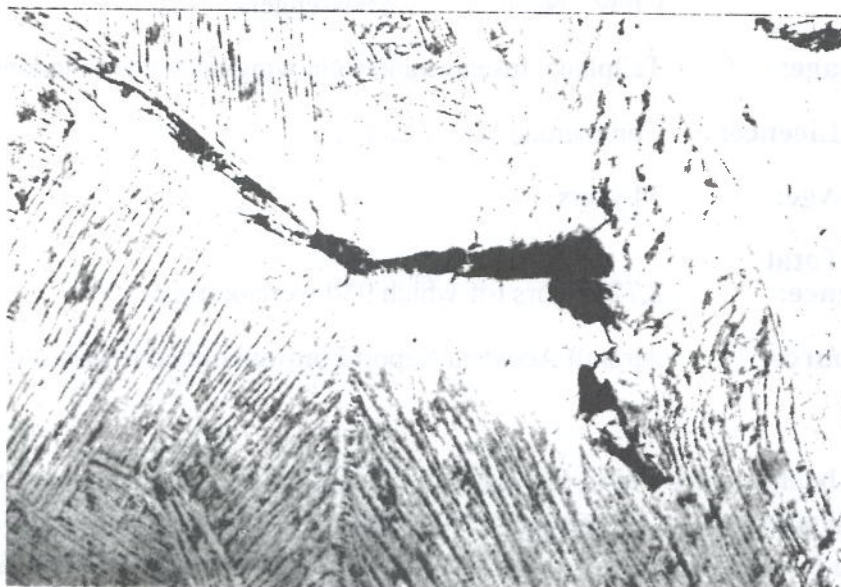
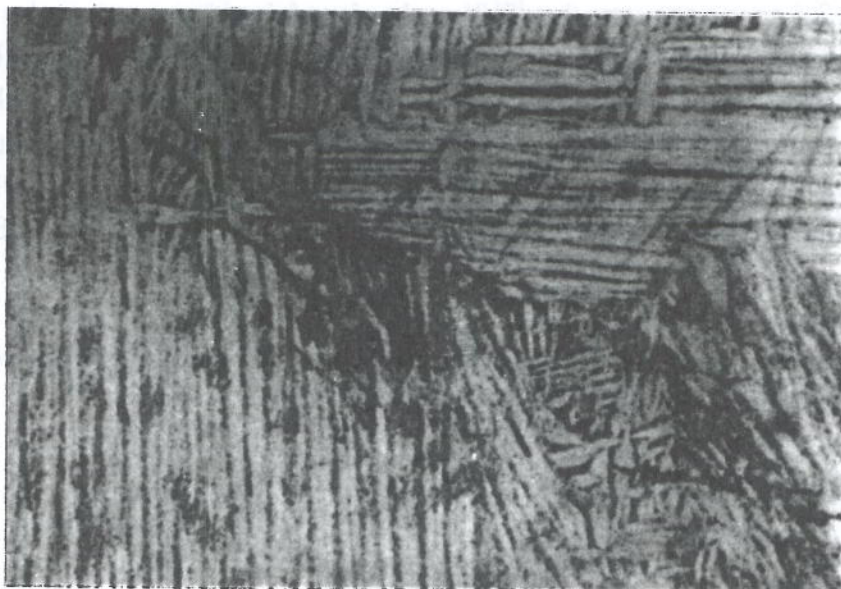
Fig 7

The heat affected zone of the TIG weld extended for a considerable distance either side of the actual joint, as indicated by the presence of coarse grained microstructure in that region. This accounted for the faceted appearance of the fracture and indicated that excessive heating had occurred during welding. At high magnification it was evident that the section immediately adjacent to the weld contained several internal cracks, which are shown in detail in Fig 7. The position and general appearance of these cracks was not consistent with fatigue but suggested instead a condition of stress cracking that can occur in the region of a weld during cooling.

Separation of the inner sliding sleeve from the body of the compensator occurred due to the growth of fatigue cracks around the whole of the circumferential attachment weld. Fractographic evidence showed that crack growth had taken place from the inside of the welded joint and suggested that some of the cracking had initiated at the inner surface. However, the sheet titanium contained cracks within the section adjacent to the fracture and these cracks had the appearance of stress cracks of the type produced when a weld cools under constraint. It seems likely that some of the fatigue cracks developed internally from these pre-existing cracks and that the stress cracks were a significant factor in the fatigue failure. Although it is not known precisely what stresses act on the failure region in service, it is assumed that they are generated by the effects of pressurisation, thermal expansion and contraction, and by resistance of the internal seals to sliding under the influence of expansion and contraction of the duct, for which the compensator is designed.

Examples of internal cracks adjacent to fatigue fracture

Detail of crack A

Detail of multiple cracks at B

Currently the FAA are proposing to issue an Airworthiness Directive, requiring the inspection, within 300 hours, of early standard compensators for cracks in this weld, with subsequent inspections every 150 hours, up to a maximum of 1800 hours from the implementation date of the AD. After that time it is proposed that later standard compensators must be fitted. The airline concerned have stated that by 27 June 1990 only compensators that are in compliance with the SB will be installed in the aft duct location on their aircraft.
