## ACCIDENT

<b>Aircraft Type and Registration:</b>	Piper PA-28-181 Cherokee Archer II, G-BTAM	
<b>No &amp; Type of Engines:</b>	1 Lycoming O-360-A4M piston engine	
<b>Year of Manufacture:</b>	1988	
<b>Date &amp; Time (UTC):</b>	24 August 2010 at 0615 hrs	
<b>Location:</b>	Isle of Man (Ronaldsway) Airport	
<b>Type of Flight:</b>	Private	
<b>Persons on Board:</b>	Crew - 1	Passengers - None
<b>Injuries:</b>	Crew - None	Passengers - N/A
<b>Nature of Damage:</b>	Aileron control rod failure	
<b>Commander's Licence:</b>	Private Pilot's Licence	
<b>Commander's Age:</b>	50 years	
<b>Commander's Flying Experience:</b>	3,538 hours (of which 2,500 were on type) Last 90 days - 101 hours Last 28 days - 34 hours	
<b>Information Source:</b>	AAIB Field Investigation

## Synopsis

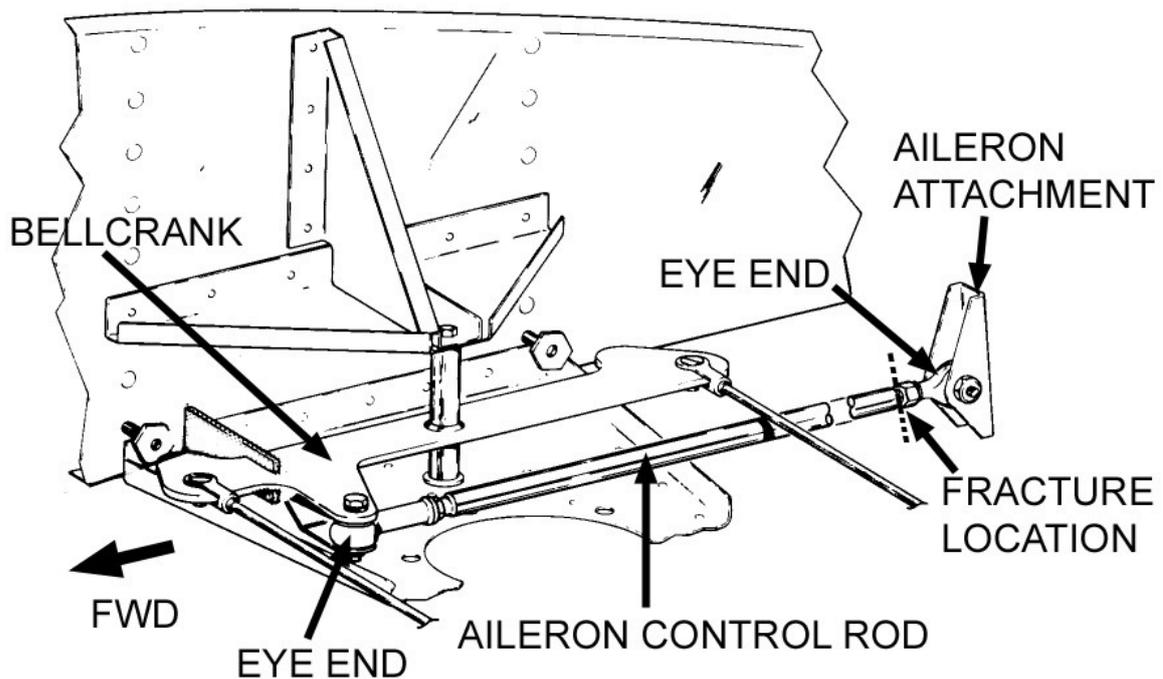
**Figure 1**

Each aileron on the Piper PA-28-181 is operated by the control wheels through a series of cables and pulleys which connect to a bellcrank in the outer wing. A control rod connects this bellcrank to the aileron, with an eye end at the bellcrank and one at the aileron attachment (Figure 1). After G-BTAM landed it was discovered that the right aileron control rod had failed at the threaded shank of the eye end at the connection to the aileron (Figures 1 and 2). Metallurgical examination revealed that the threaded shank of the eye end had failed in bending due to fatigue and that the ball inside the

Location of aileron control rod and fractured eye end
