ACCIDENT

Aircraft Type and Registration:	Rockwell Commander AC11, N115TB	
No & Type of Engines:	1 Lycoming TI0 540 AG/A piston engine	
Year of Manufacture:	2000	
Date & Time (UTC):	31 January 2006 at 1640 hrs	
Location:	Oxford Airport, Oxfordshire	
Type of Flight:	Private	
Persons on Board:	Crew - 2	Passengers - None
Injuries:	Crew - None	Passengers - N/A
Nature of Damage:	Damage to propeller, nose landing gear doors and nose landing gear actuator	
Commander's Licence:	Private Pilot's Licence (FAA)	
Commander's Age:	53 years	
Commander's Flying Experience:	485 hours (of which 310 were on type) Last 90 days - 8 hours Last 28 days - 1 hour	
Information Source:	Aircraft Accident Report Form submitted by the pilot, AAIB examination and enquiries

Synopsis

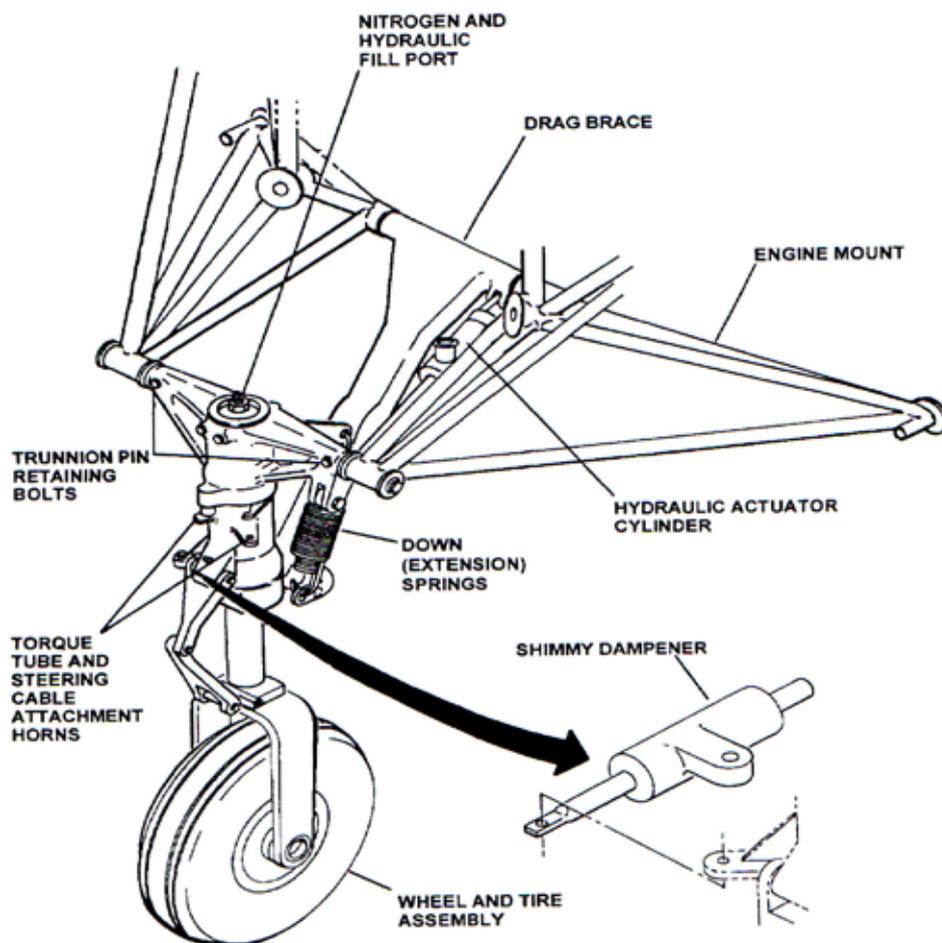
Figure 1
Nose landing gear assembly

When the aircraft's nose was lifted during recovery it was noted that during the ground roll the nose landing gear had been pushed toward the retracted position. The extension of the nose landing gear actuator shaft confirmed that the nose gear had not been fully extended when the aircraft contacted the runway. The pin attaching the nose gear actuator to the nose leg was removed following which the leg fell unhindered and unaided into the down and locked position. A thorough search was carried out from the aircraft touchdown point to the area where it came to rest; no items which could have fallen from the aircraft and which may have interfered with the nose landing gear mechanism were identified.

The aircraft was towed to the maintenance facility for a further examination by the maintenance organisation. A thorough examination of the nose landing gear revealed no witness marks to indicate that full extension may have been inhibited by a foreign object. There were some blue paint marks from the nose gear doors on the leg itself. The hydraulic pump reservoir was noted to be full. The damaged actuator was removed and a pressure test of the system carried out; this was within limits, although the hydraulic pack was only tested for a short period of time. The nose gear actuator was disassembled; fluid on the shaft side of the piston was found to contain a piece of metallic debris, which was probably a crushed drilled out rivet head. This debris was not considered to be of a sufficient size to restrict the flow of fluid from the actuator. There were no signs of scoring on the inner surface of the cylinder to indicate that the debris had been trapped between the piston and the cylinder wall.

Subsequent examination of the nose landing gear microswitch showed that one attachment screw nut was missing and it was loose on its mounting. It was demonstrated that this could prevent the nose gear down and locked indicator light from illuminating; however, this was an intermittent fault. The condition of the screw, with dirt and grease present on the thread, suggested that it had been missing for some time.

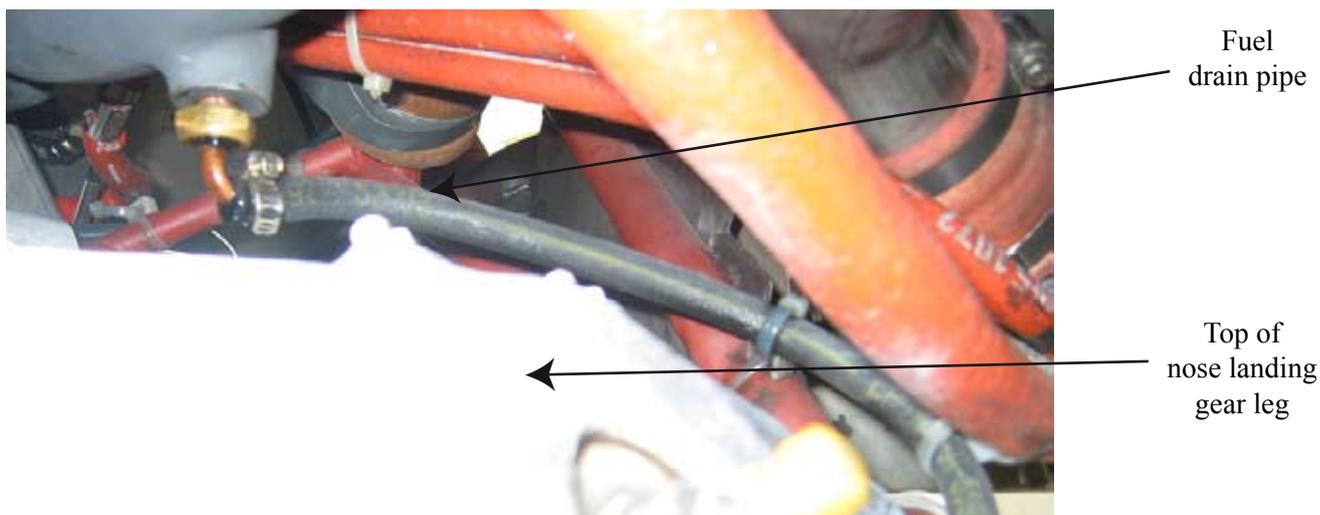
Figure 2

The engine installation included a flexible fuel drain pipe from the induction manifold (Figure 2). This attached to the underside of the engine and was tie-wrapped at various points to route it around the nose landing gear bay. Some tie-wraps were present and their condition indicated that these had not been disturbed during the recent maintenance work; however the pipe was loose around the front of the nose leg. It was reported to the AAIB that on another aircraft it was possible to demonstrate that, if this pipe were loose, the nose gear could be jammed, preventing full extension by fouling the down spring lever arm around

Flexible Fuel drain pipe

the fuel drain pipe. During the AAIB examination it was not possible to demonstrate such a jam on the accident aircraft.
