ACCIDENT

Aircraft Type and Registration:	P&M Aviation QuikR, G-DALI	
No & Type of Engines:	1 Rotax 912ULS piston engine	
Year of Manufacture:	2009	
Date & Time (UTC):	18 January 2010 at about 1300 hrs	
Location:	English Channel, approximately 20 nm west of Le Touquet, France	
Type of Flight:	Private	
Persons on Board:	Crew - 1	Passengers - None
Injuries:	Crew - 1 (Fatal)	Passengers - N/A
Nature of Damage:	Aircraft missing	
Commander's Licence:	National Private Pilot's Licence	
Commander's Age:	49 years	
Commander's Flying Experience:	Estimated 700 hours (of which about 500 were on flex-wing microlights)	
Information Source:	AAIB Field Investigation

Synopsis

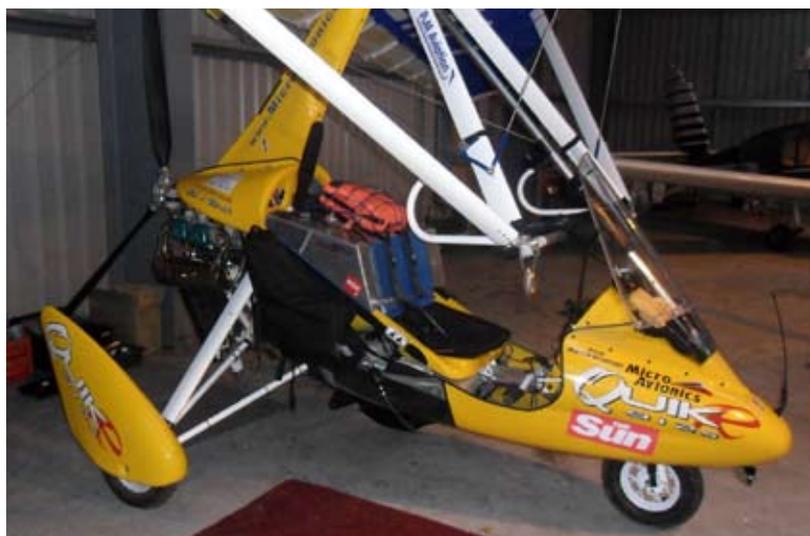
Figure 1

Trike unit of G-DALI, showing auxiliary fuel tank with life-raft secured above

The pilot had obtained a single man life-raft of a type used in military fast jet aircraft. This was stowed behind his head, on top of the additional fuel tank, secured under elastic netting (see Figure 1). He was wearing a life-jacket with manually activated inflation, which was equipped with a flare and a personal location beacon (PLB). He was also wearing a thermal flying suit with thermal undergarments. He had taken a full immersion suit with him but this was packed in his luggage for use later in the journey. When the pilot was found, none of

The pilot was not wearing an immersion suit for the Channel crossing, although he was known to be carrying one with him. Given the time of year and weather conditions, if he had been, his potential survival time following a ditching would have been significantly increased.

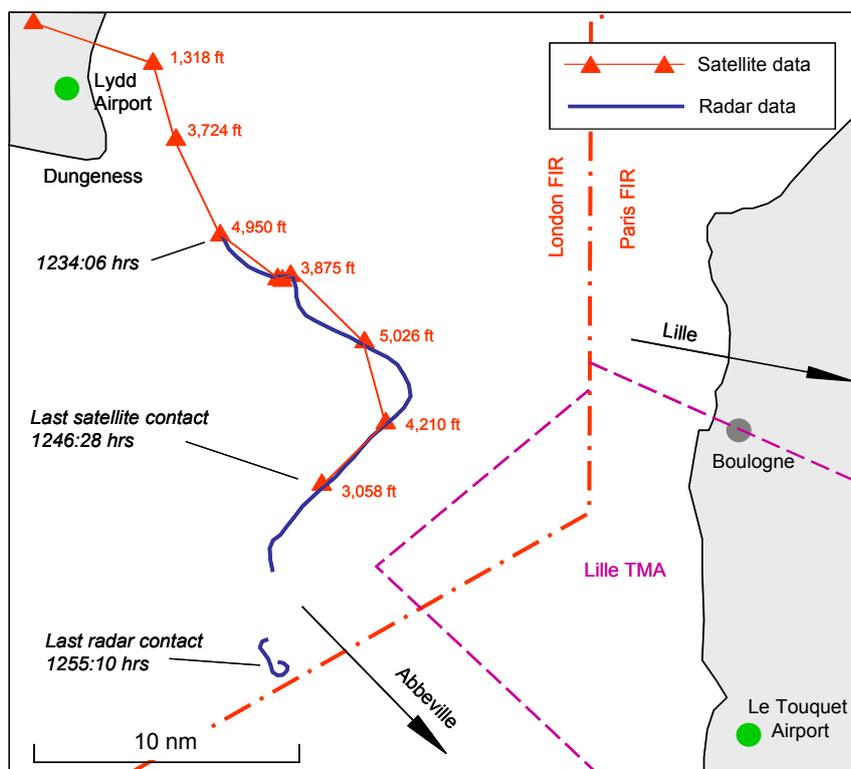
Figure 2 shows a composite picture of the final stages of the flight, using data from French radar and the satellite system. The aircraft was equipped with a transponder but no Mode C altitude information was observed. However, each satellite position included GPS derived altitude information.

Radar track of G-DALI over the English Channel, with GPS derived position and altitude information

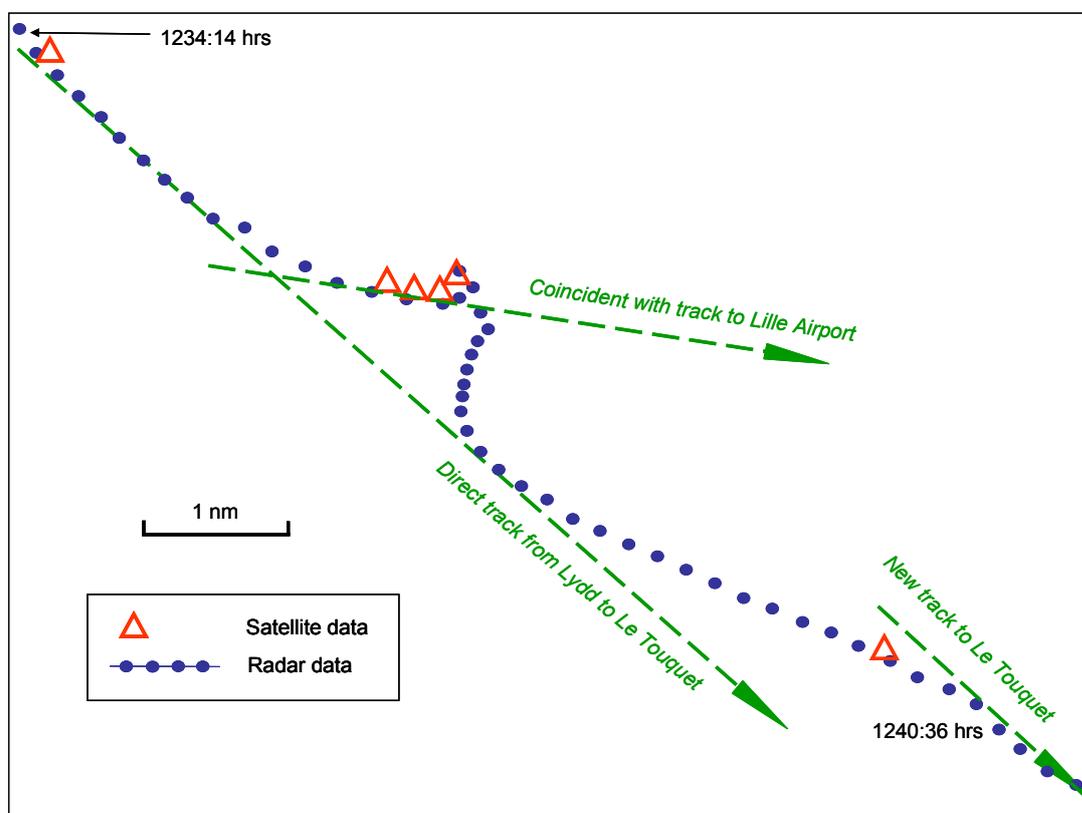
Figure 3 shows G-DALI's track immediately after the aircraft appeared on French radar at 1234:14 hrs, commencing about two minutes after the pilot declared his intention to divert to Abbeville. The aircraft was initially tracking along a direct line between Lydd Airport and Le Touquet Airport (the aircraft had diverted around Lydd itself, establishing on this track once it was over the Channel). At 1235:34 hrs, the aircraft turned left and was established, for a short while, on a track, possibly coincidentally, for Lille Airport.

As Figure 3 shows, there was then a block of radar returns, which saw the aircraft slow down, possibly make a left hand orbit, and eventually take up a southerly track. Coincidental with this event, four unscheduled satellite positions were recorded, consistent with the 'emergency button' having been pushed, with time

After these returns, the aircraft resumed the track from Lydd to Le Touquet, before deviating left of it once again. At 1240:28 hrs, for a period of about one minute, the aircraft stabilised on a new direct track to Le Touquet. The aircraft then turned south-westwards, onto a track approximately parallel with the Lille TMA boundary but some three to four miles north of it. At 1249:36 hrs, the aircraft started a gentle left turn and was tracking about 30° right of the required course for Abbeville when radar contact was lost temporarily.

Track of G-DALI shortly after first appearing on French radar

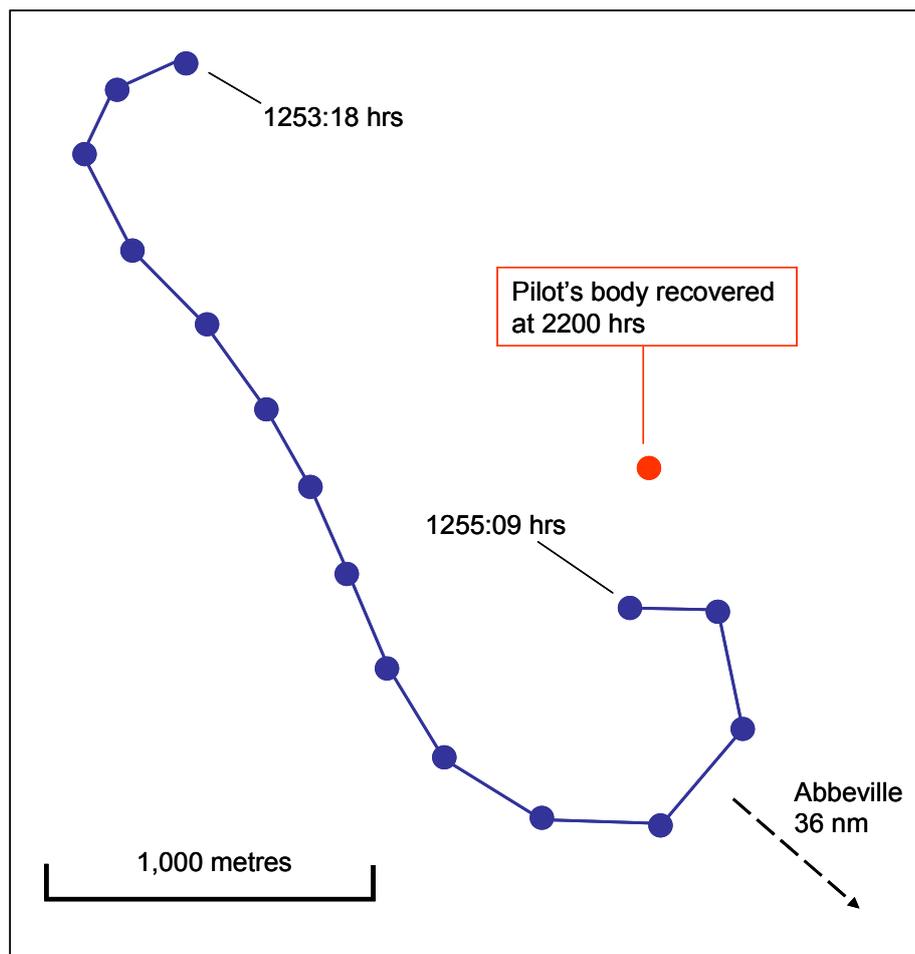
Figure 4 shows the last series of radar returns from G-DALI. Radar contact was regained at 1253:18 hrs, at which point the aircraft appears to have been tracking in a left turn at relatively slow speed, before taking up a track of about 160°(T). The aircraft then made a further turn to the left, during which radar contact was finally lost. The last radar return was timed at 1255:09 hrs.

Final radar returns, with the reported location where the pilot was found

The aircraft reappeared on radar shortly after the pilot told ATC that he was heading towards Abbeville. It was heading not towards Abbeville but in a more westerly direction. The lack of any additional information to ATC at this stage suggests that this manoeuvring was not due to a technical issue. Although the aircraft then took up an approximate course for Abbeville for a short while, the final radar returns show that the pilot had deviated again from his intended track. Based upon tidal calculations and the proximity of the last radar return to the position the pilot was found, the aircraft probably crashed soon after it disappeared from radar.

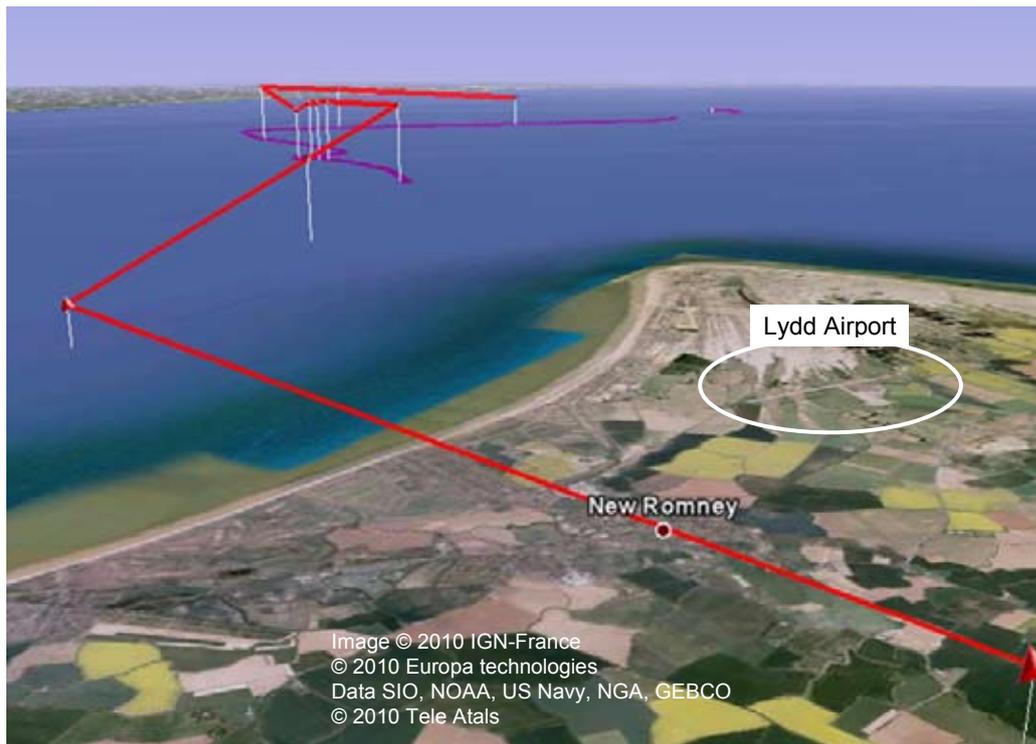
Figure 5

communications with London, reaching a maximum of 5,026 ft. At the last recorded satellite position, the GPS altitude was 3058 ft. An oblique view of the recorded satellite track is at Figure 5.

Oblique projection of aircraft satellite track, showing change in GPS derived altitude (radar ground track shown in purple)

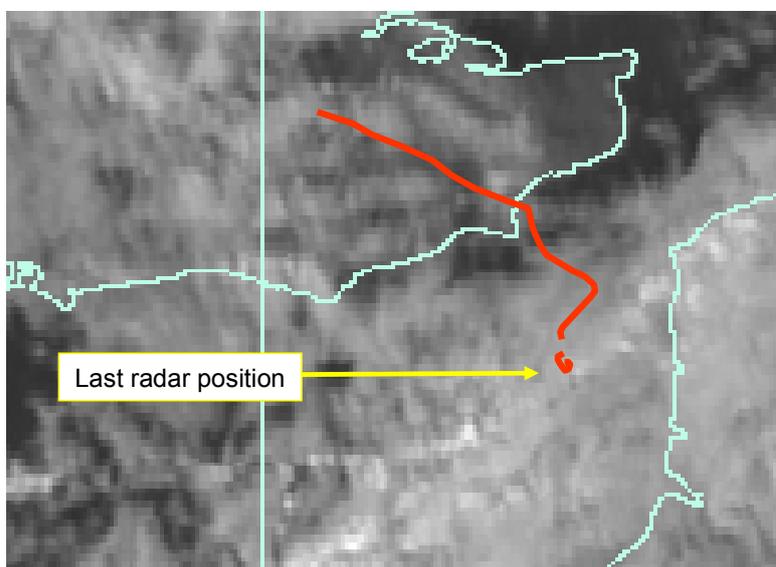
It was noted that the forecast information from the MetForm 215⁵ and the TAFs conformed reasonably well with the actual information summarised above, in terms of weather and visibility. However, whereas Form 215 forecast areas of isolated cumulus and strato-cumulus, the observations and satellite imagery suggested this cloud was more widespread. Part of the satellite image from the report, overlaid with G-DALI's track and final radar position, is reproduced at Figure 6.

High resolution visible satellite image, 1315 hrs
(Crown Copyright [2010] Met Office)

When the aircraft turned south-westwards, it was apparently to avoid the Lille TMA, but the satellite image at Figure 6 suggests that a line of weather could also have been the reason. If continued, this south-westerly track would have taken the aircraft away from potential landing sites. Therefore, the pilot would have been faced with an increasing need to turn left as soon as he was able or, otherwise, to turn right
