INCIDENT

Aircraft Type and Registration:	Falcon 2000, CS-DFE	
No & Type of Engines:	2 CFE 738-1-1B turbofan engines	
Year of Manufacture:	2003	
Date & Time (UTC):	11 November 2009 at 1259 hrs	
Location:	Biggin Hill Airport, Kent	
Type of Flight:	Maintenance	
Persons on Board:	Crew - 3	Passengers - 3
Injuries:	Crew - None	Passengers - None
Nature of Damage:	Fire damage to tyres, fuselage, landing gear and wing	
Commander's Licence:	Airline Transport Pilot's Licence	
Commander's Age:	37 years	
Commander's Flying Experience:	4,152 hours (of which 575 were on type) Last 90 days - 30 hours Last 28 days - 5 hours	
Information Source:	AAIB Field Investigation

Synopsis

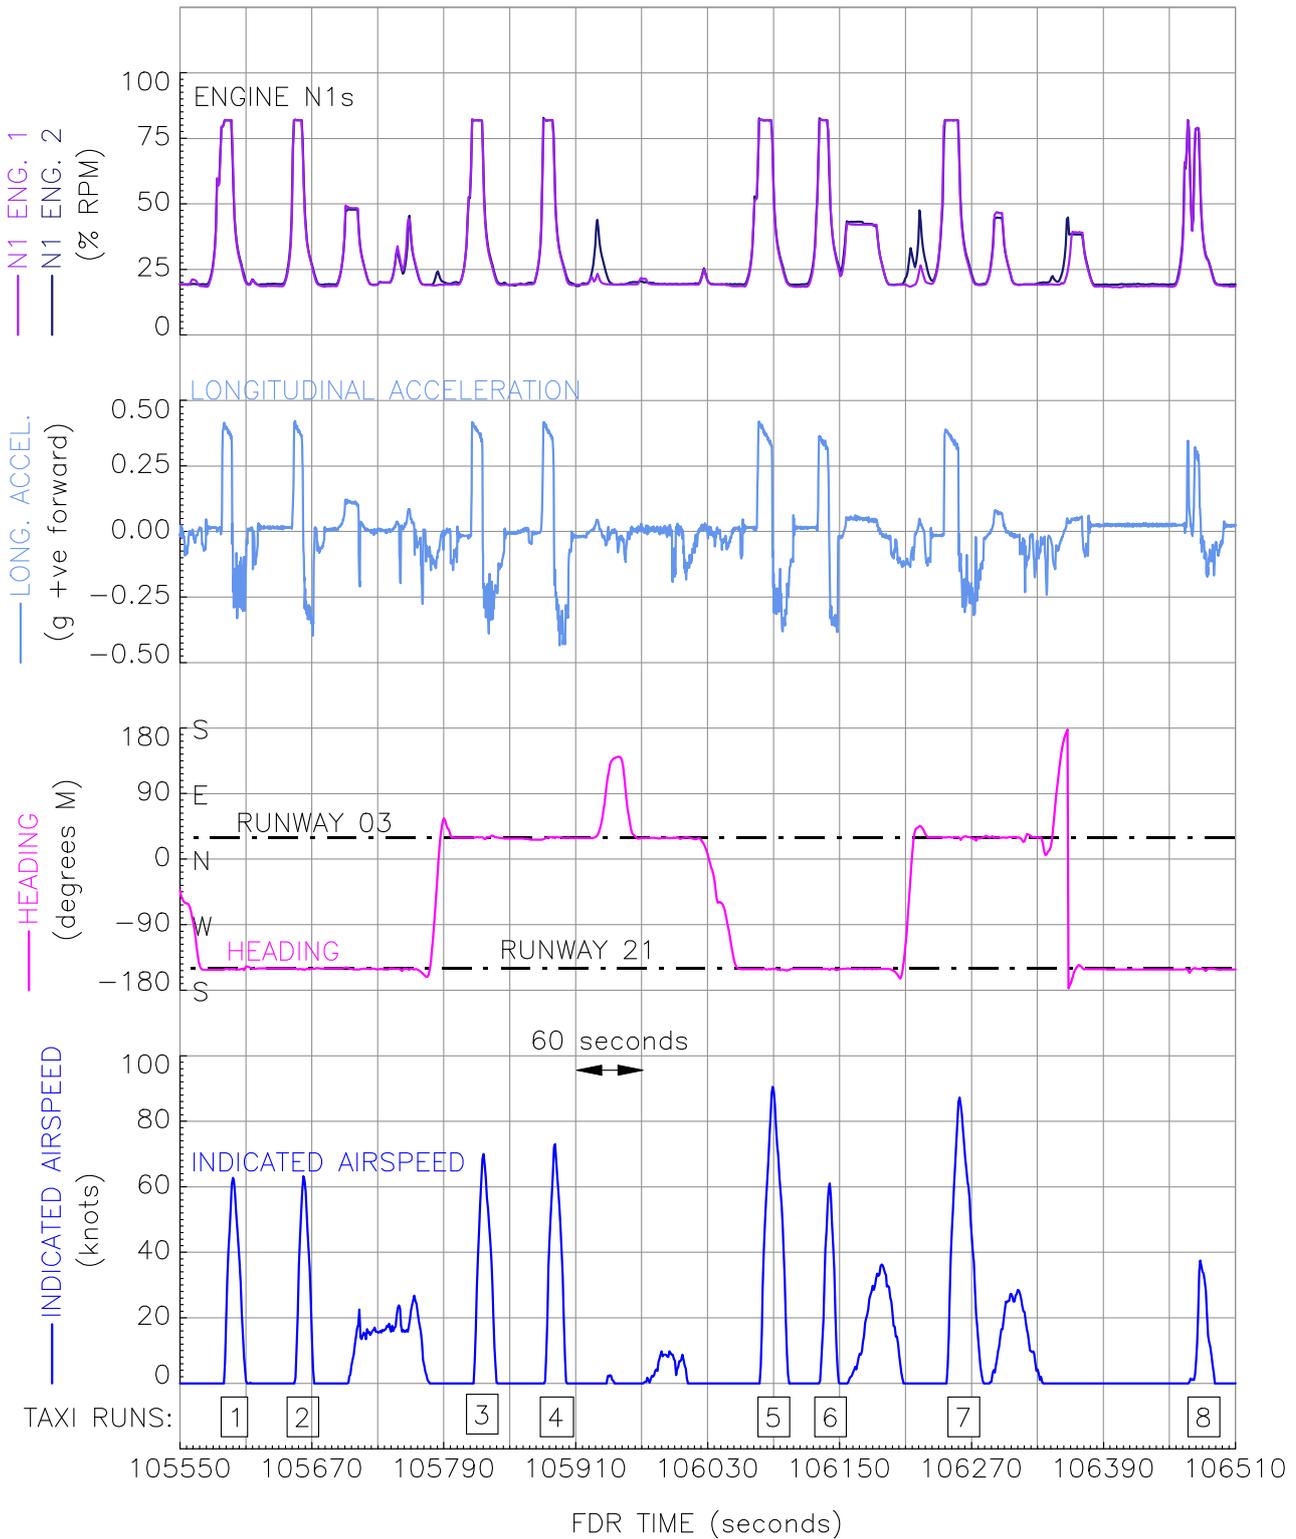
Figure 2
Salient FDR parameters from CS-DFE of high-speed taxi runs

The salient FDR parameters are presented at Figure 2 and show that in total, eight high-speed taxi runs were completed over a period of just under 16 minutes. The first seven runs achieved speeds of between 60 kt and 90 kt. The final run was aborted at just over 35 kt¹ when

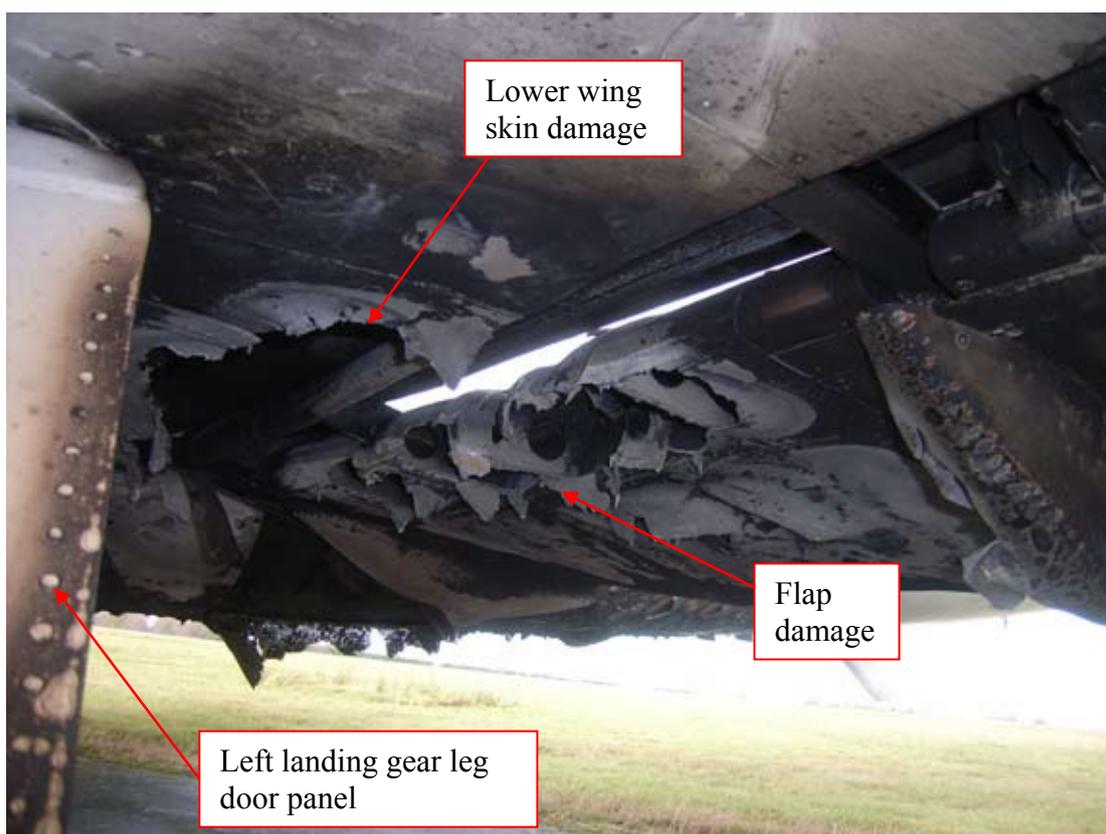
Figure 4

An initial inspection of the aircraft was carried out on the taxiway which confirmed severe fire damage. A significant section of the lower skin of the left wing, rear of the landing gear bay, was burnt away, as was the

lower skin of the adjacent flap, which had been partially deployed at the time (Figure 4). The landing gear bay within the wing was heavily sooted with extensive heat damage evident to the upper wing skin and the electrical wiring looms running along the rear of the wing. The fuselage panels adjacent to the left MLG bay were severely heat damaged and the whole of the fuselage, rear of the wings, was heavily sooted. The number two hydraulic system reservoir level indicator showed that the system contained no hydraulic fluid; the number one hydraulic system reservoir was indicating just over half full. There was no evidence of fire around the right MLG.

Lower wing skin and flap fire damage

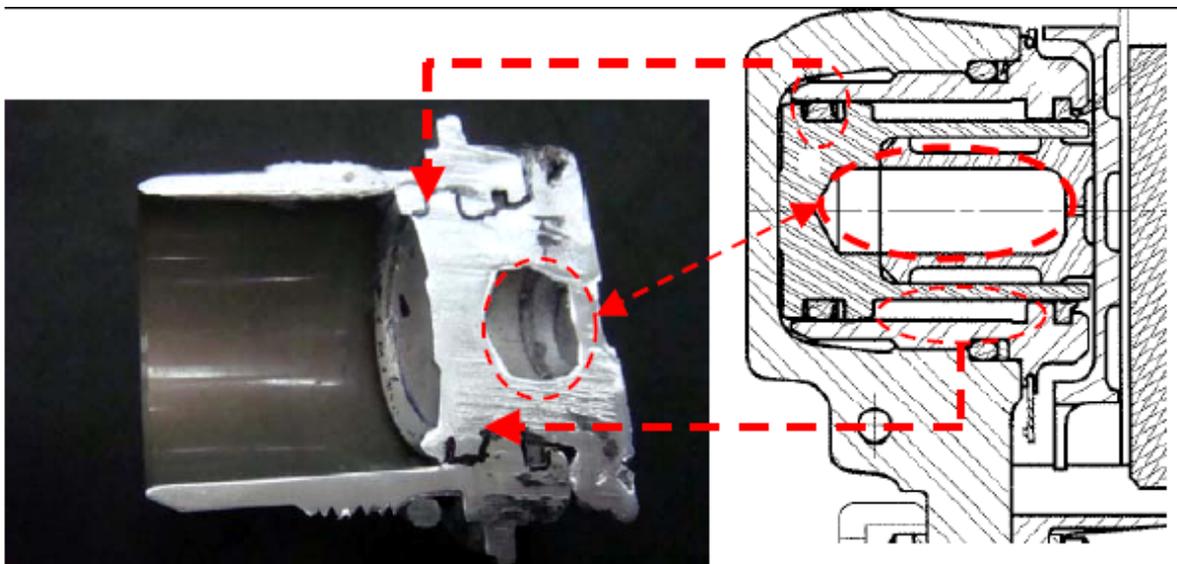
Figure 5

The inspection found that all three units displayed severe heat damage after experiencing 'exceptionally' high brake energies. The elastomeric static and dynamic piston seals were completely destroyed (seal degradation would have started at a temperature of 183°C). The aluminium alloy housings within the brake piston assembly had melted, indicating temperatures in excess of 200°C and the pistons themselves were significantly deformed (Figure 5). The protective coating on the carbon discs had been removed indicating temperatures in excess of 1,200°C.

Brake piston deformation
